City of Broken Arrow

Drainage Advisory Committee

PROJECT REPORT

DATE:	June 24, 2025
NAME	Tyler Yoak
ADDRESS / LOCATION	Indian Springs County Club
WATERSHED	Arkansas River (Elm Creek)
ESTIMATE	\$125,000
CASE NO.	25-015

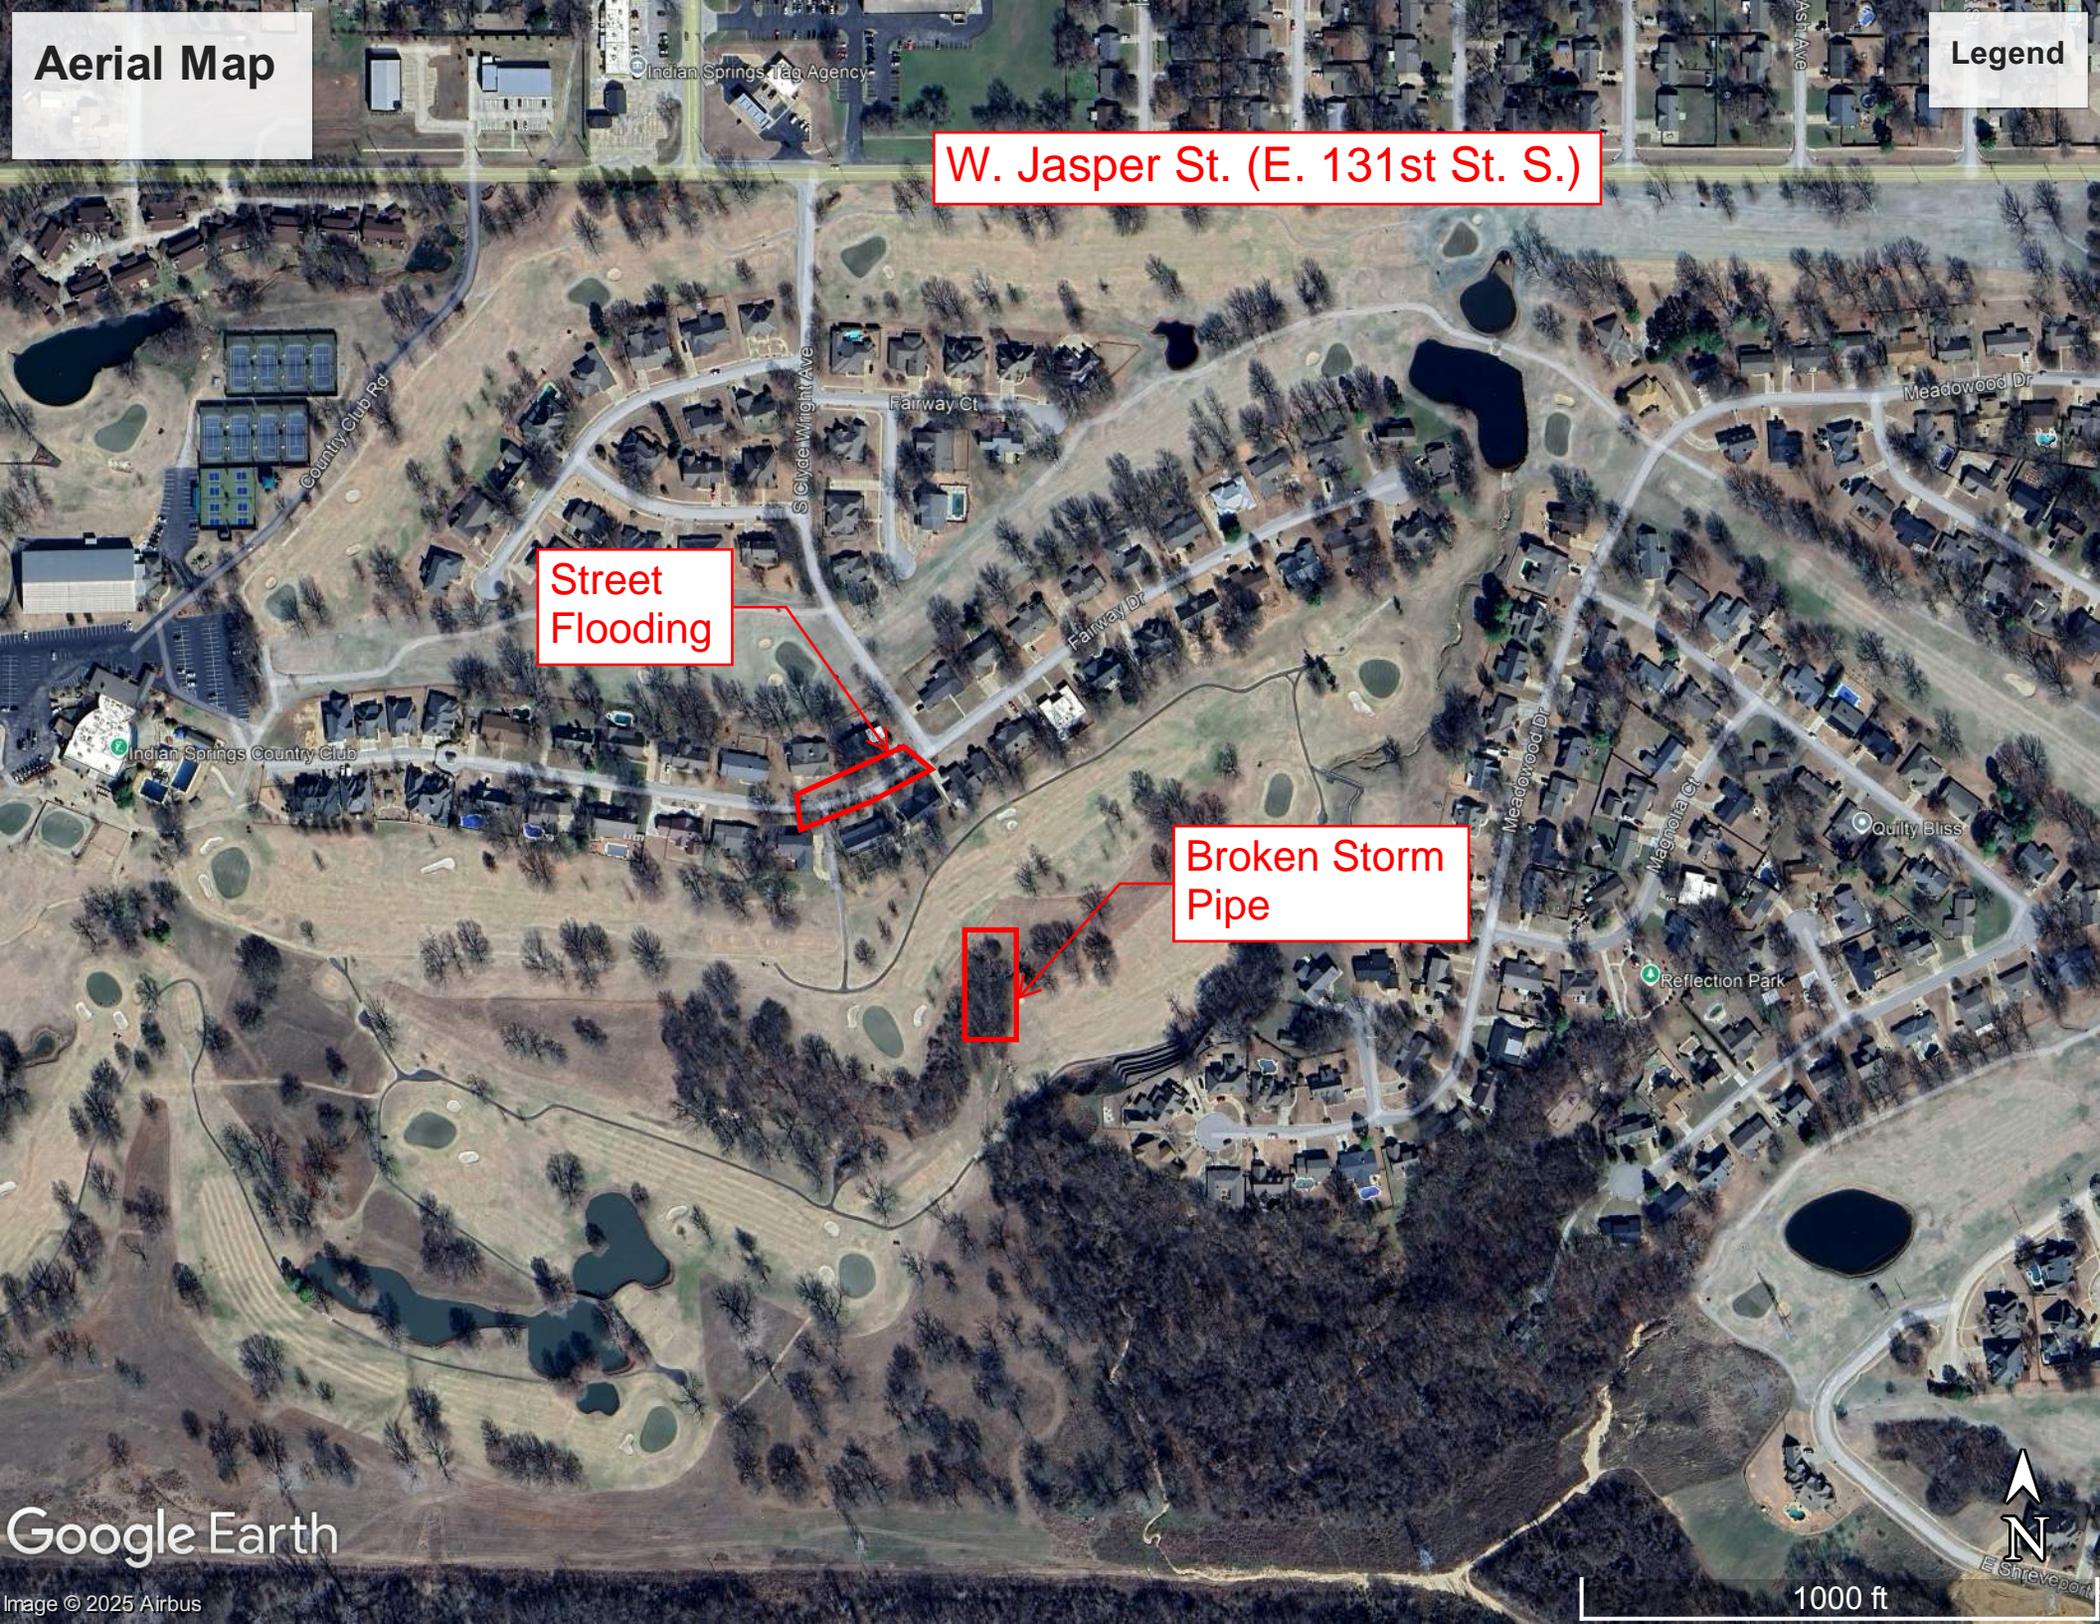
Street
Flooding

Broken Storm
Pipe

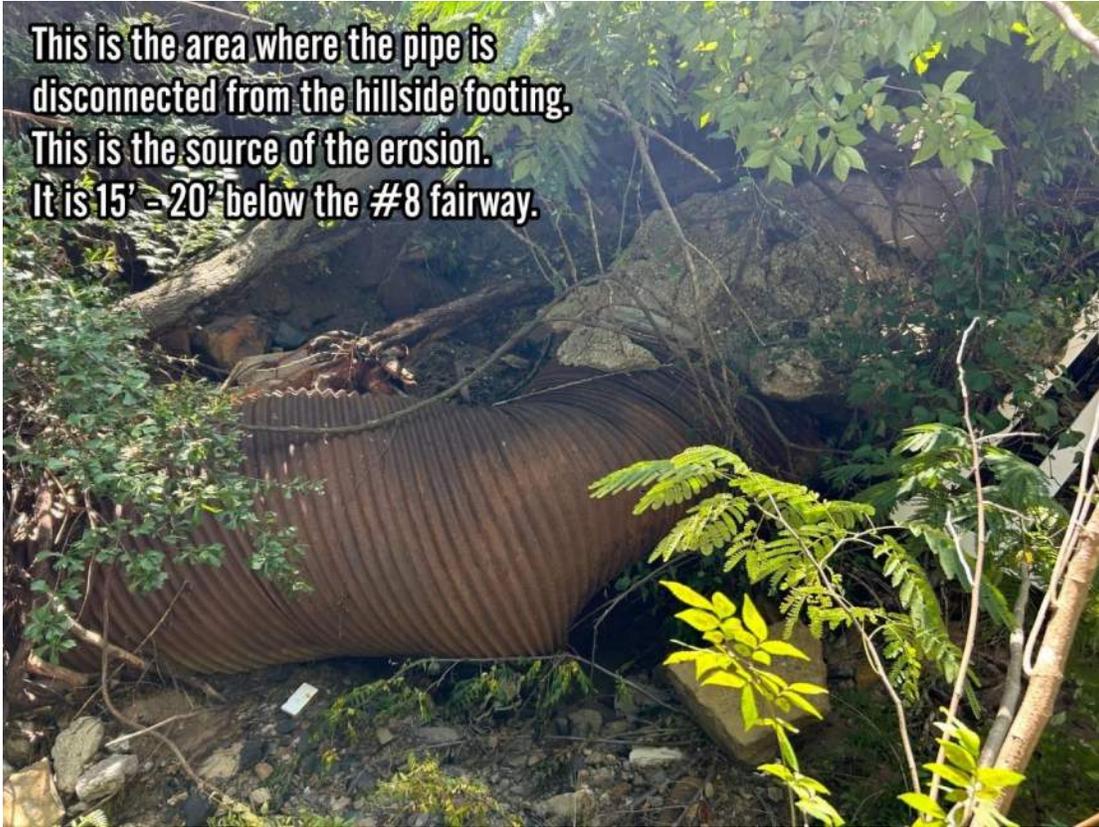
This is the area where the pipe is disconnected from the hillside footing. This is the source of the erosion. It is 15' - 20' below the #8 fairway.

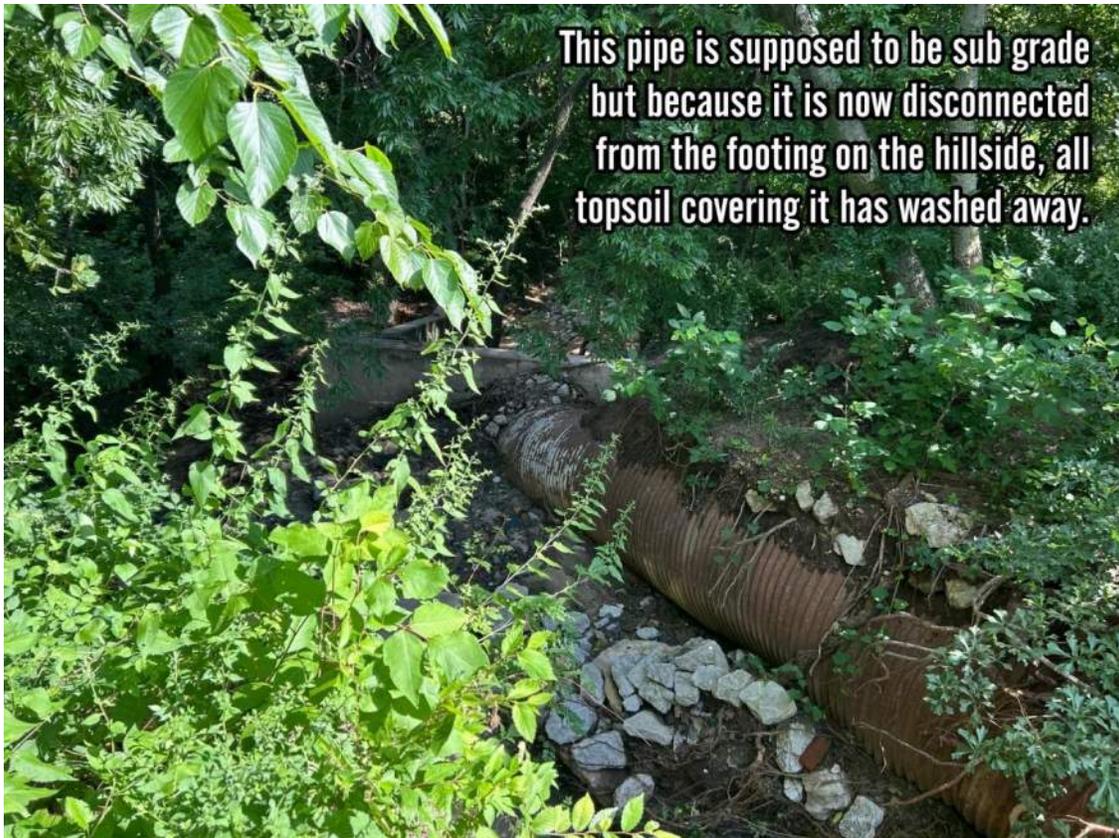
This pipe is supposed to be sub grade but because it is now disconnected from the footing on the hillside, all topsoil covering it has washed away.

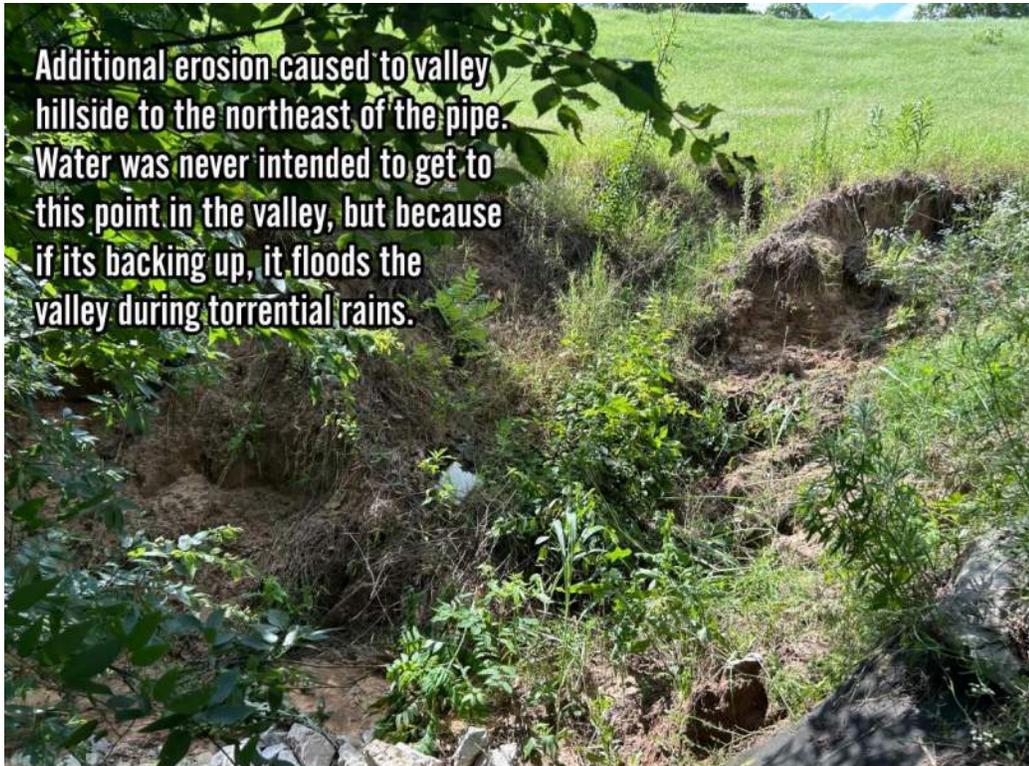
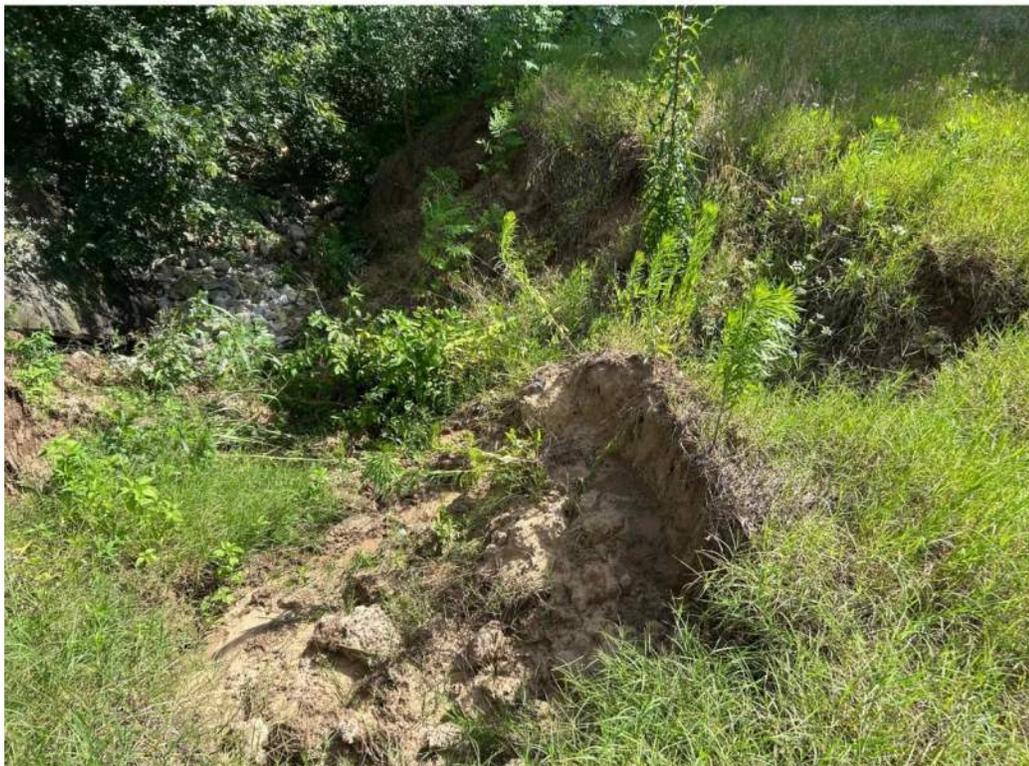
**Additional erosion caused to valley
hillside to the northeast of the pipe.
Water was never intended to get to
this point in the valley, but because
if its backing up, it floods the
valley during torrential rains.**

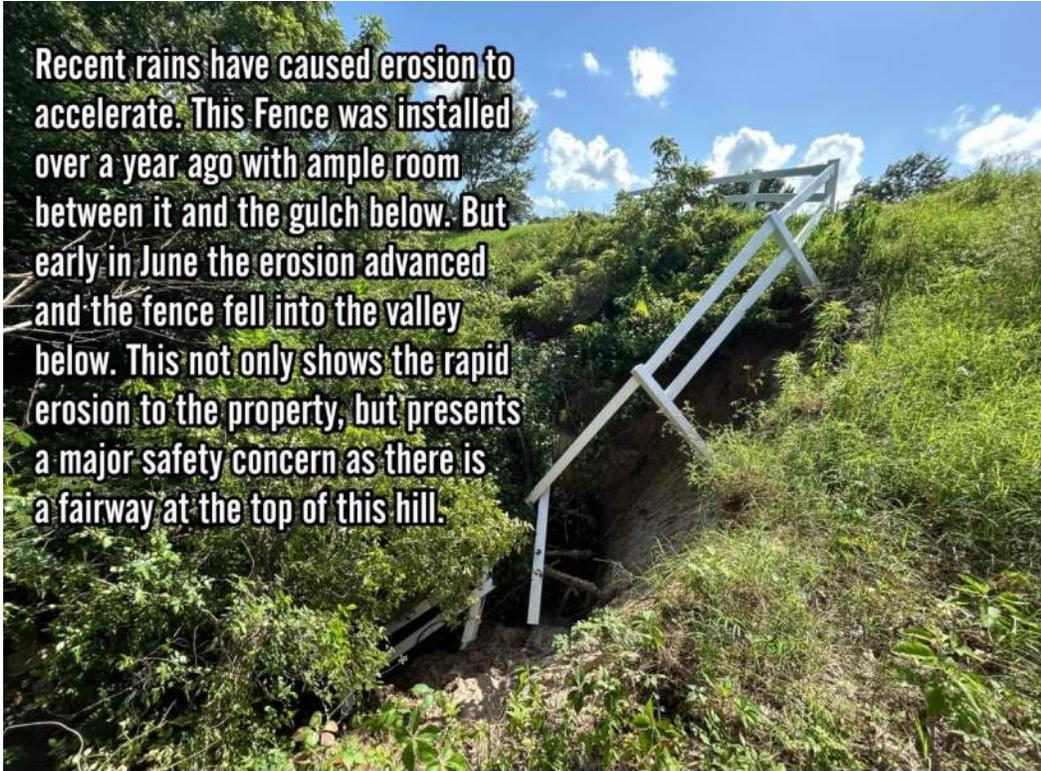
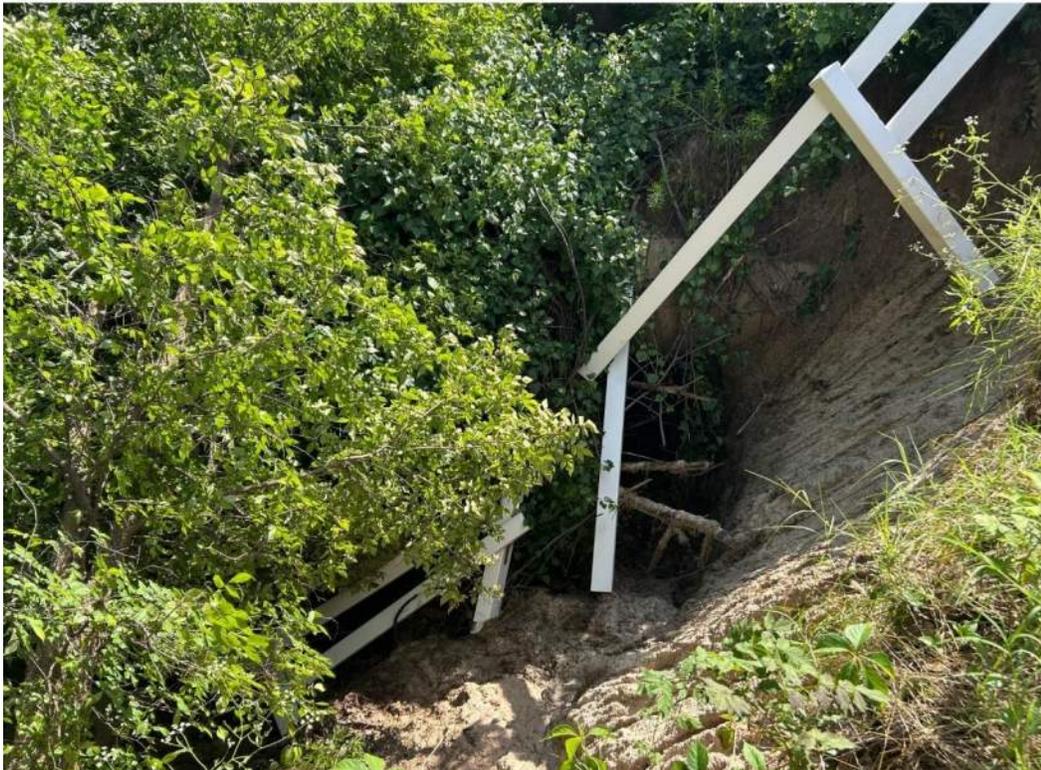
Recent rains have caused erosion to accelerate. This Fence was installed over a year ago with ample room between it and the gulch below. But early in June the erosion advanced and the fence fell into the valley below. This not only shows the rapid erosion to the property, but presents a major safety concern as there is a fairway at the top of this hill.
