City of Broken Arrow

Drainage Advisory Committee

PROJECT REPORT

DATE:	January 23, 2024
NAME	Patrick Wilson, City of Broken Arrow
ADDRESS / LOCATION	
WATERSHED	Adams Creek
ESTIMATE	\$50,000.00
CASE NO.	24-002

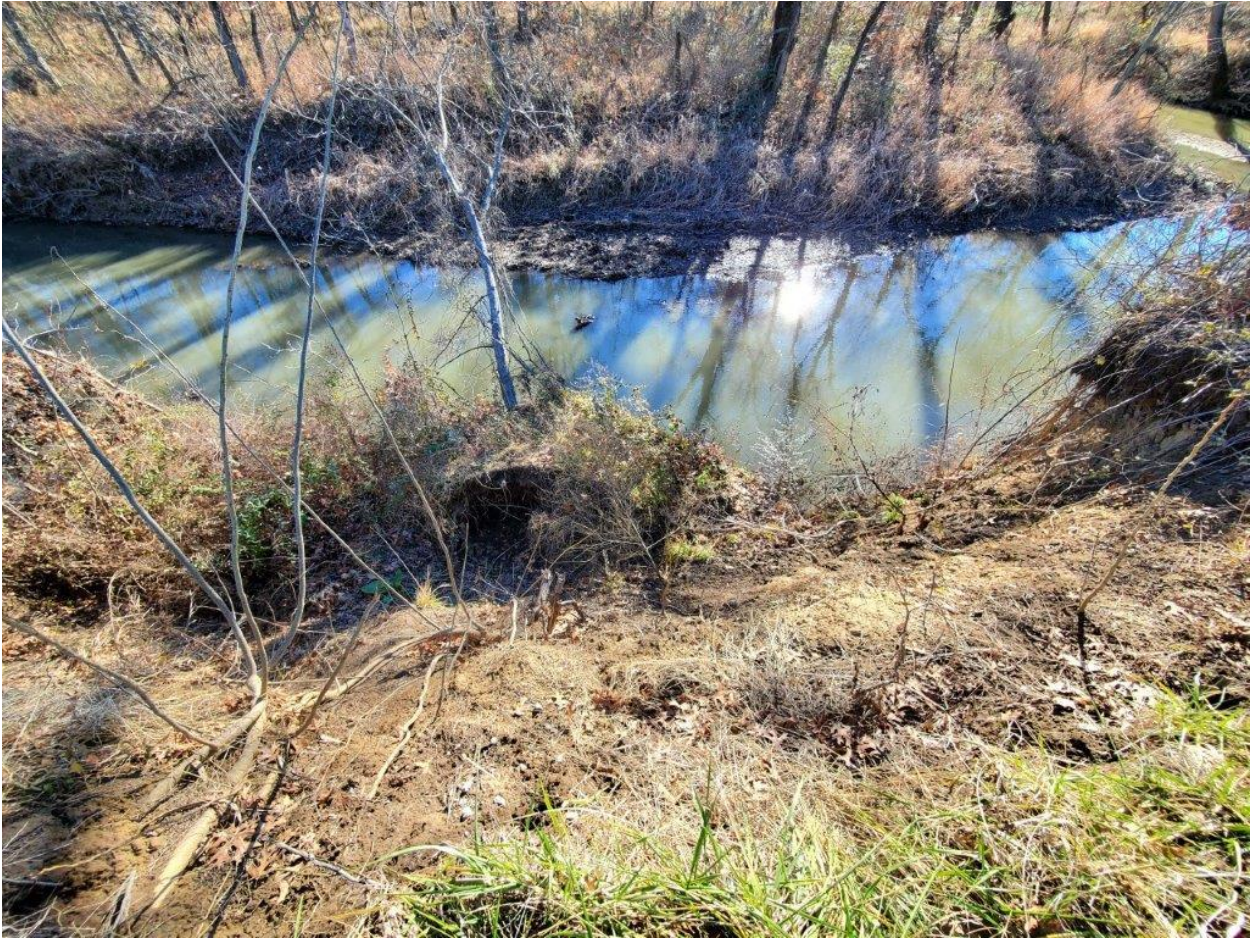
On walking trail, looking down to stream

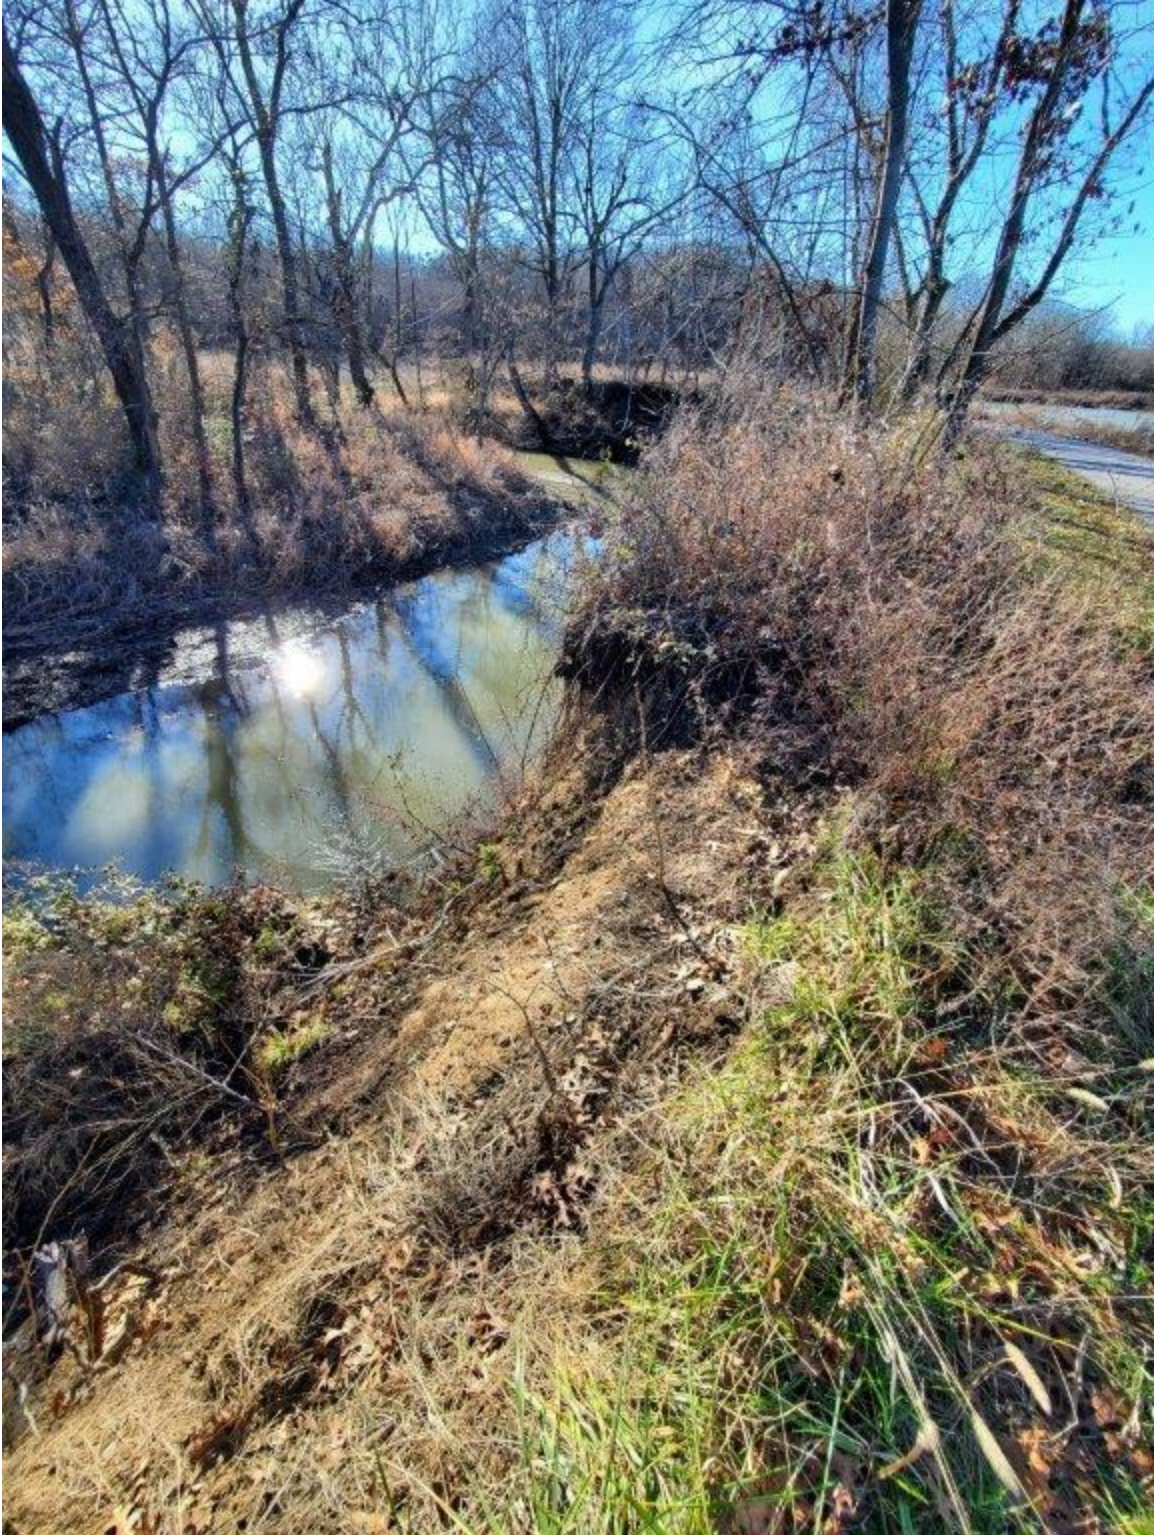
Looking along bank

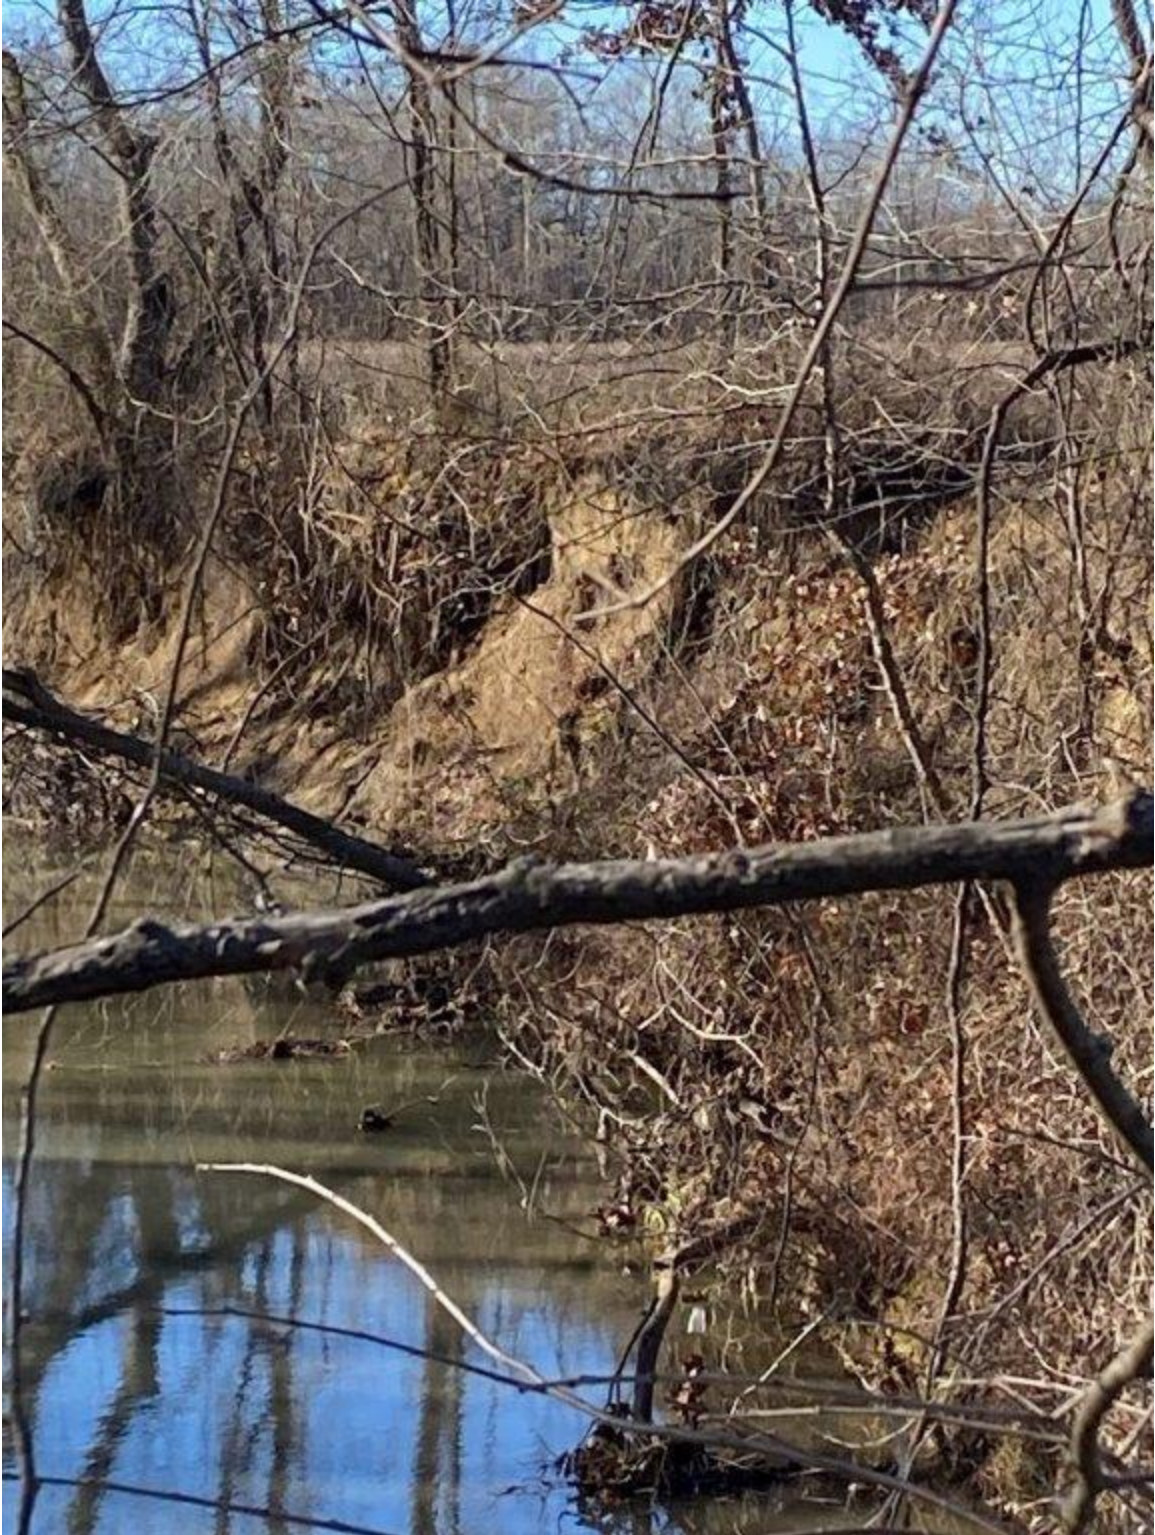
Looking along bank

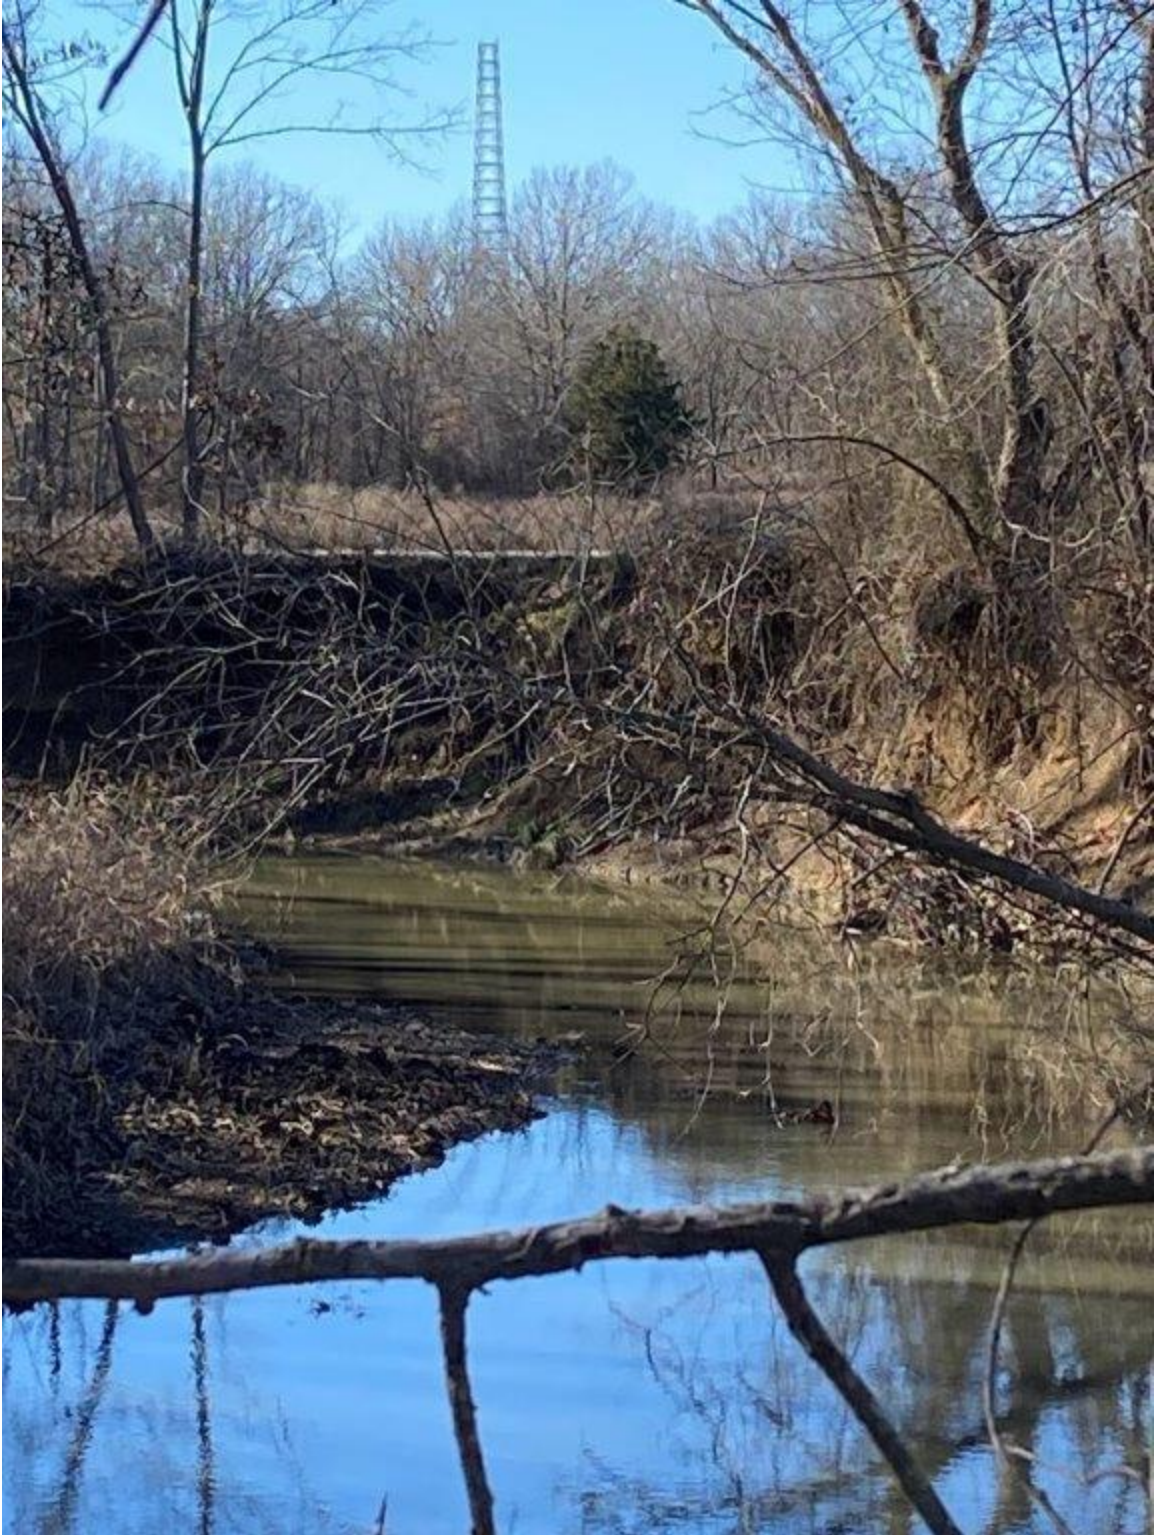
Looking along the bank

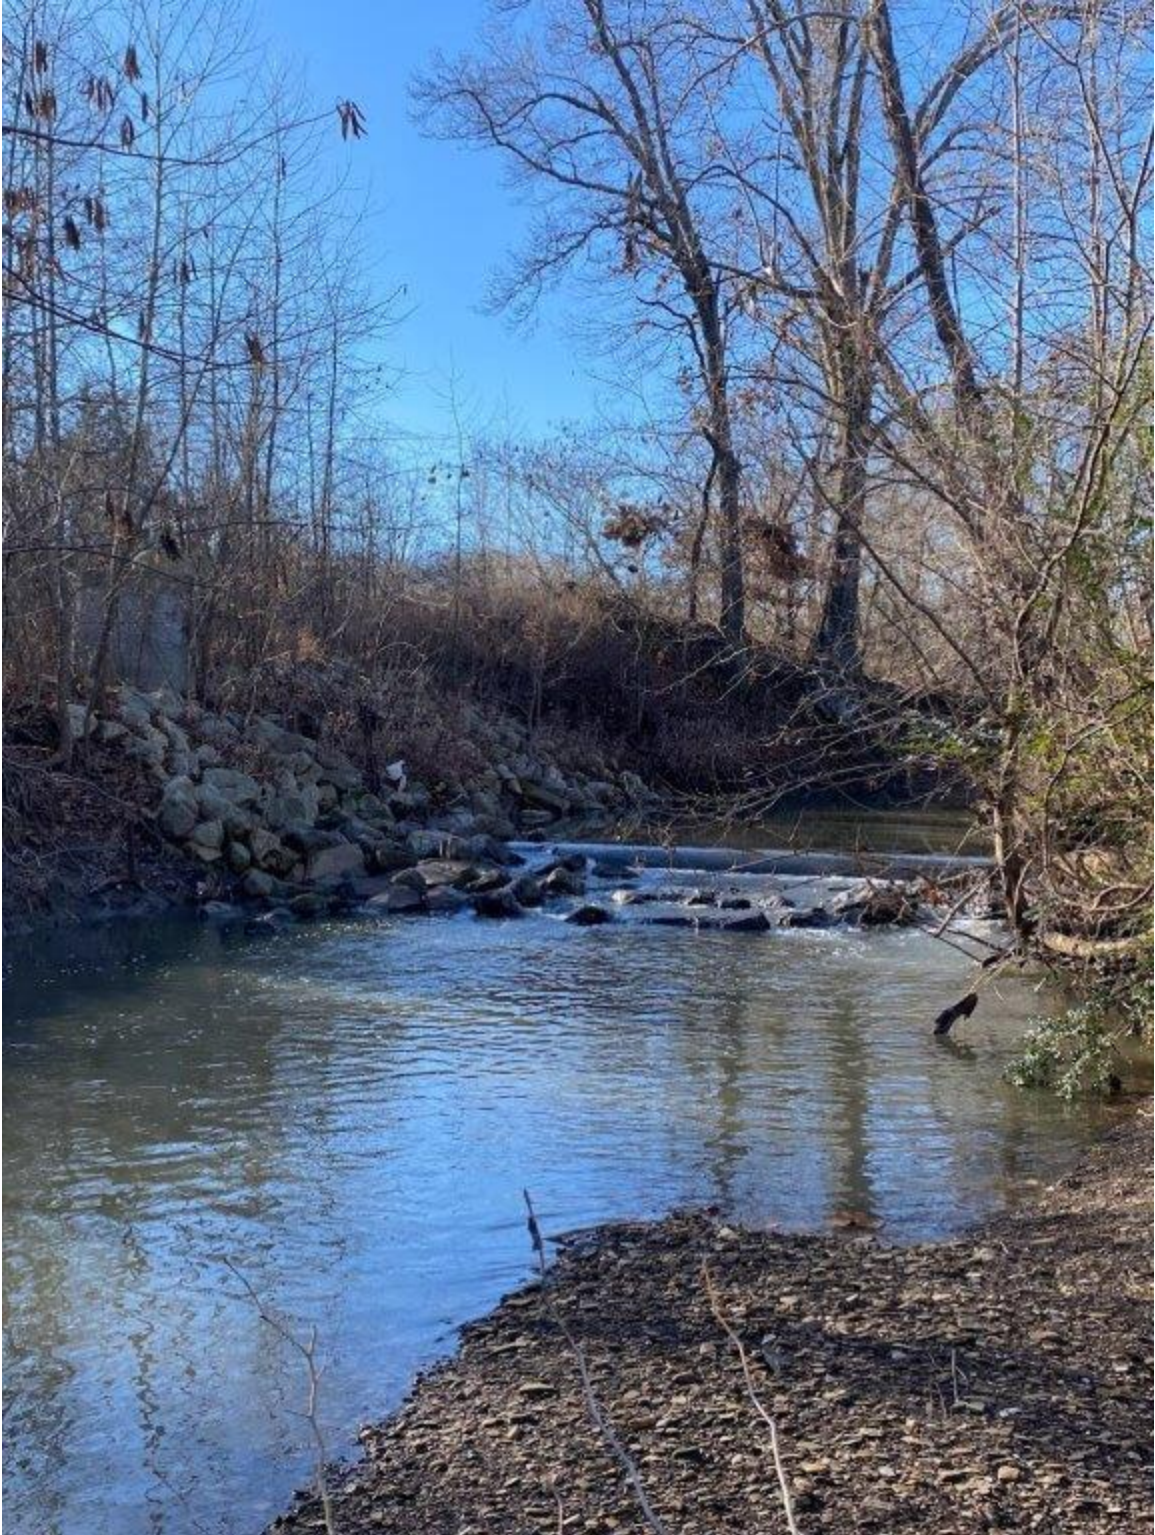
A 30-inch sanitary sewer runs parallel to the detention pond and along/through Adams Creek to the Adams Creek Northwest lift station. A portion of the steel casing over the line is exposed on the creek.

Looking upstream to sanitary sewer line.
