Memorandum:

Recommendation for Termination of Contract #23300 – Brentwood  
Concrete Panel Replacement Street Repair

Exhibit 1:

Photos of Contractor Deficiencies

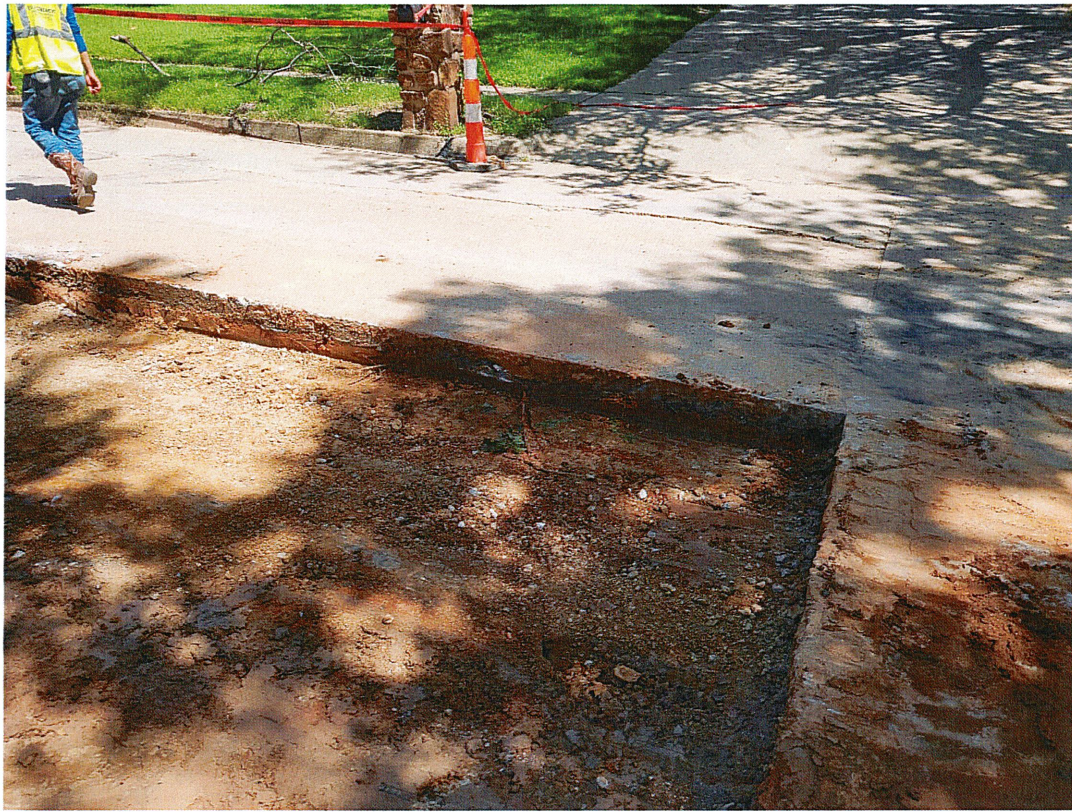
*Figure 1: Improper Depth of Sawcut*

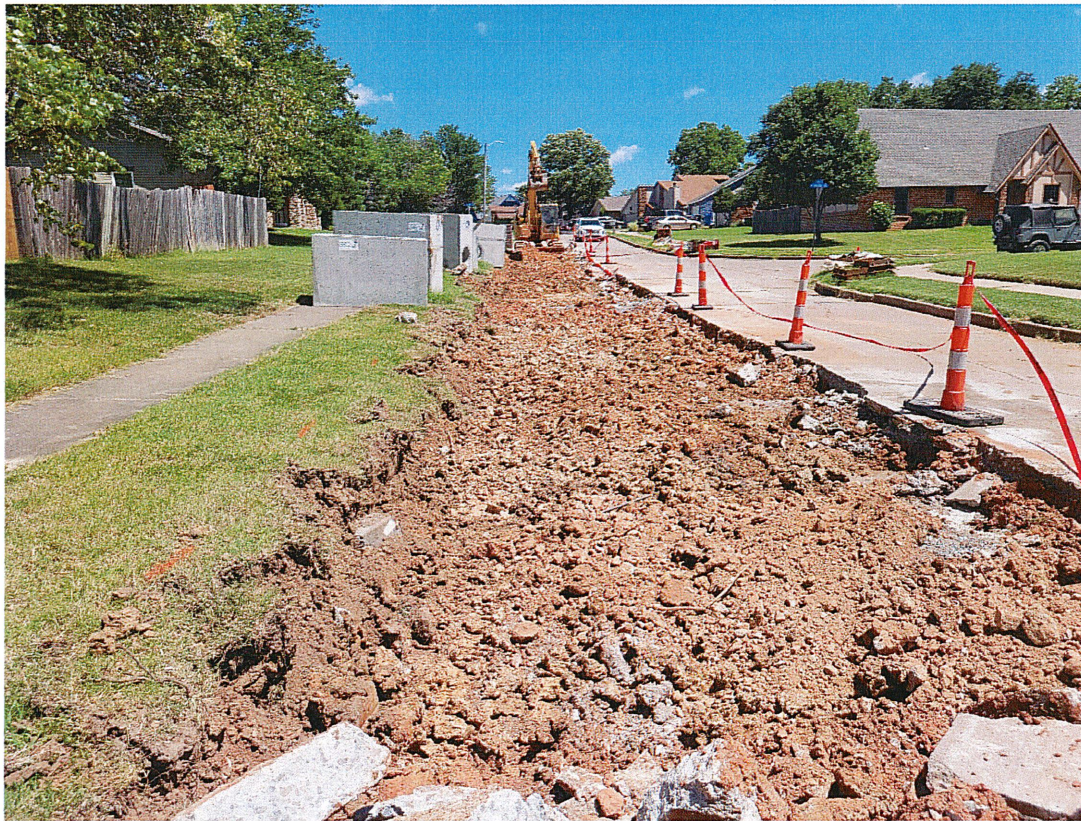
*Figure 2: No Sawcut on right*

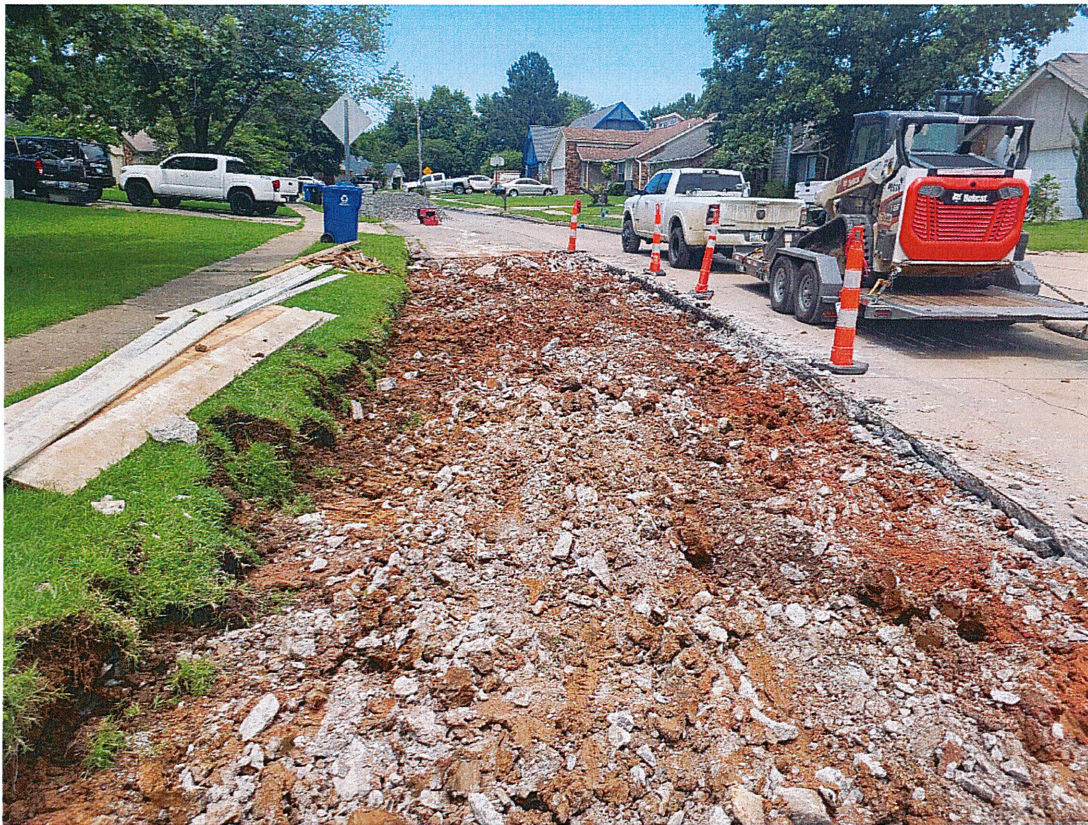
*Figure 3: Scouring on right but not full depth cut, dowels still intact from no sawcut*

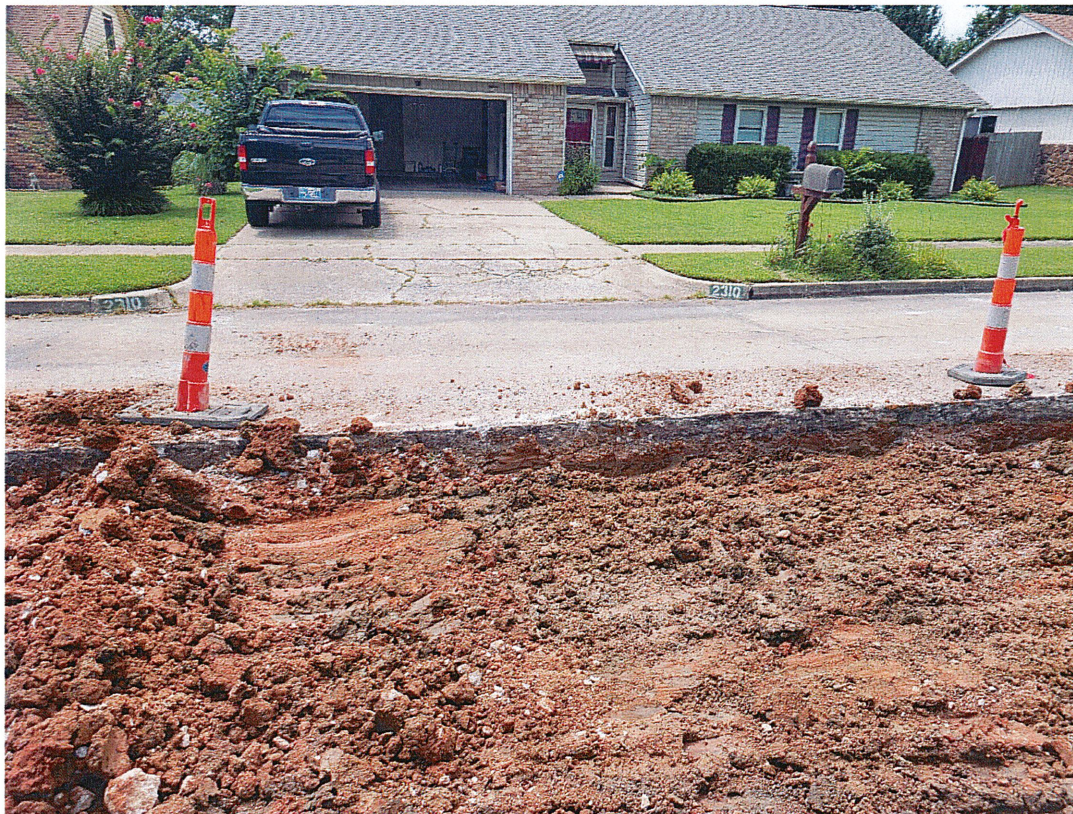
*Figure 4: Subgrade too wet, chipping, scouring*

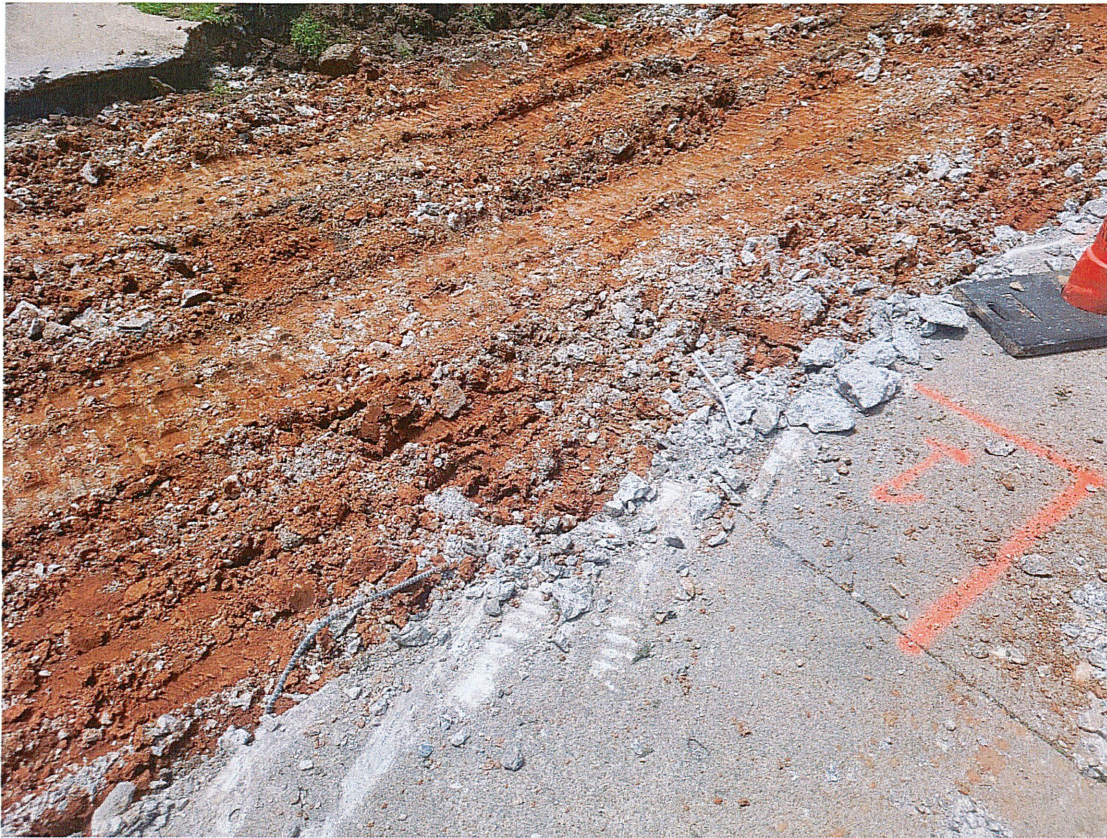
*Figure 5: Teeth marks showing excavator used to break concrete*

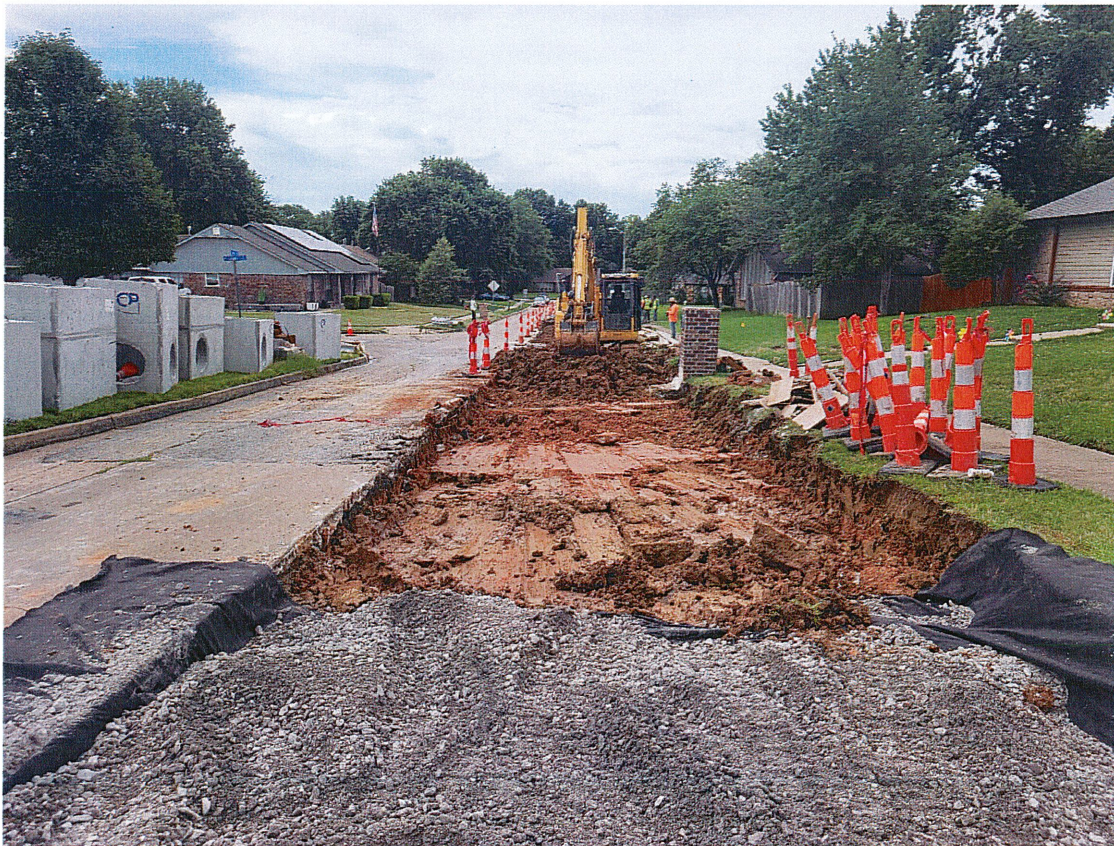
*Figure 6: Underbreakage and chipping on left*

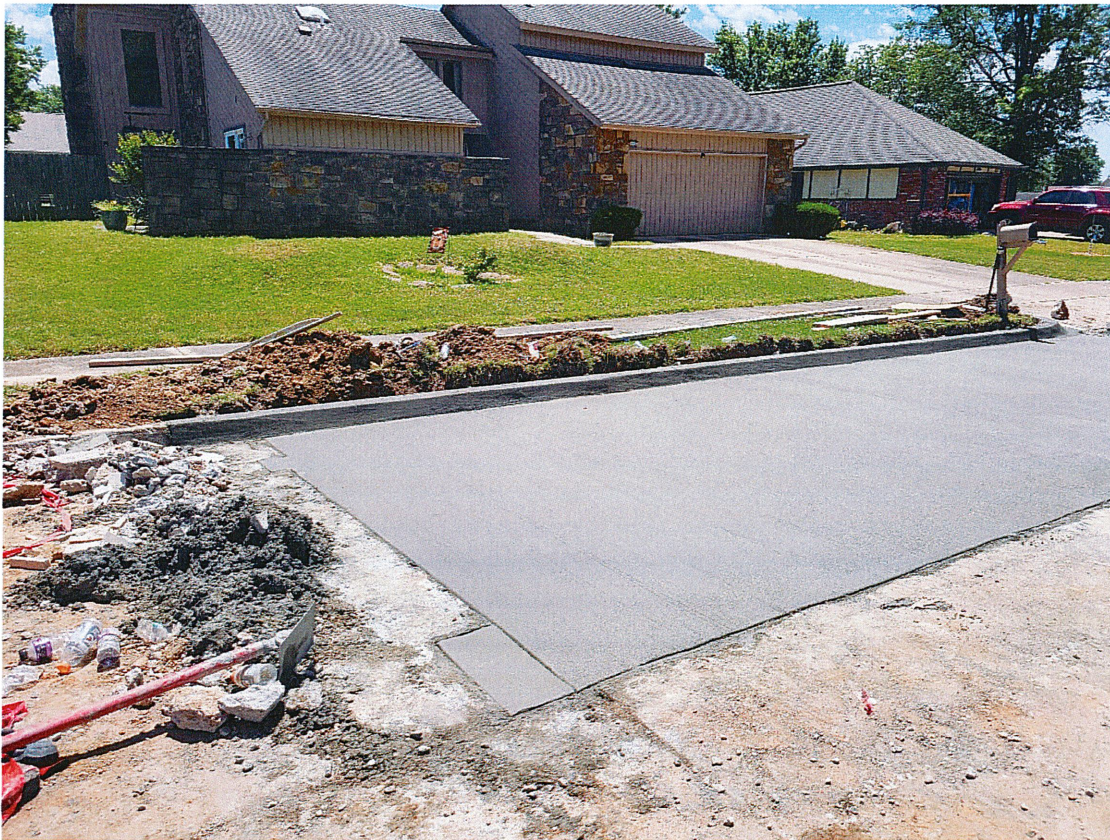
*Figure 7: Improper edge line due to chipping*

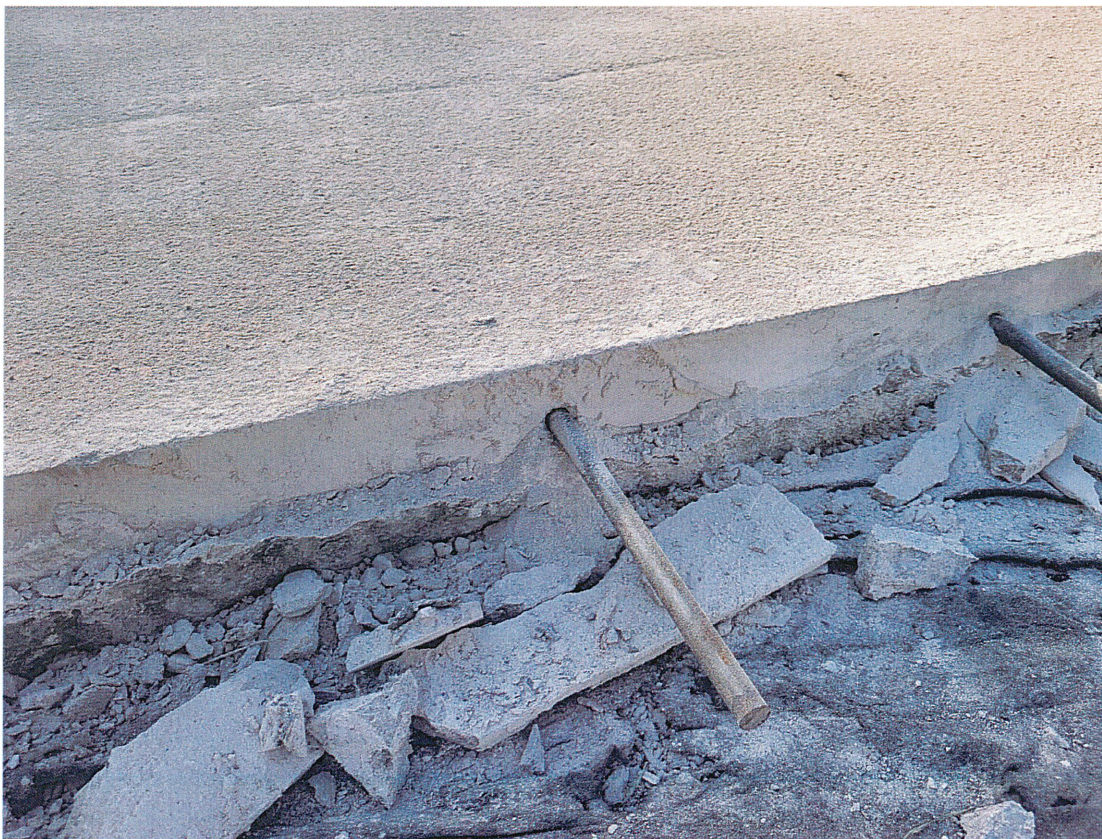
*Figure 8: no epoxy, improper sawcut depth*

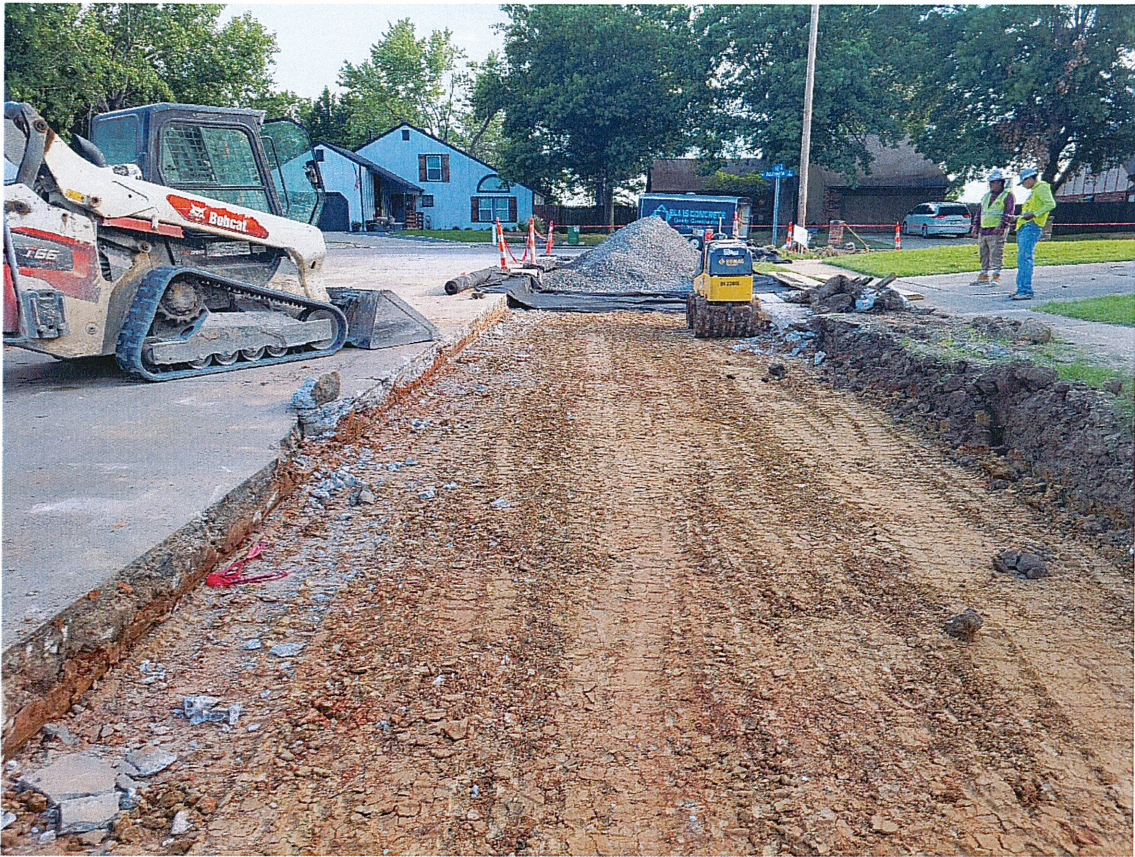
*Figure 9: Left Edge scoured, chipped and underbreakage*

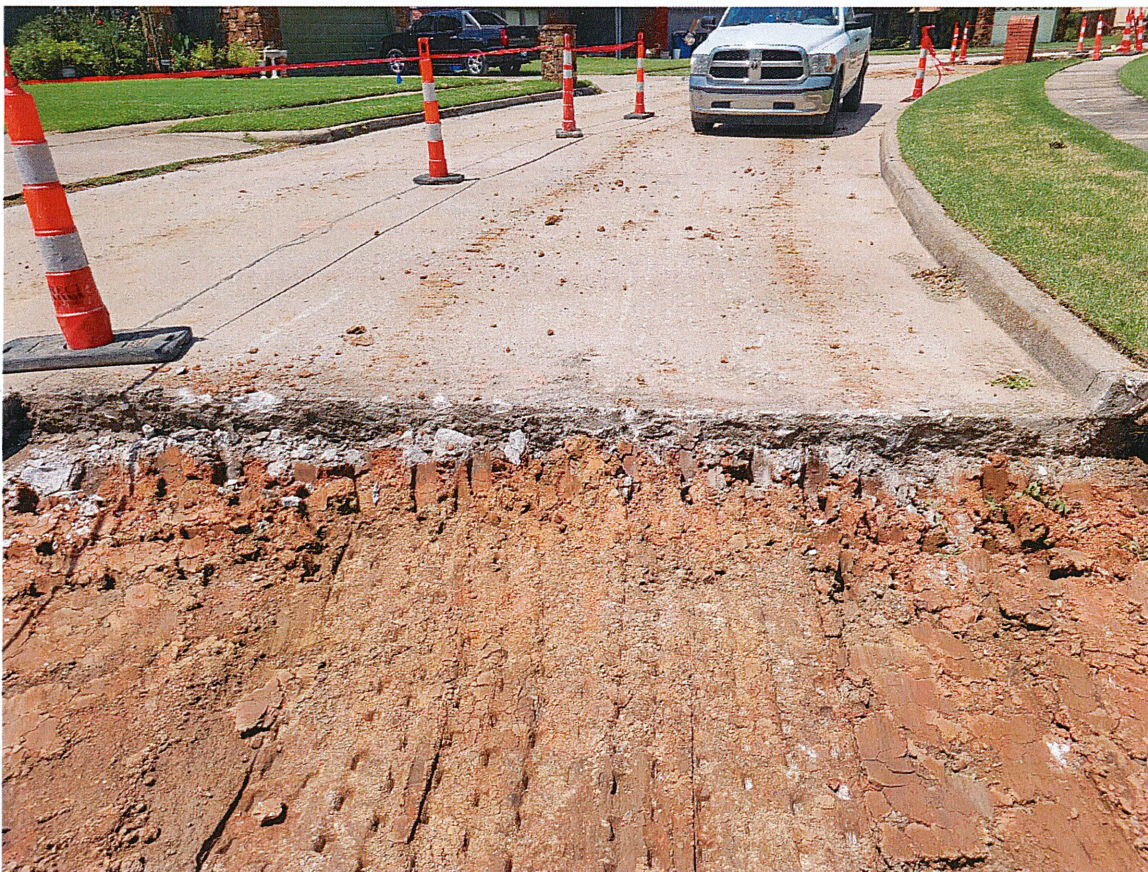
*Figure 10: chipping from Excavator*

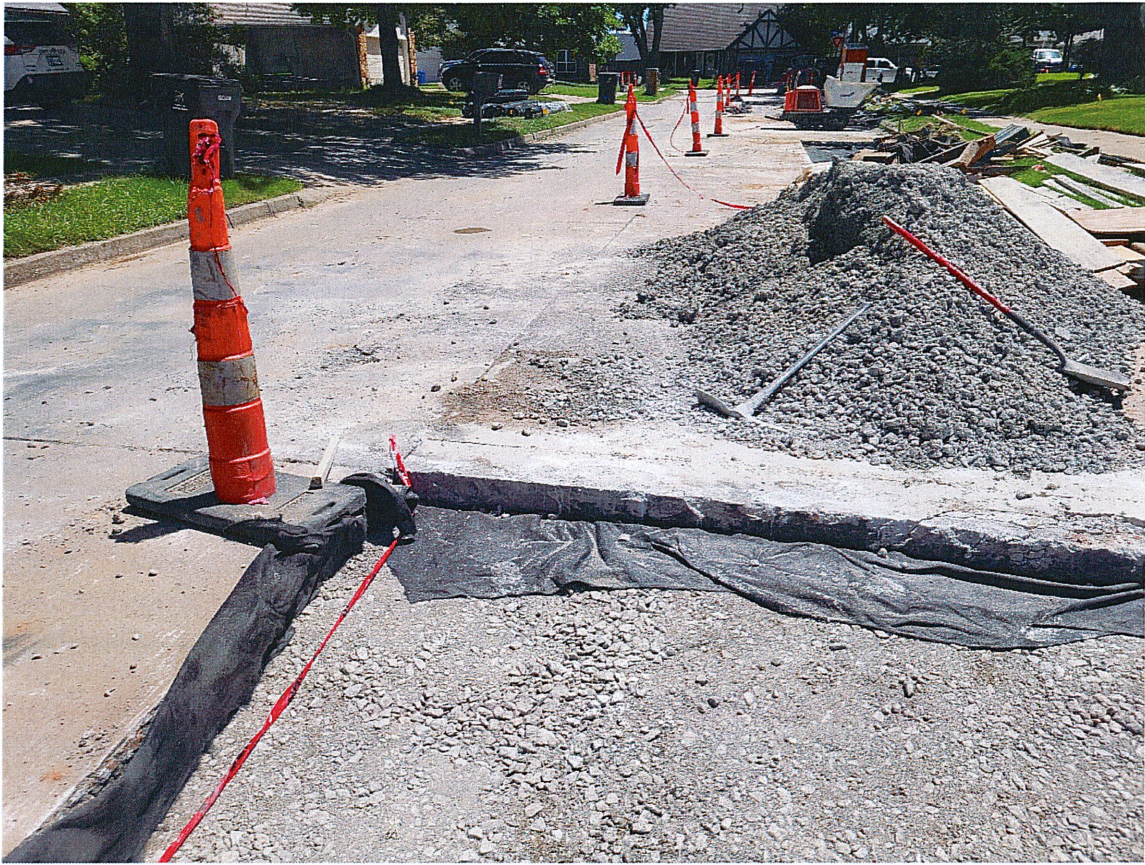
*Figure 11: New edge cut due to chipping and improper methods*

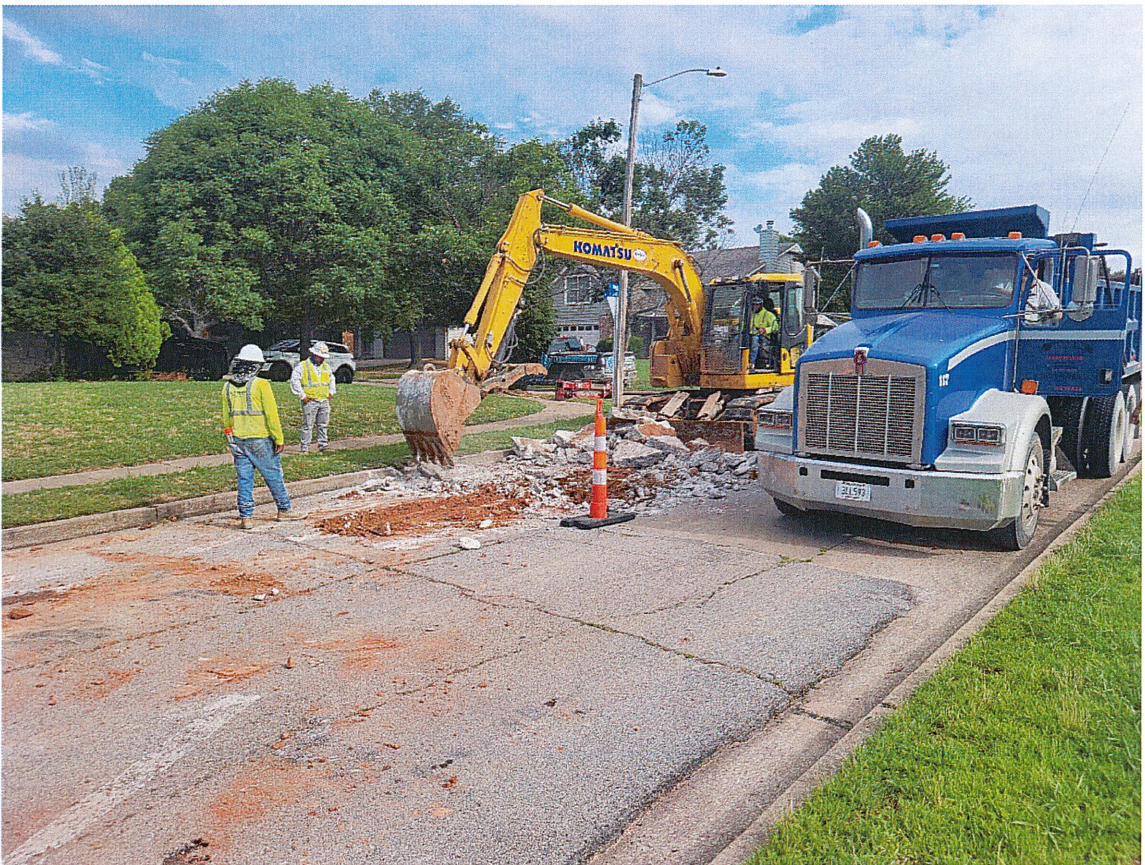
*Figure 12: Active breaking using excavator*

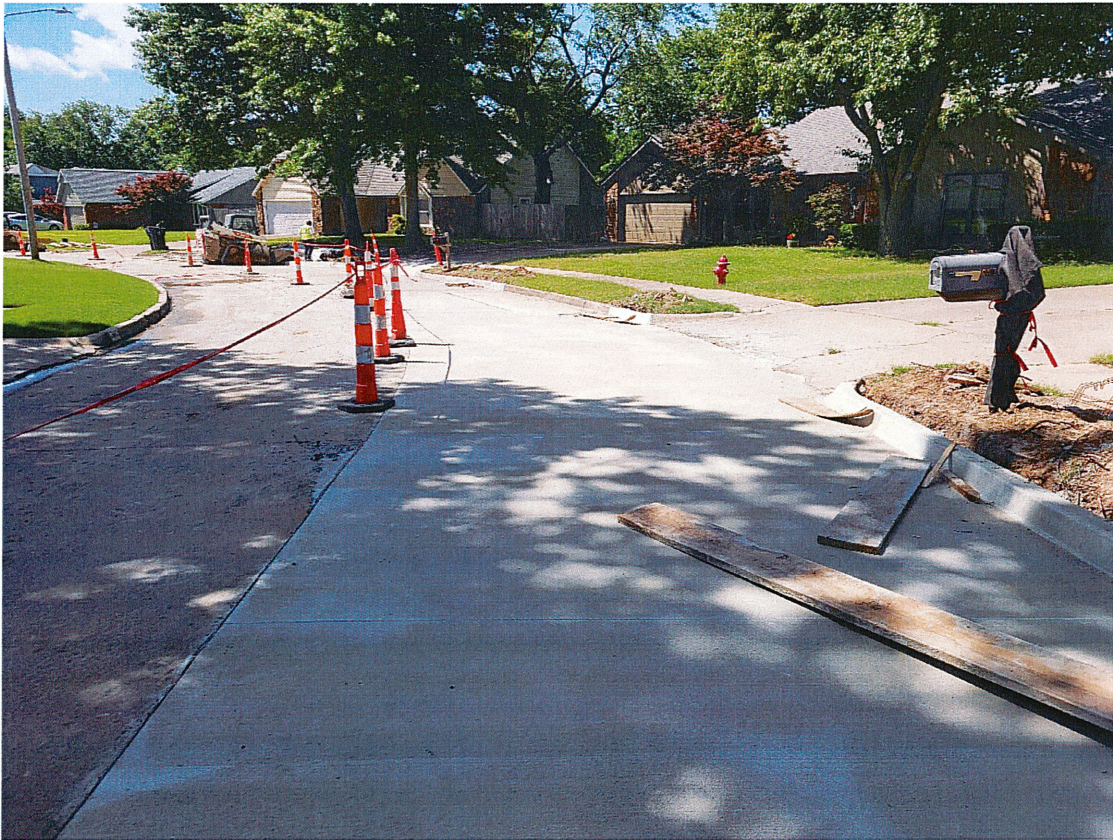
*Figure 13: showing centerline being filled due to chipping*

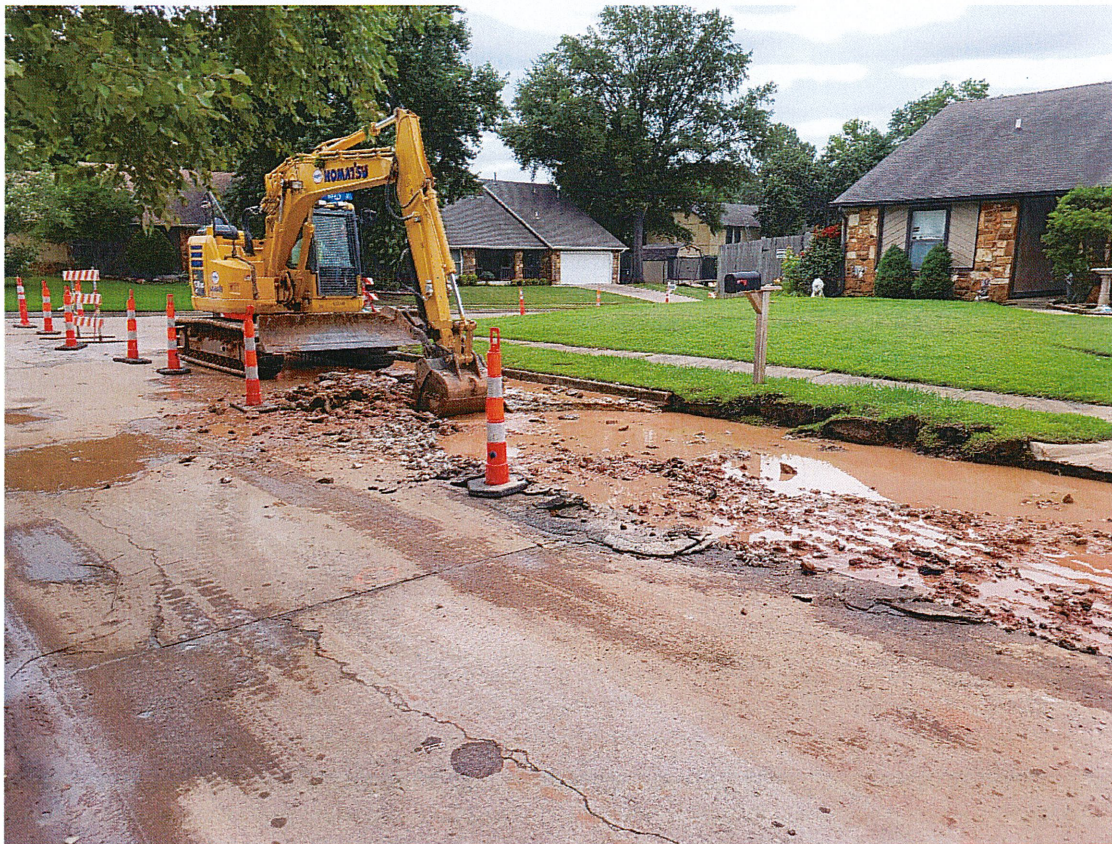
*Figure 14: Showing active use of excavator to break*

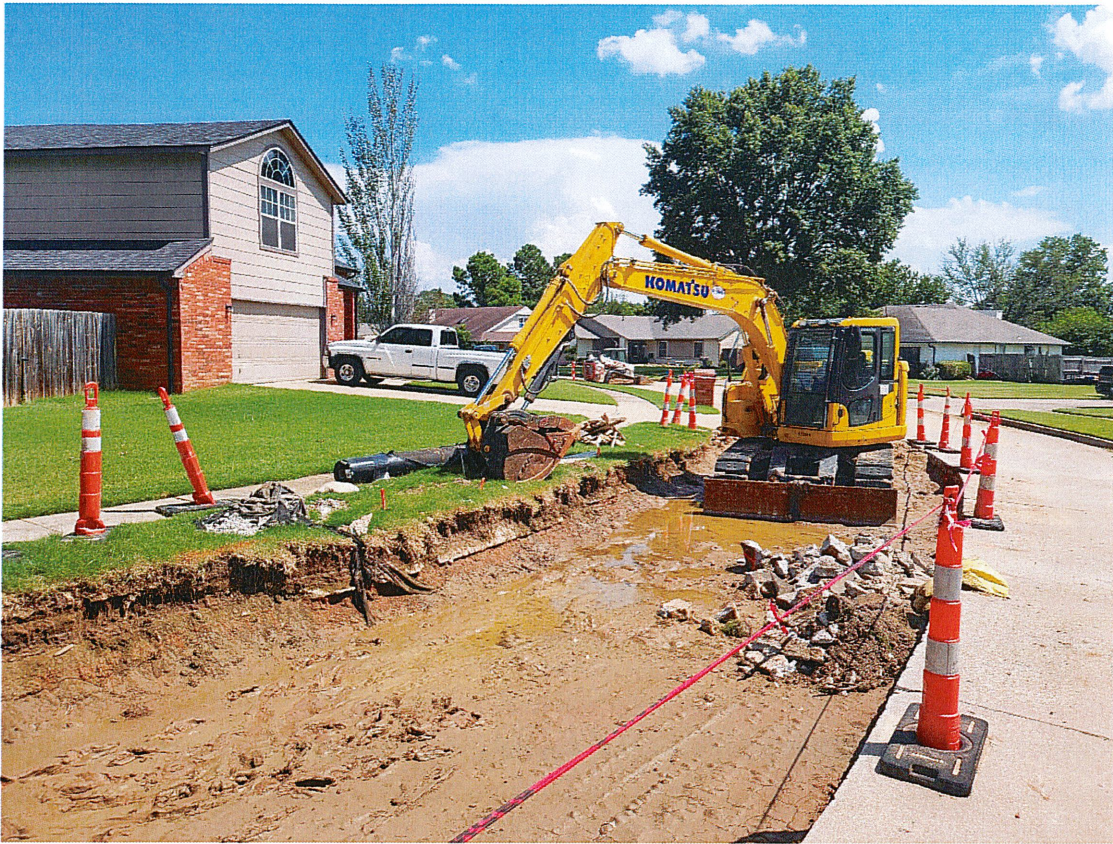
*Figure 17: 3rd Day no pumping*

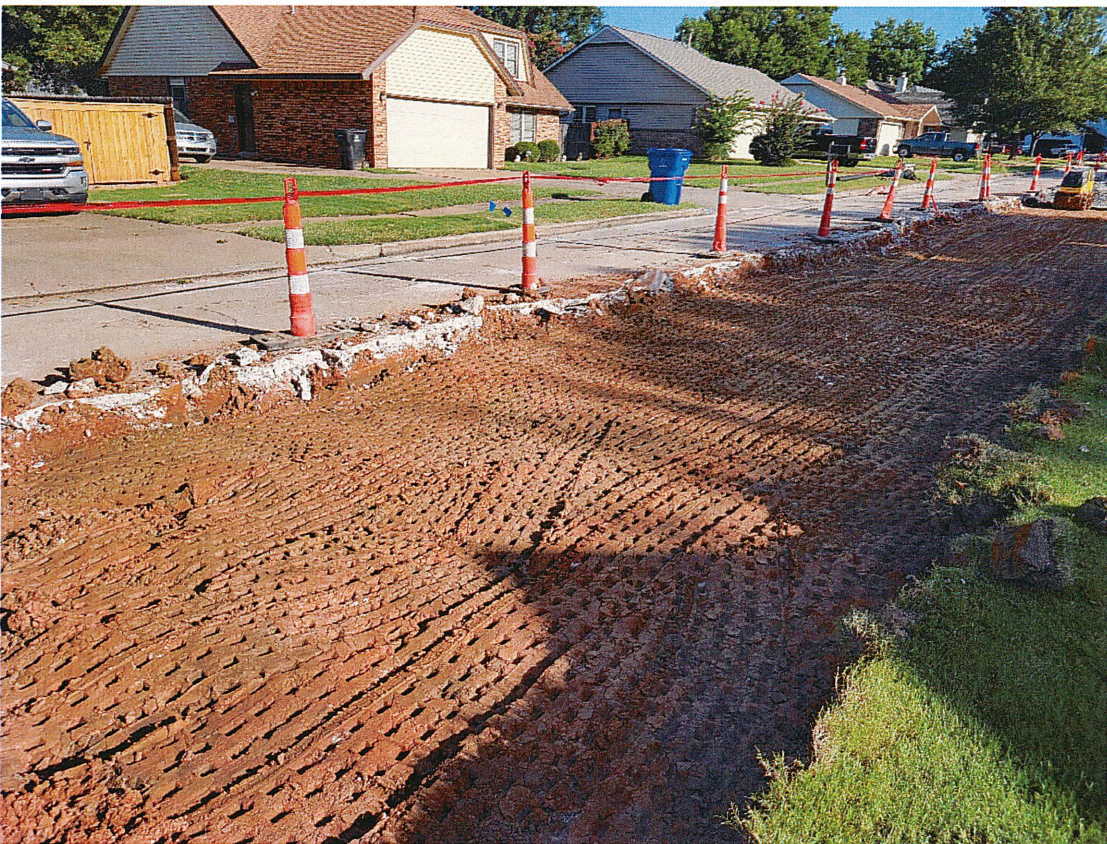
*Figure 18: Failed roll test on subgrade*

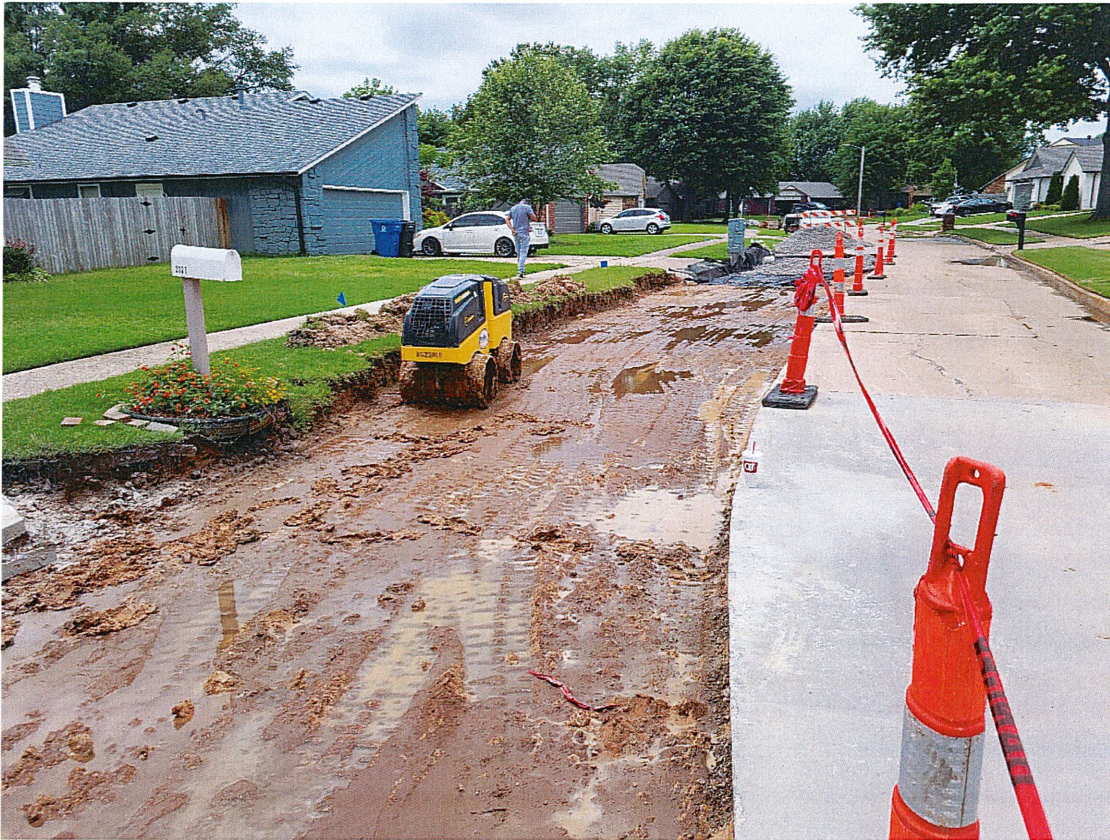
*Figure 19: Contractor trying to compact when too wet*

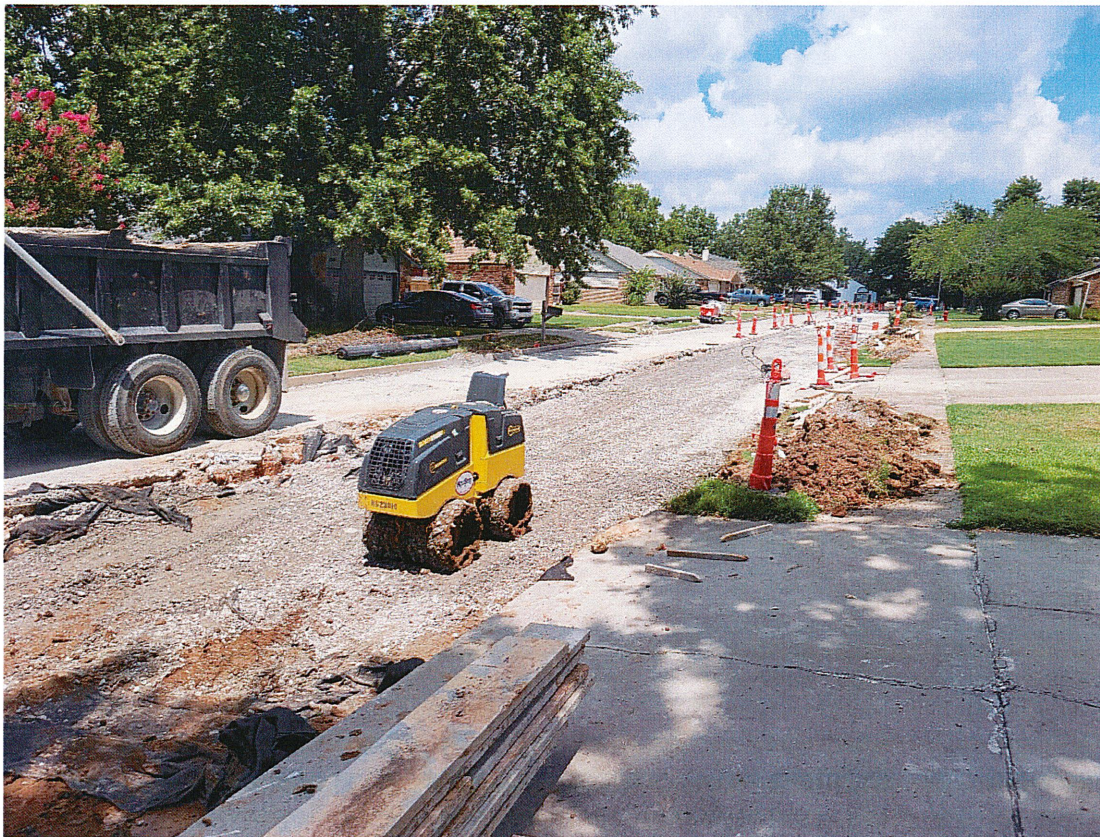
*Figure 20: Showing material too wet to compact*

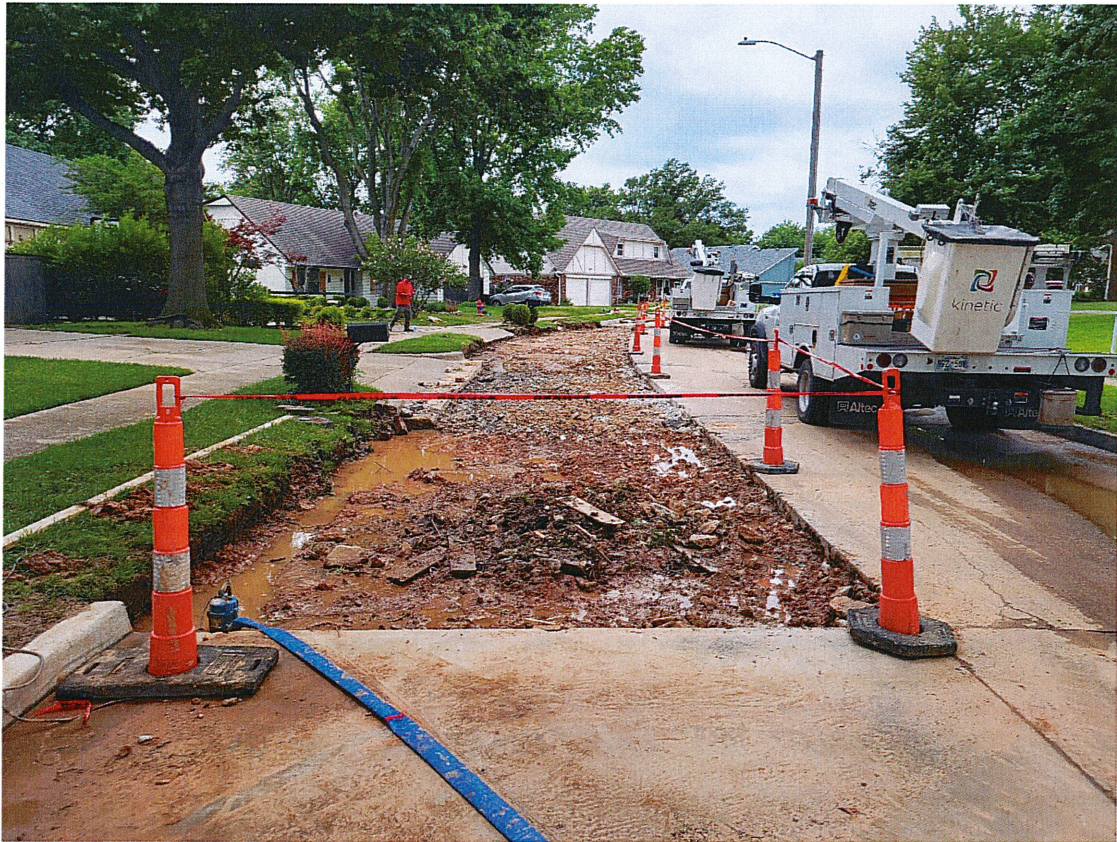
*Figure 21: No excavation 1 foot past curb*

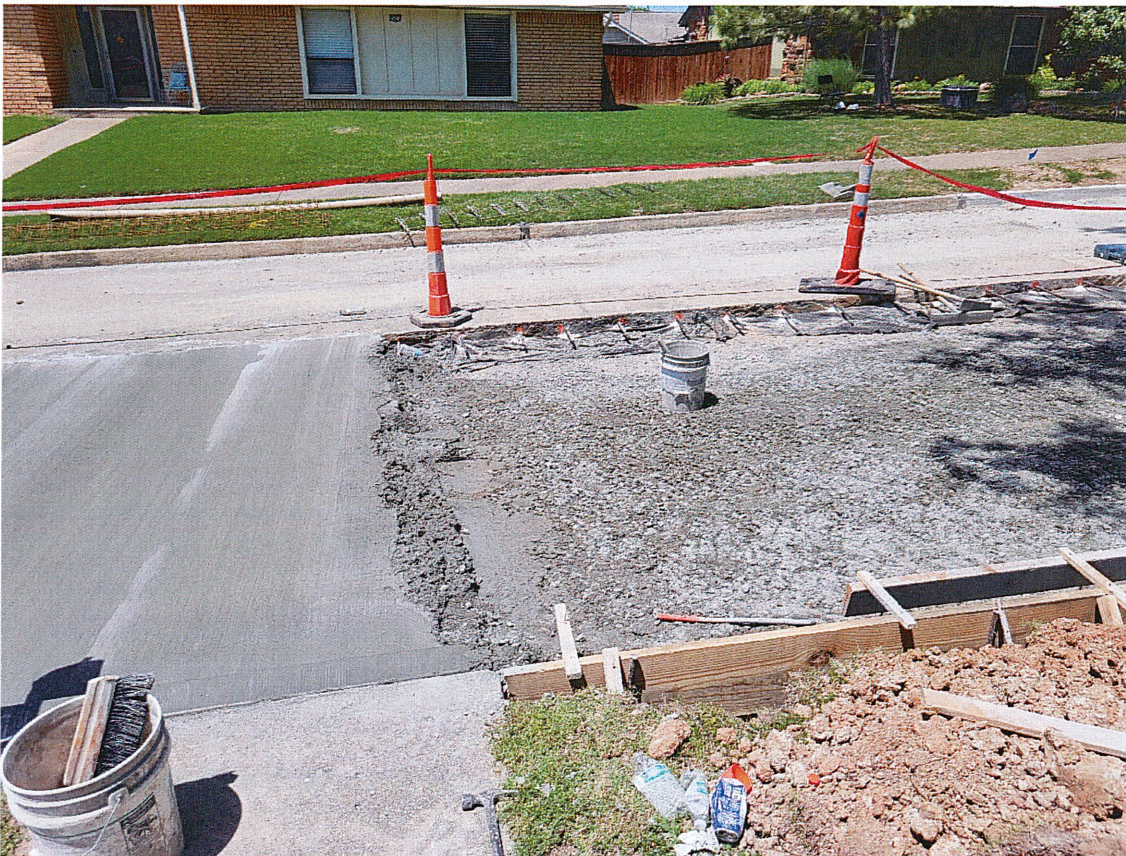
*Figure 22: No Form Board on end of pour*
