# City of Broken Arrow

## PROJECT REPORT

| ADDRESS / LOCATION | Liberty Trail along Creek Turnpike, west of S. Elm St. |

**Subject: Liberty Trail retaining wall evaluation – Broken Arrow, OK**

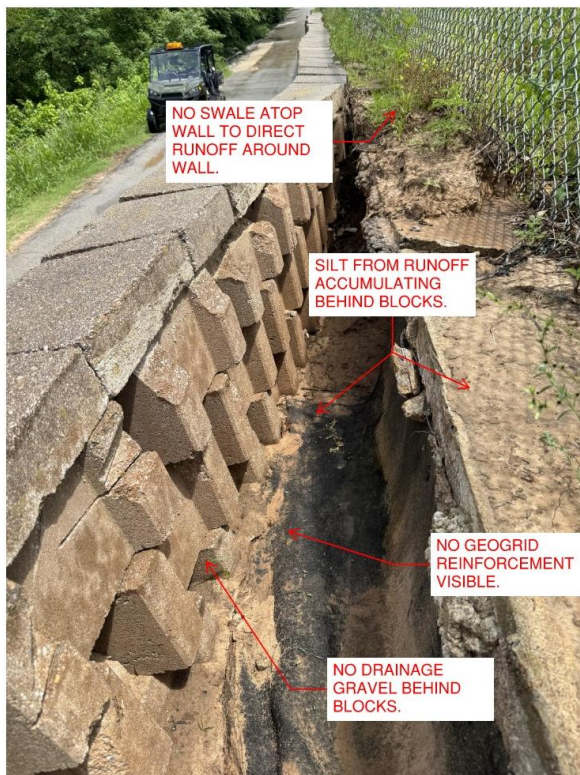
Figure 1: Bulge in wall

- A pronounced bulge has developed in a section of the wall, where several blocks have dislodged from the earth fill behind them. (pictures at end of report)
- The wall exhibits significant undulations and surface irregularities that appear to exceed acceptable service tolerances.
- A chain-link fence installed atop the wall is contributing to instability, as its weight and lateral forces are causing separation in the upper block courses.

- The wall is located downslope from a highway approximately 35 feet away, with no evident drainage infrastructure to intercept runoff from the road. Surface water appears to be flowing directly toward the wall.
- Sediment accumulation behind the wall, as seen in the bulged section, suggests prolonged water migration and silt deposition are exerting pressure on the wall face (see Figure 1).

- **Demolish and reconstruct** the existing wall using a segmental block retaining wall system that complies with current industry standards and best practices.
- **Reuse existing block units** that remain in good structural condition to reduce material costs.
- **Install a surface drainage swale** along the top of the wall to intercept and redirect stormwater runoff from the turnpike, thereby minimizing water accumulation behind the wall.
