# City of Broken Arrow

## Drainage Advisory Committee

## PROJECT REPORT

DATE:	5/17/22
NAME	Brian Morgan
ADDRESS / LOCATION	315 West Galveston Street
WATERSHED	Haikey Creek
ESTIMATE	\$51,000.00
CASE NO.	22-004

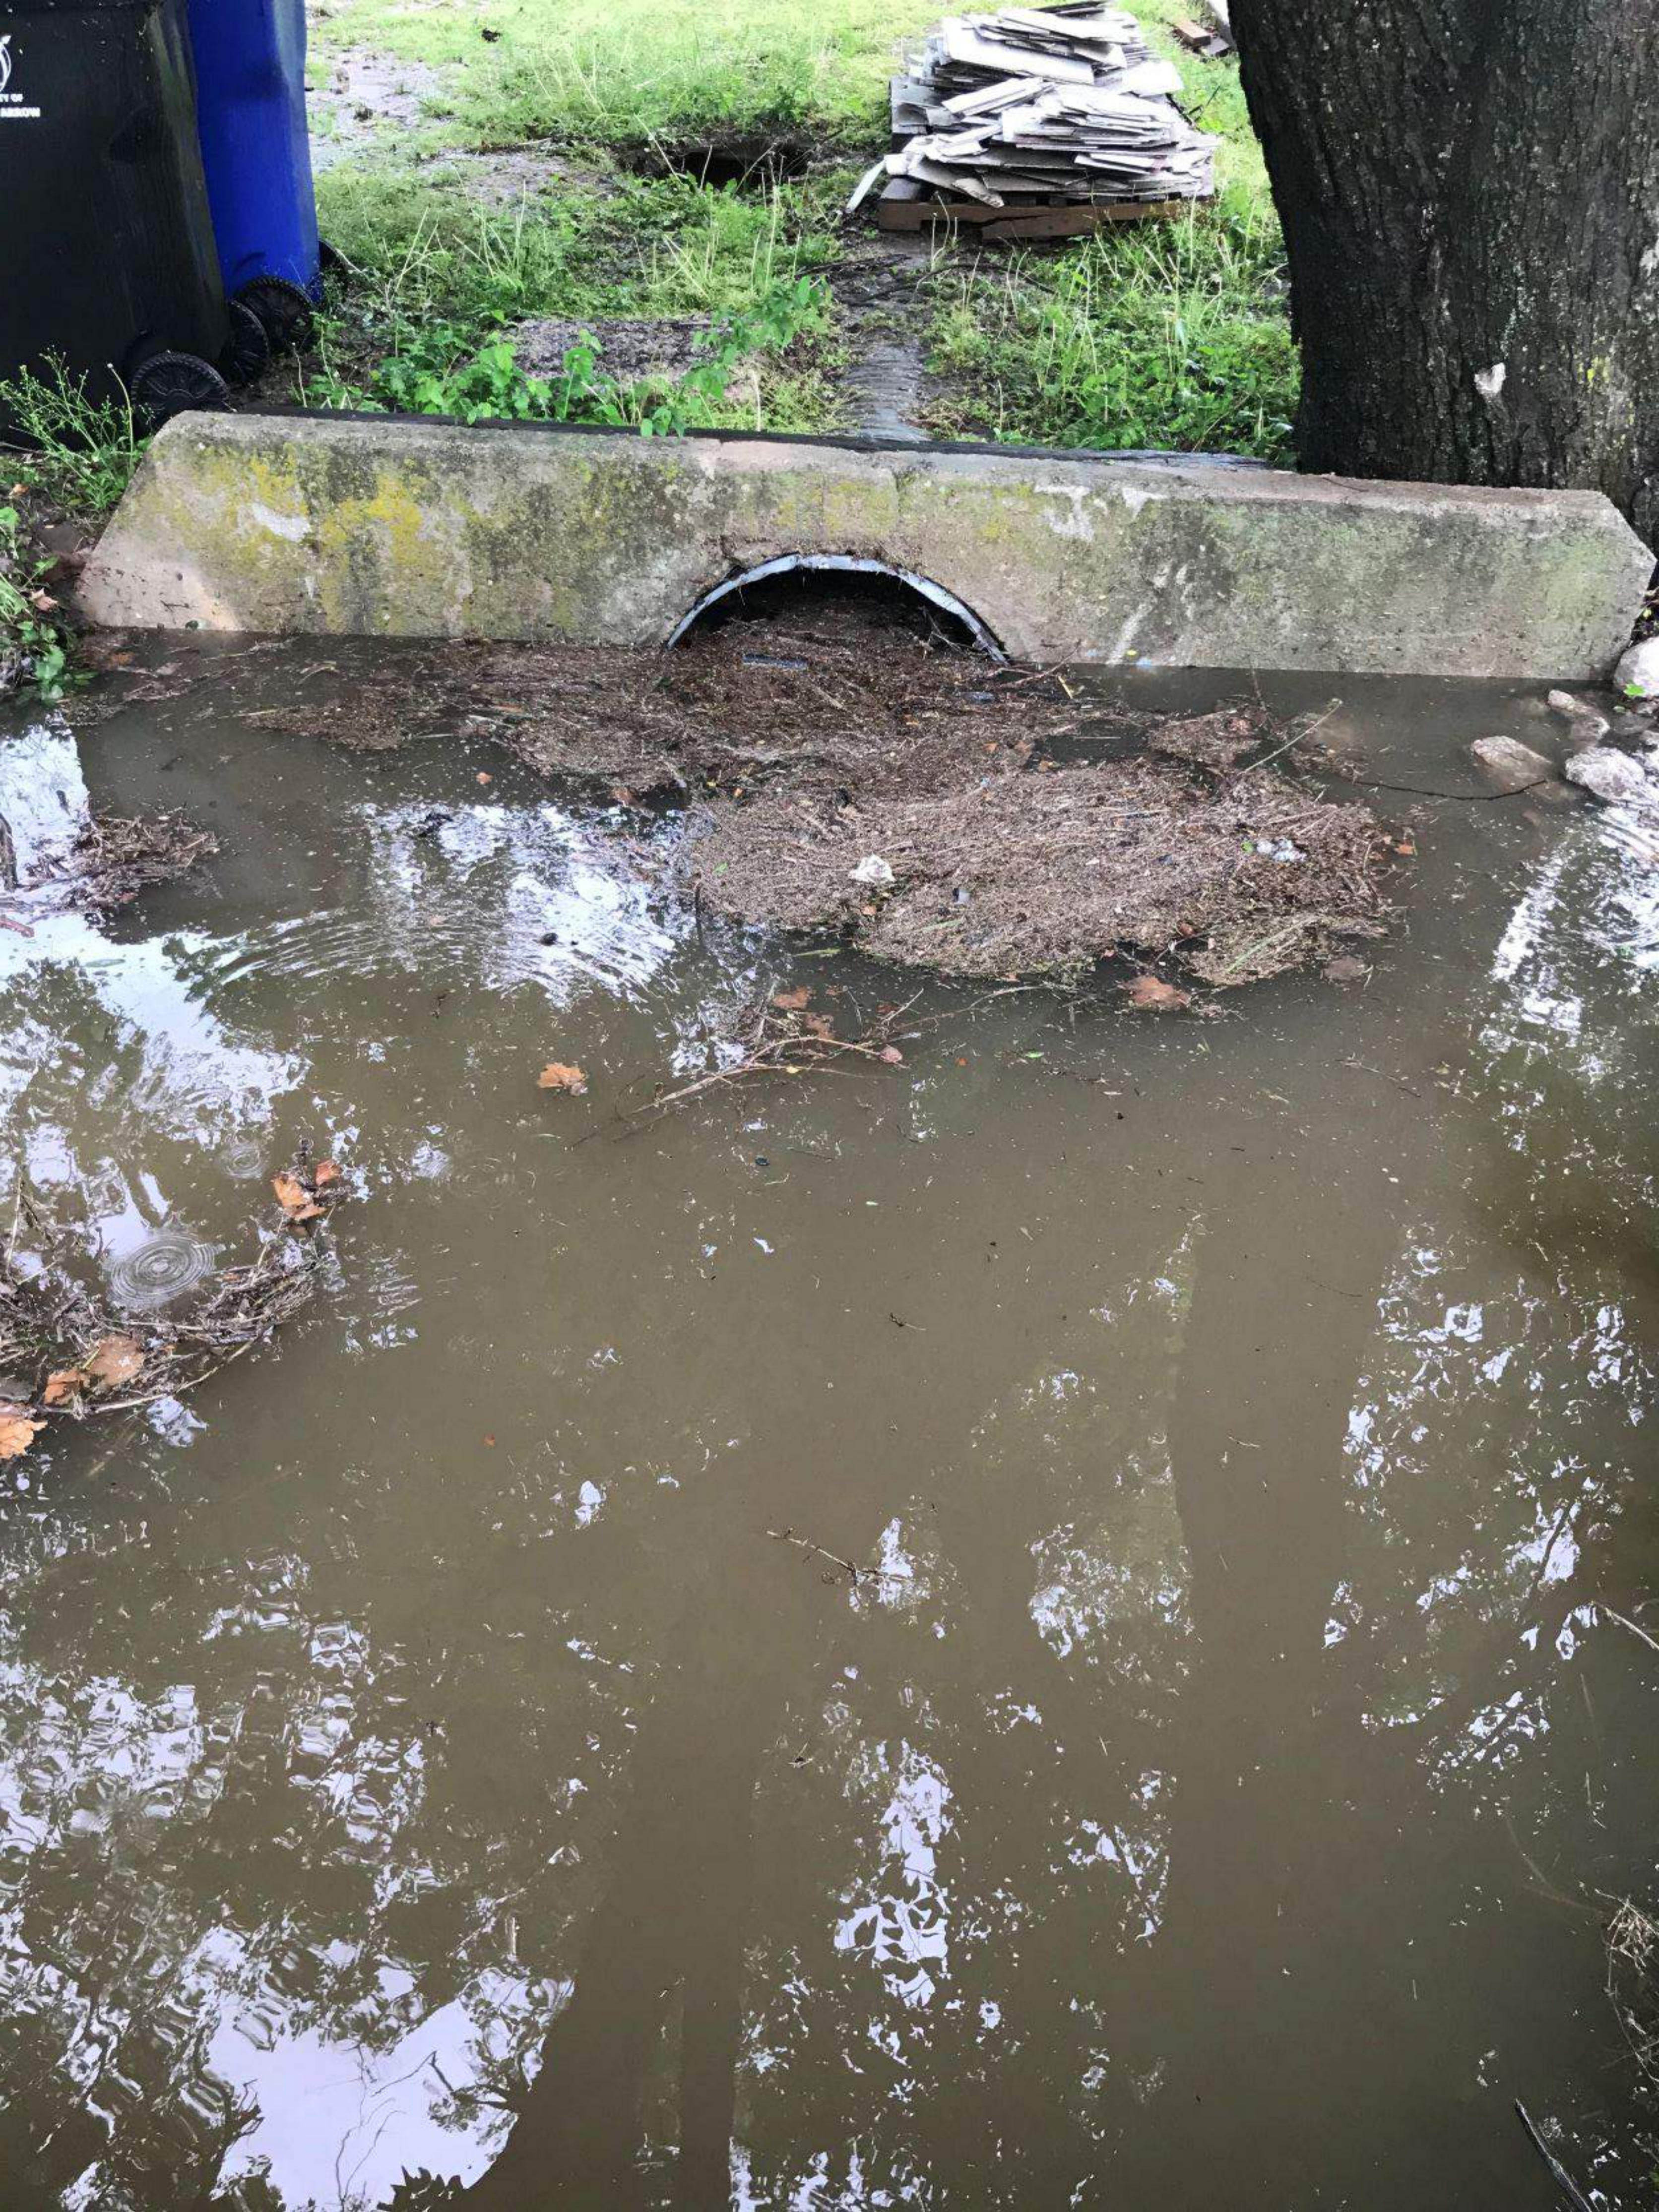
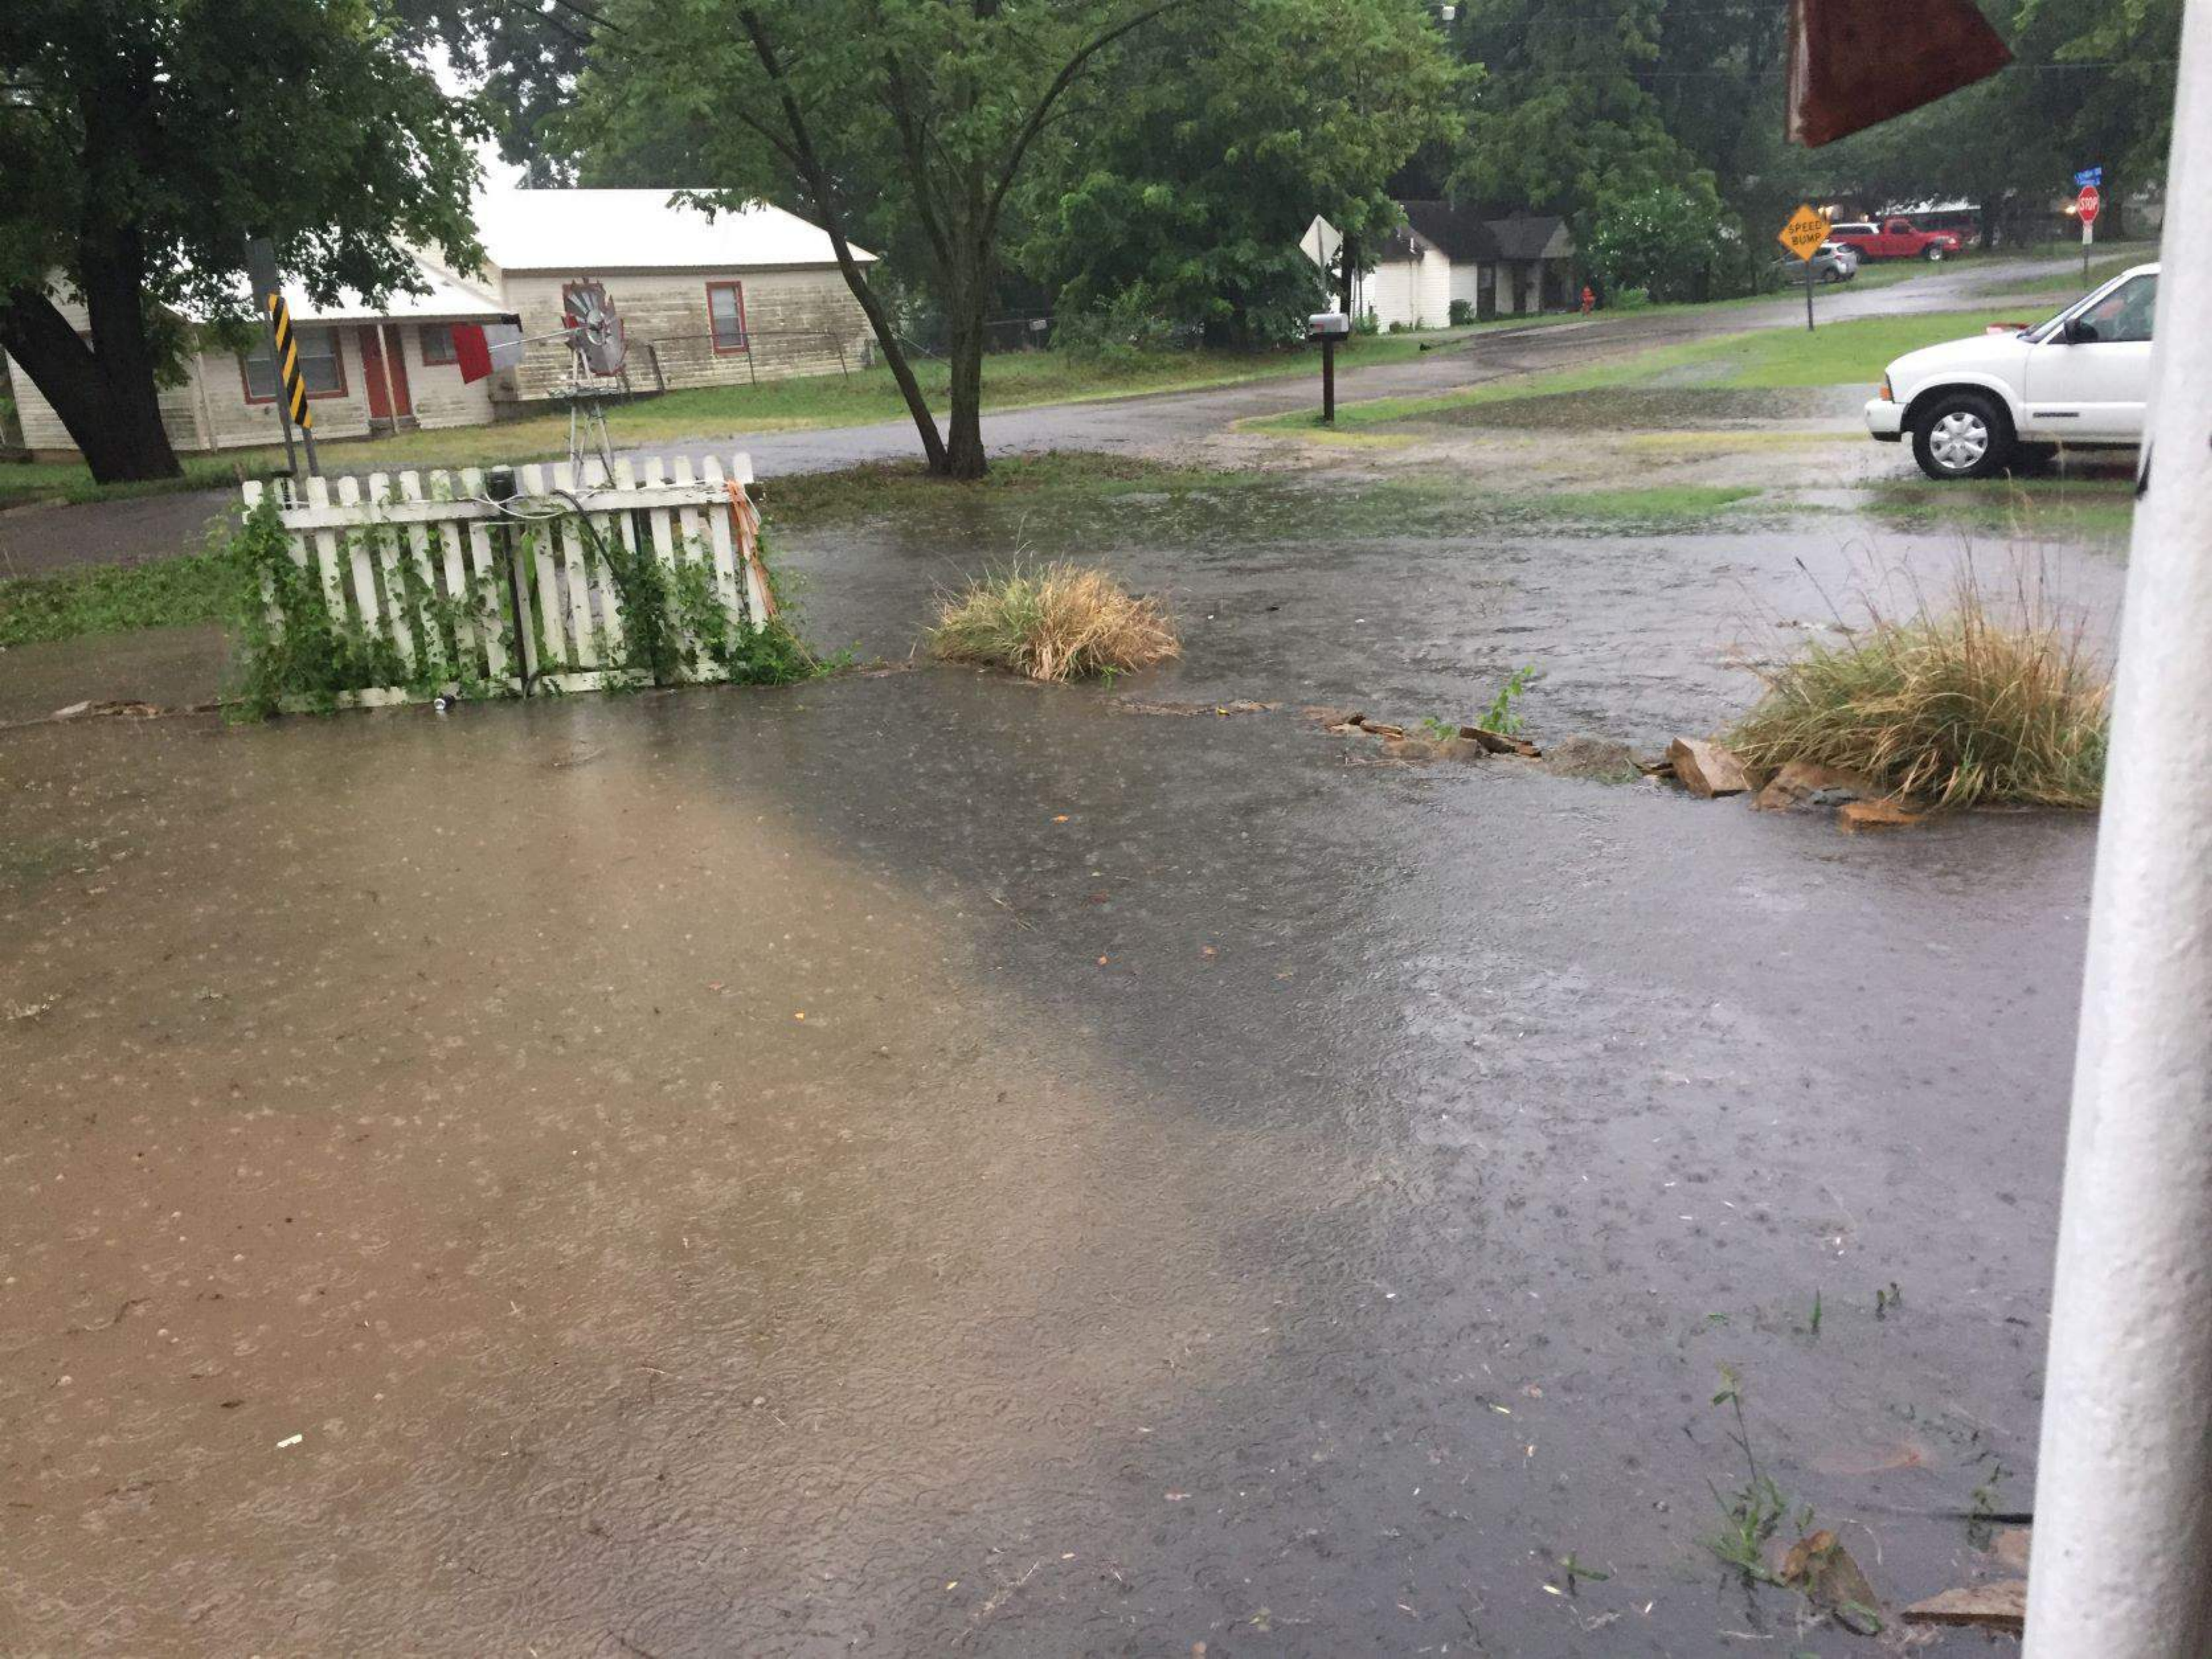
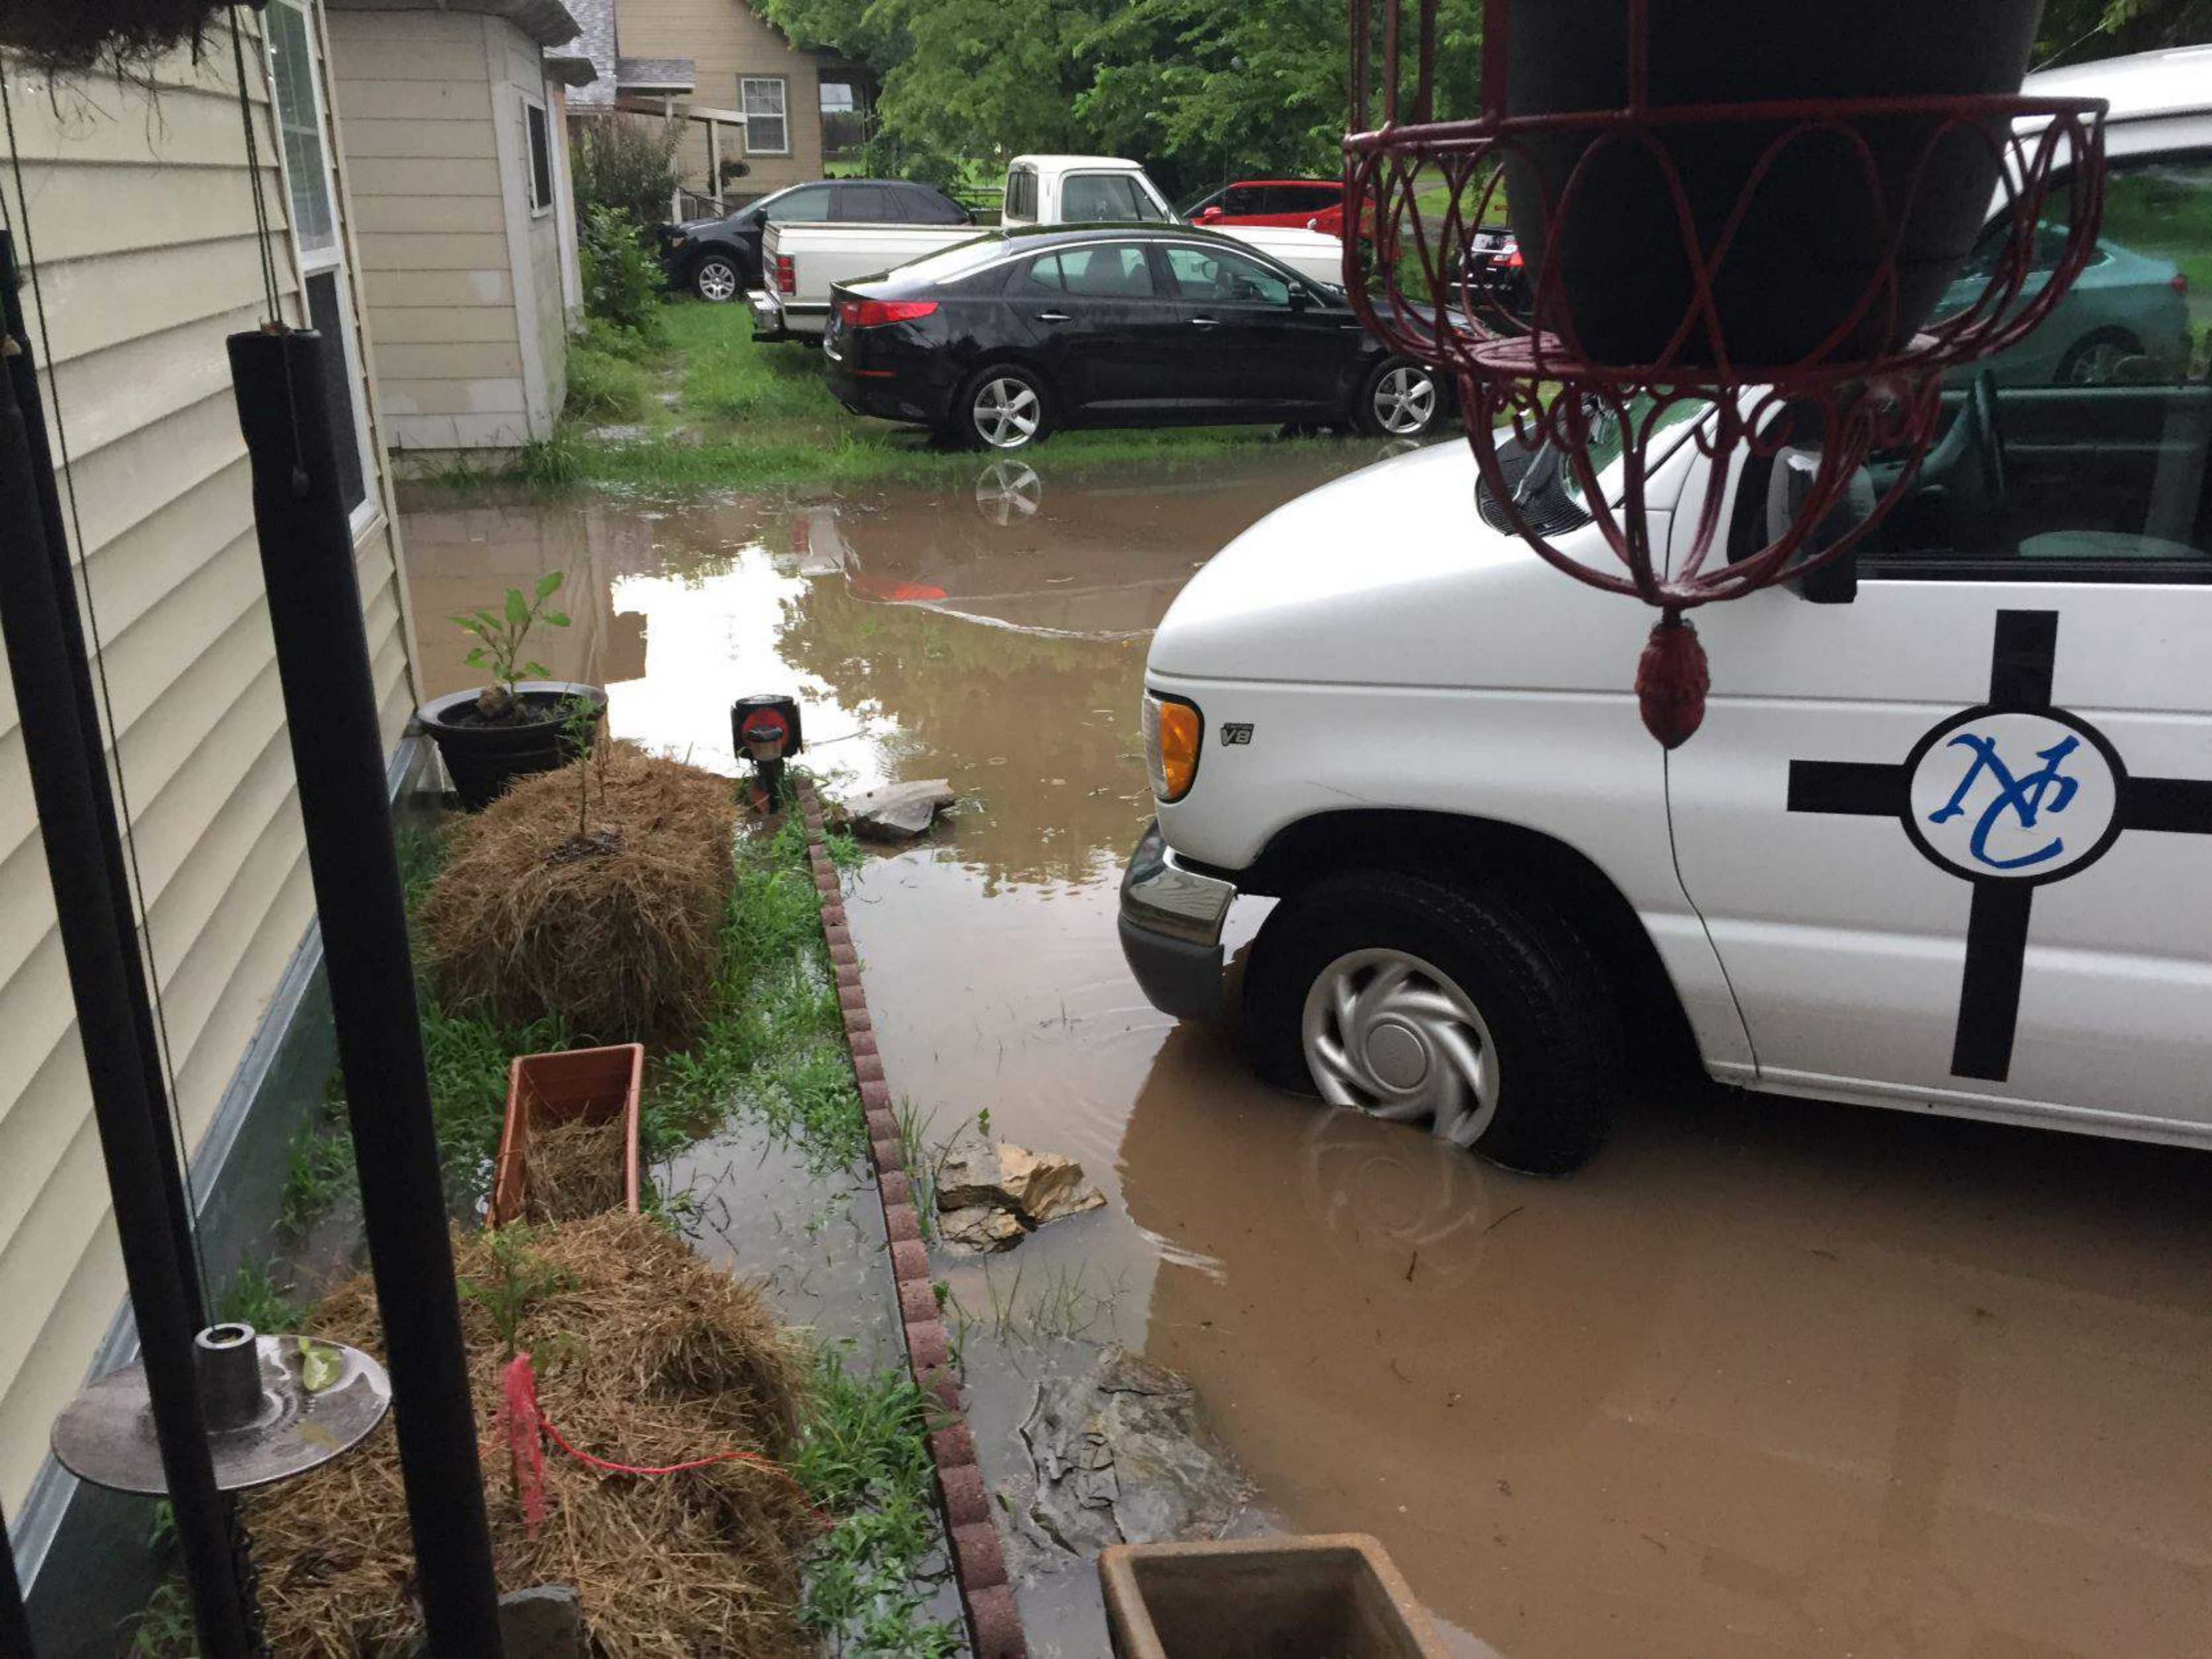
A 36 inch corrugated metal pipe (CMP) was placed in the open ditch in the late 1970's to early 1980's by a previous home owner. Over time the CMP has started to fail and is clogging. The failure is seen through multiple holes forming around the pipe. The clogging of the pipe is restricting the flow and causing localized flooding around the houses upstream of the pipe. The localized flooding is impacting traffic and the roadway has overtopped according to residents.

Corrugated pipe is deteriorating, obstructing flow of drain water. Because of this, the area floods. This includes but is not limited to the yards, driveways, crawl spaces and roads of our street (Galveston) We all love our street and area we live, but the drainage problem is a big problem every time we get a descent rain.

Staff recommend replacing the failing 36 inch CMP with a plastic 36 inch pipe as a maintenance item. This will clear the pipe and allow the water to flow downstream greatly reducing the localized flooding.
