December 18, 2015

City of Broken Arrow, Oklahoma
Attn: Thomas Hendrix, PE
Tim Robins, PE
485 North Poplar Avenue
Broken Arrow, Oklahoma 74012

RE: Repair Recommendations for Retaining Wall at Hillside Park
Broken Arrow, Oklahoma
Olsson Project No. 015-1894.300

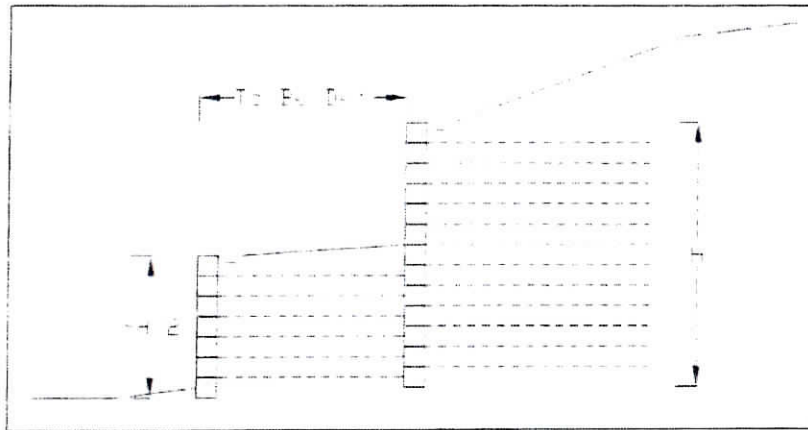
We performed preliminary calculations to determine at what height the existing wall would need to be buried in order to conform to current NCMA requirements. Our preliminary calculations indicate that the wall would need to be reduced to approximately half of the existing height across most of the wall length. The figure below presents a general cross-section of the

Option 3 – Construct Wall in Front of Existing Wall

An additional supplemental wall could be built in front of the existing wall. This option would also leave the existing wall in place, but would require occupying additional real-estate in front of the wall. Several different wall types could be considered, but the most cost effective being a similar reinforced modular block wall a distance (to be designed) in front of the existing wall. That distance would vary based on the height of the wall and the block used, but would likely be in the range of 7 to 20 feet from the face of the wall.

proposed option. We estimate the cost for option 3 to be between 50 and 100 dollars per square foot of new wall face.
