City of Broken Arrow

Drainage Advisory Committee

PROJECT REPORT

DATE:	6/8/23
NAME	Patrick Wilson, PE, CFM, Stormwater Division Manager, City of Broken Arrow
ADDRESS / LOCATION	901-913 W Fargo Dr, Broken Arrow, OK
WATERSHED	Haikey Creek
ESTIMATE	\$55,000.00
CASE NO.	23-002

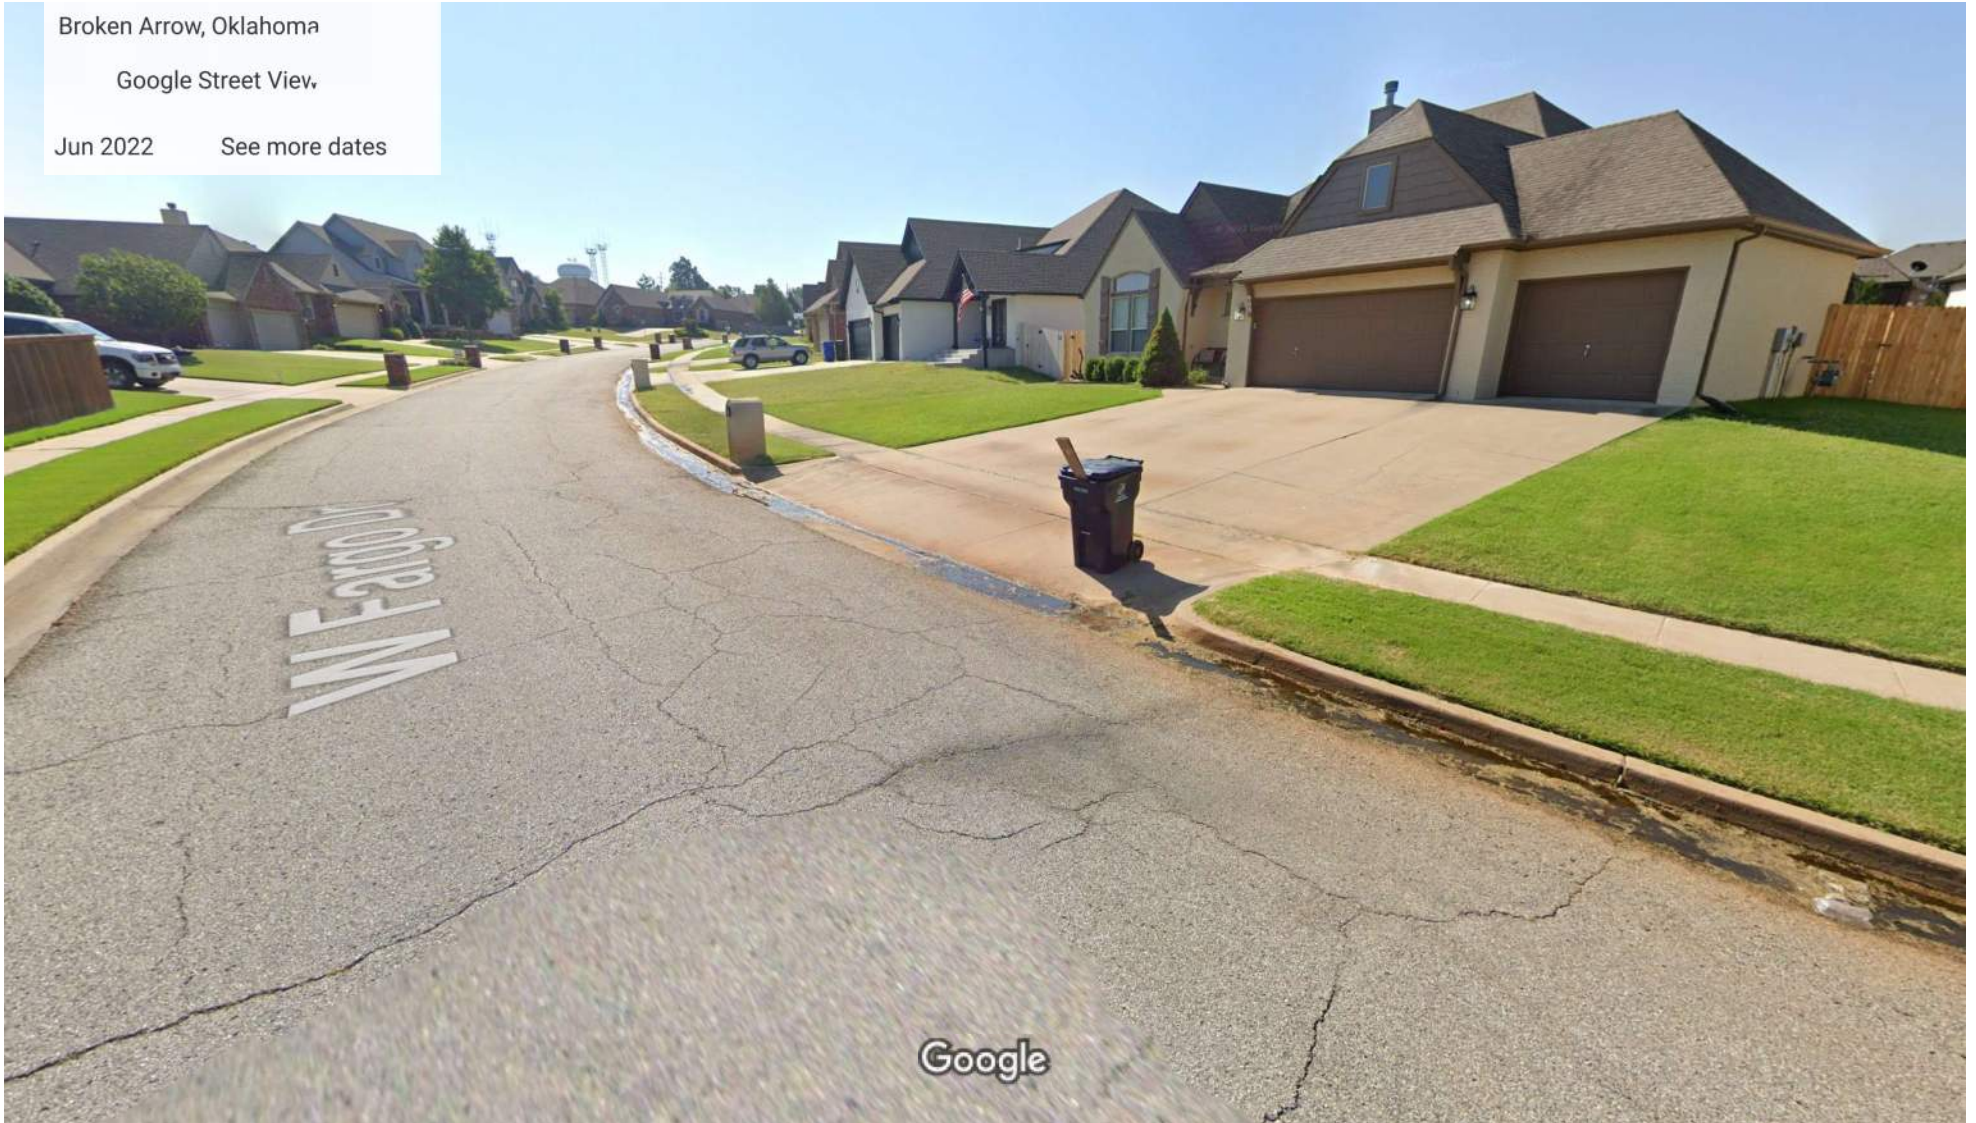
Google Maps 909 W Fargo Dr

From 901-913 W Fargo Dr, there appears to be groundwater seeping through driveways and sidewalks into the gutter and street. Observations noted most residents in the area have installed French drains to help drain the yards. The groundwater contains iron, which has turned the driveways and sidewalks red. The iron in the groundwater has also caused algae to form in certain areas, causing a potential slipping hazard.

Installation of a French drain under the sidewalk to transport the groundwater to the storm sewer system.
