PROJECT REPORT

DATE:	04/16/24
NAME	Patrick Wilson, PE, CFM, Stormwater Division Manager, City of Broken Arrow
ADDRESS / LOCATION	12300 E 91 st St Broken Arrow, OK 74012
WATERSHED	Haikey
ESTIMATE	\$50,000.00 for design
CASE NO.	24-002

Drainage Advisory Committee

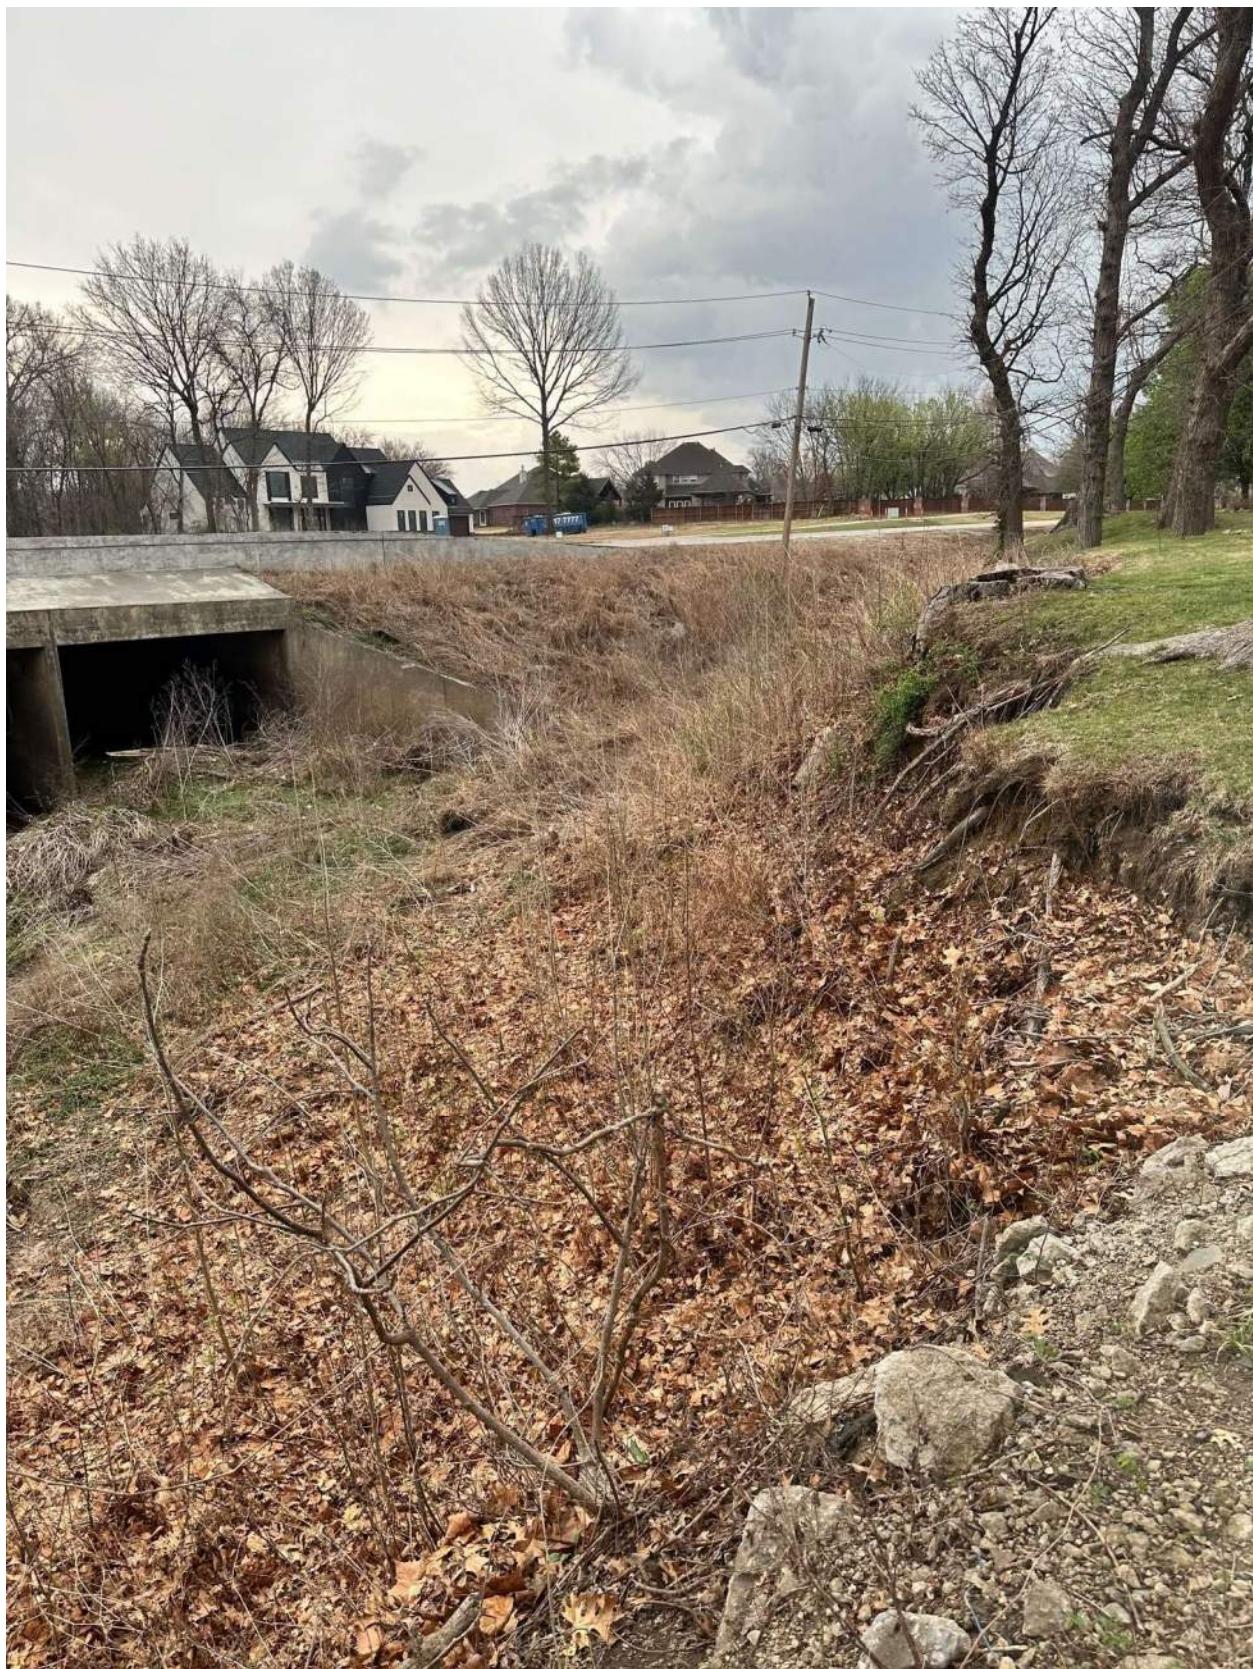
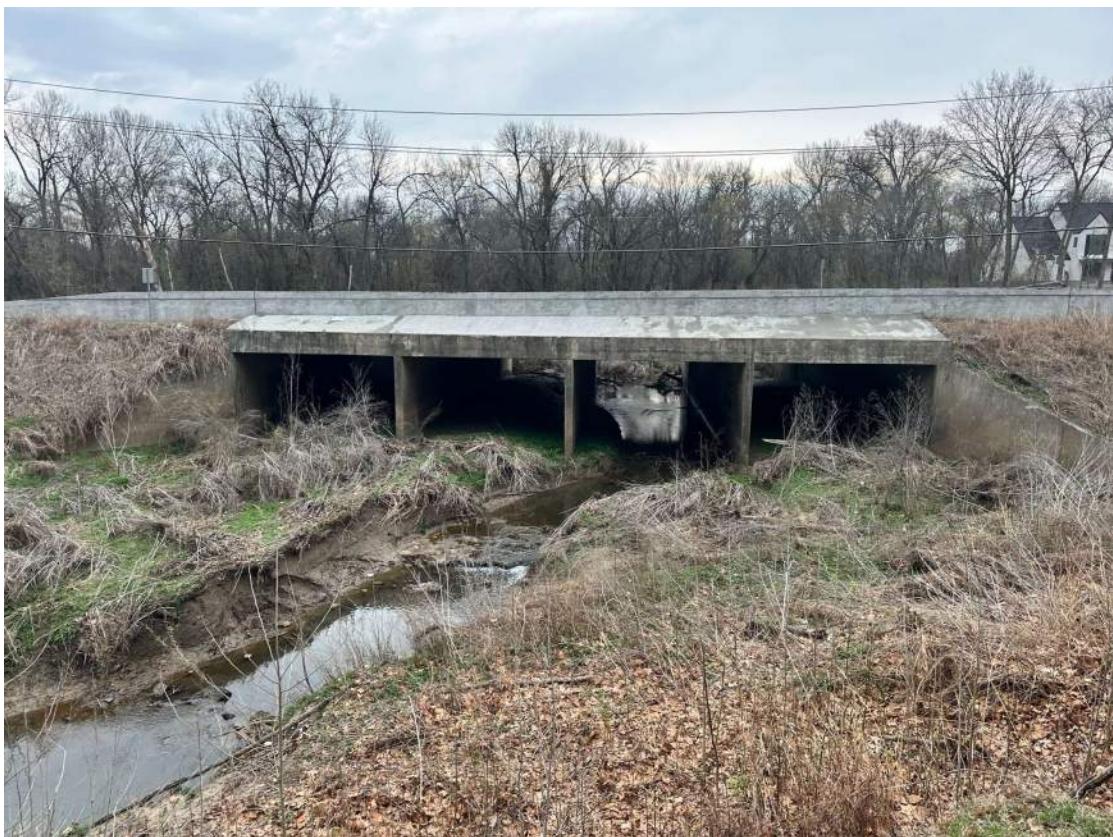
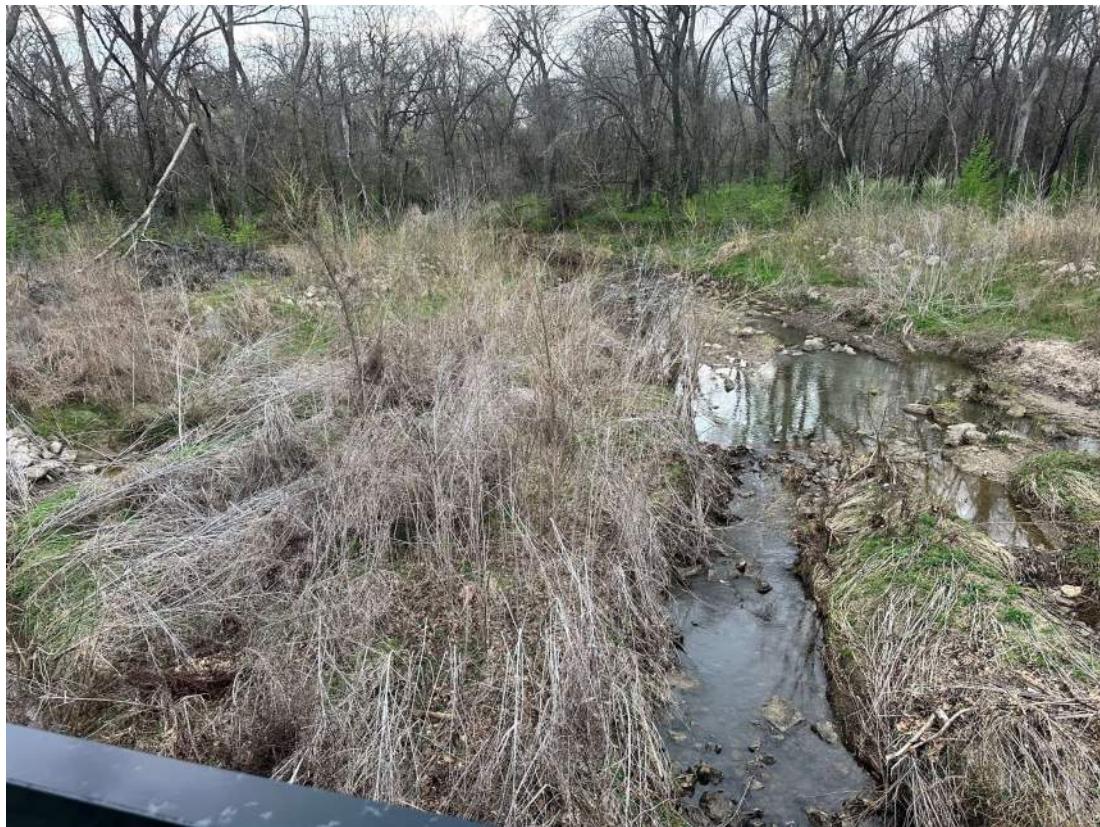
The culvert has silted in and blocking flow in 3 of the boxes. This appears to be causing the flow through the one box to increase thereby increasing the normal velocity through the one cell.

The increased velocity has caused the south bank of Haikey creek to erode. The project will be to clean the box culvert, the north channel, and to armor the southern bank.

Approve the request for the expenditure of \$50,000 to design erosion control and channel stabilization of the southern bank.
