PROJECT REPORT

DATE:	09/24/24
NAME	Patrick Wilson, PE, CFM, Stormwater Division Manager, City of Broken Arrow
ADDRESS / LOCATION	4110 S. Aspen Ave, Aspen Pond, Broken Arrow
WATERSHED	Aspen
ESTIMATE	\$100,000.00
CASE NO.	24-014

APPLICATION

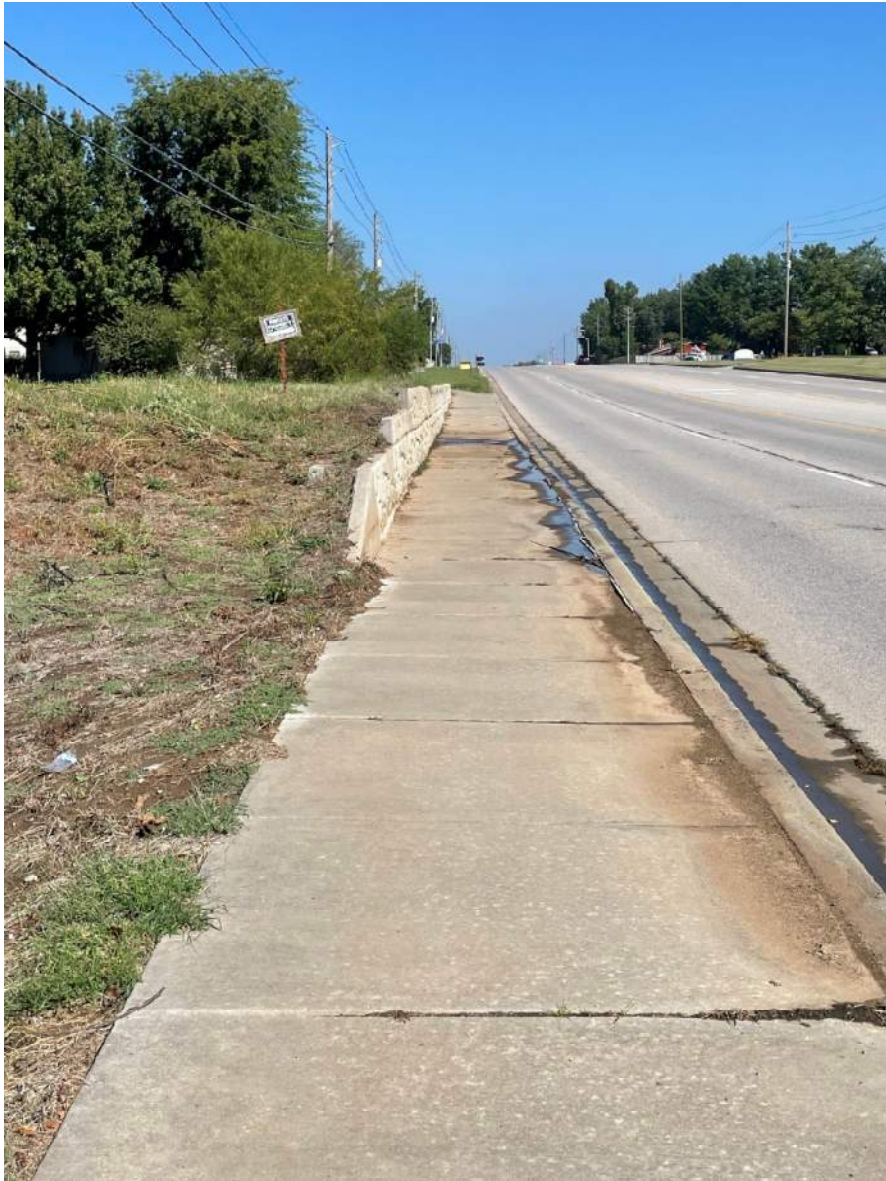
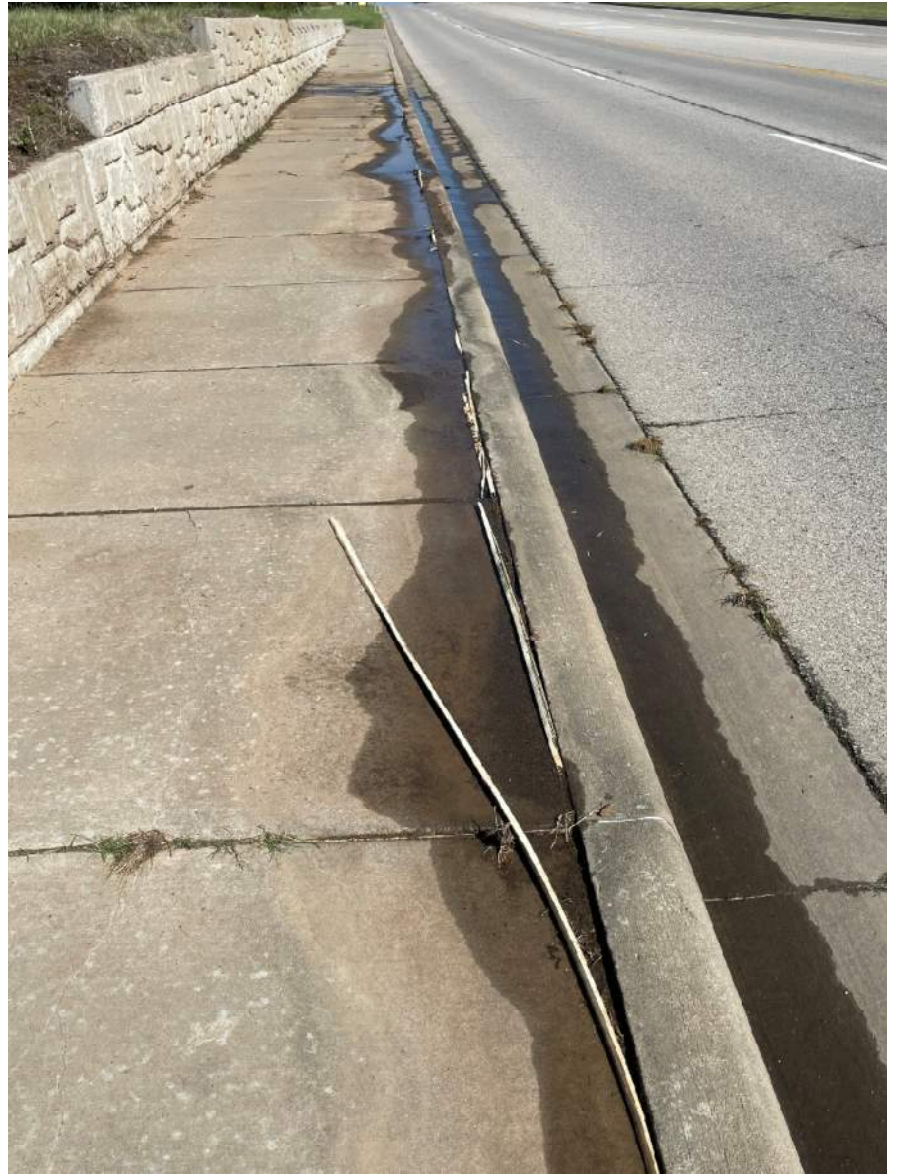
DESCRIPTION OF PROBLEM: (*PHOTOS SHOULD ACCOMPANY APPLICATION)	
Retaining wall holding back private pond is leaking and water/sediment is getting onto the sidewalk and into the street.	
SIGNATURE:

SLOUGHING EMBANKMENT AND EXPOSED SHEET PILE WALL

BENEFIT	
<p>Mitigating the leak should keep the sidewalk clear of water and sediment which could be a potential slip hazard and slick spot on the road.</p>	
RECOMMENDATION	
<p>Approval of the request to expend \$100,000 for investigation and design funds for the retaining wall.</p>	
COMPLETED BY:	Sarah Walters
DATE:	09/26/24

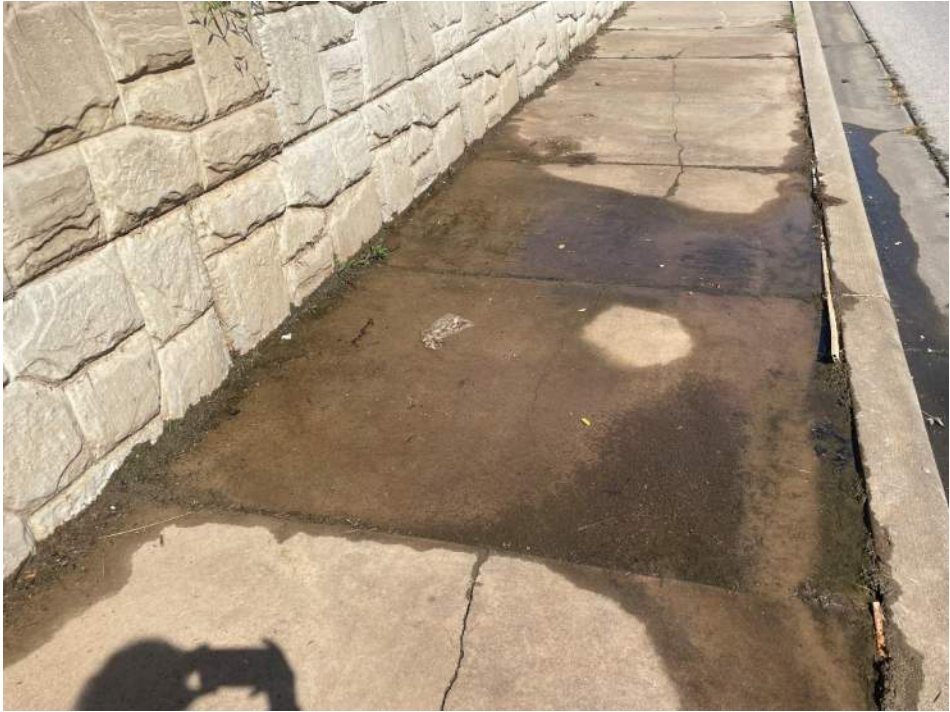
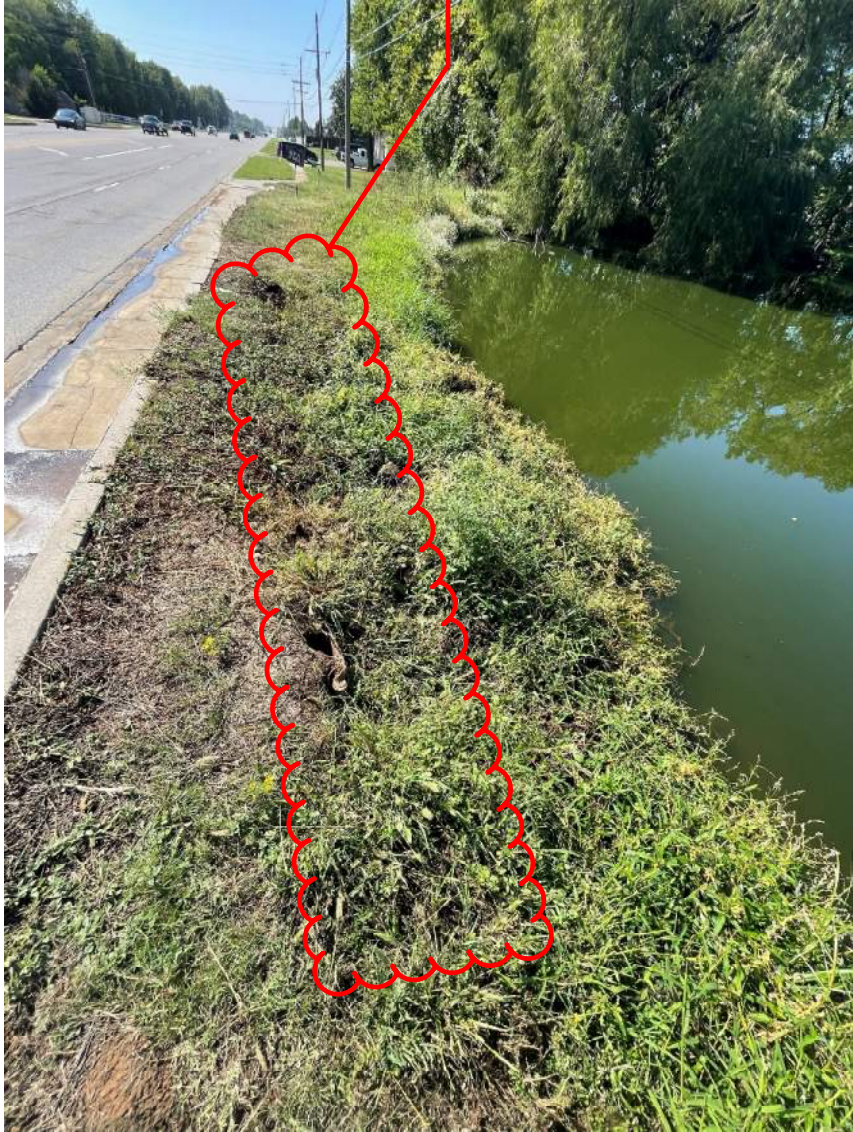
EXPOSED
SHEET PILE
WALL
