PROJECT REPORT

DATE:	09/24/24
NAME	Patrick Wilson, PE, CFM, Stormwater Division Manager, City of Broken Arrow
ADDRESS / LOCATION	4110 S. Aspen Ave, Aspen Pond, Broken Arrow
WATERSHED	Aspen
ESTIMATE	\$100,000.00
CASE NO.	24-014

Drainage Advisory Committee

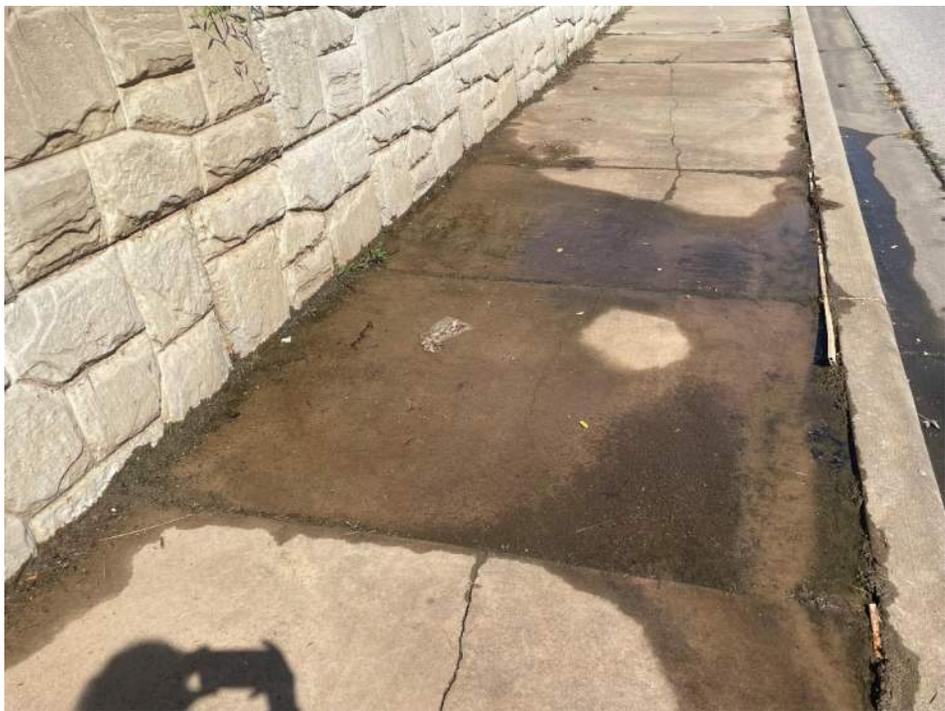
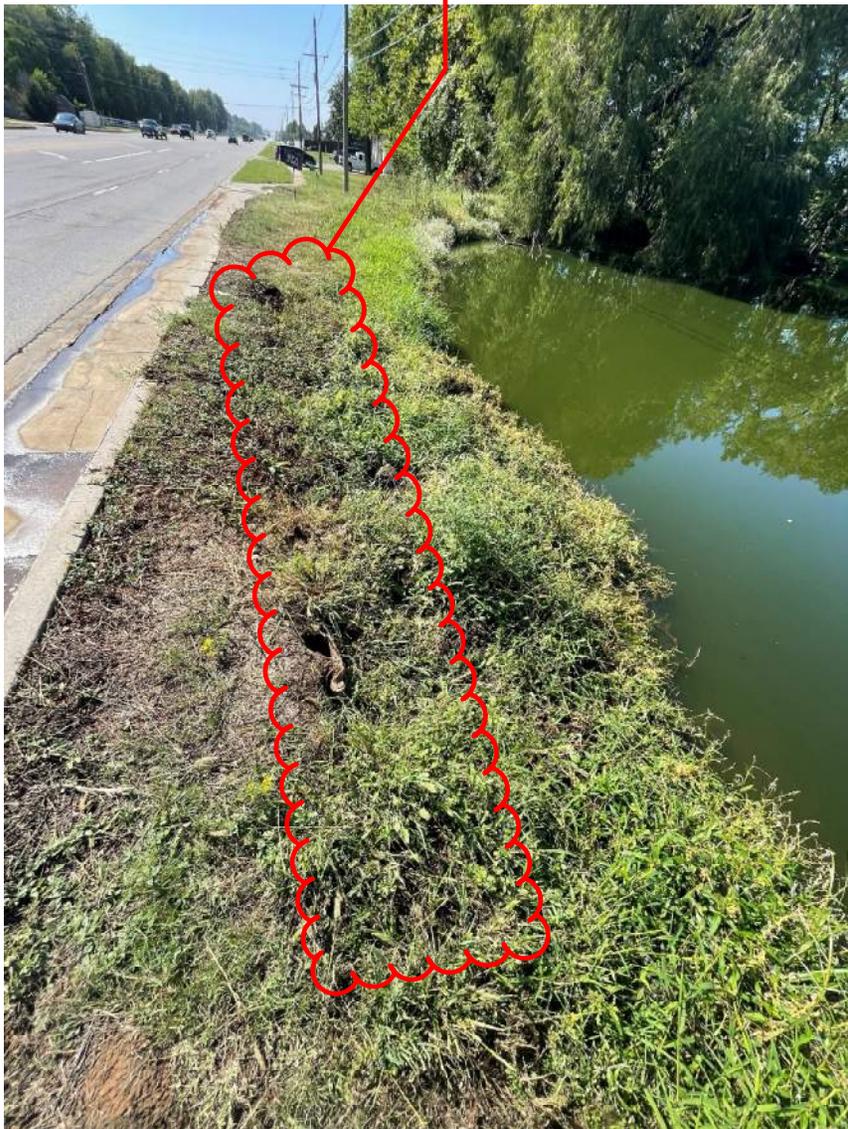
EXPOSED
SHEET PILE
WALL
