# City of Broken Arrow

## Drainage Advisory Committee

## PROJECT REPORT

# DALLAS STREET STORM SEWER IMPROVEMENTS

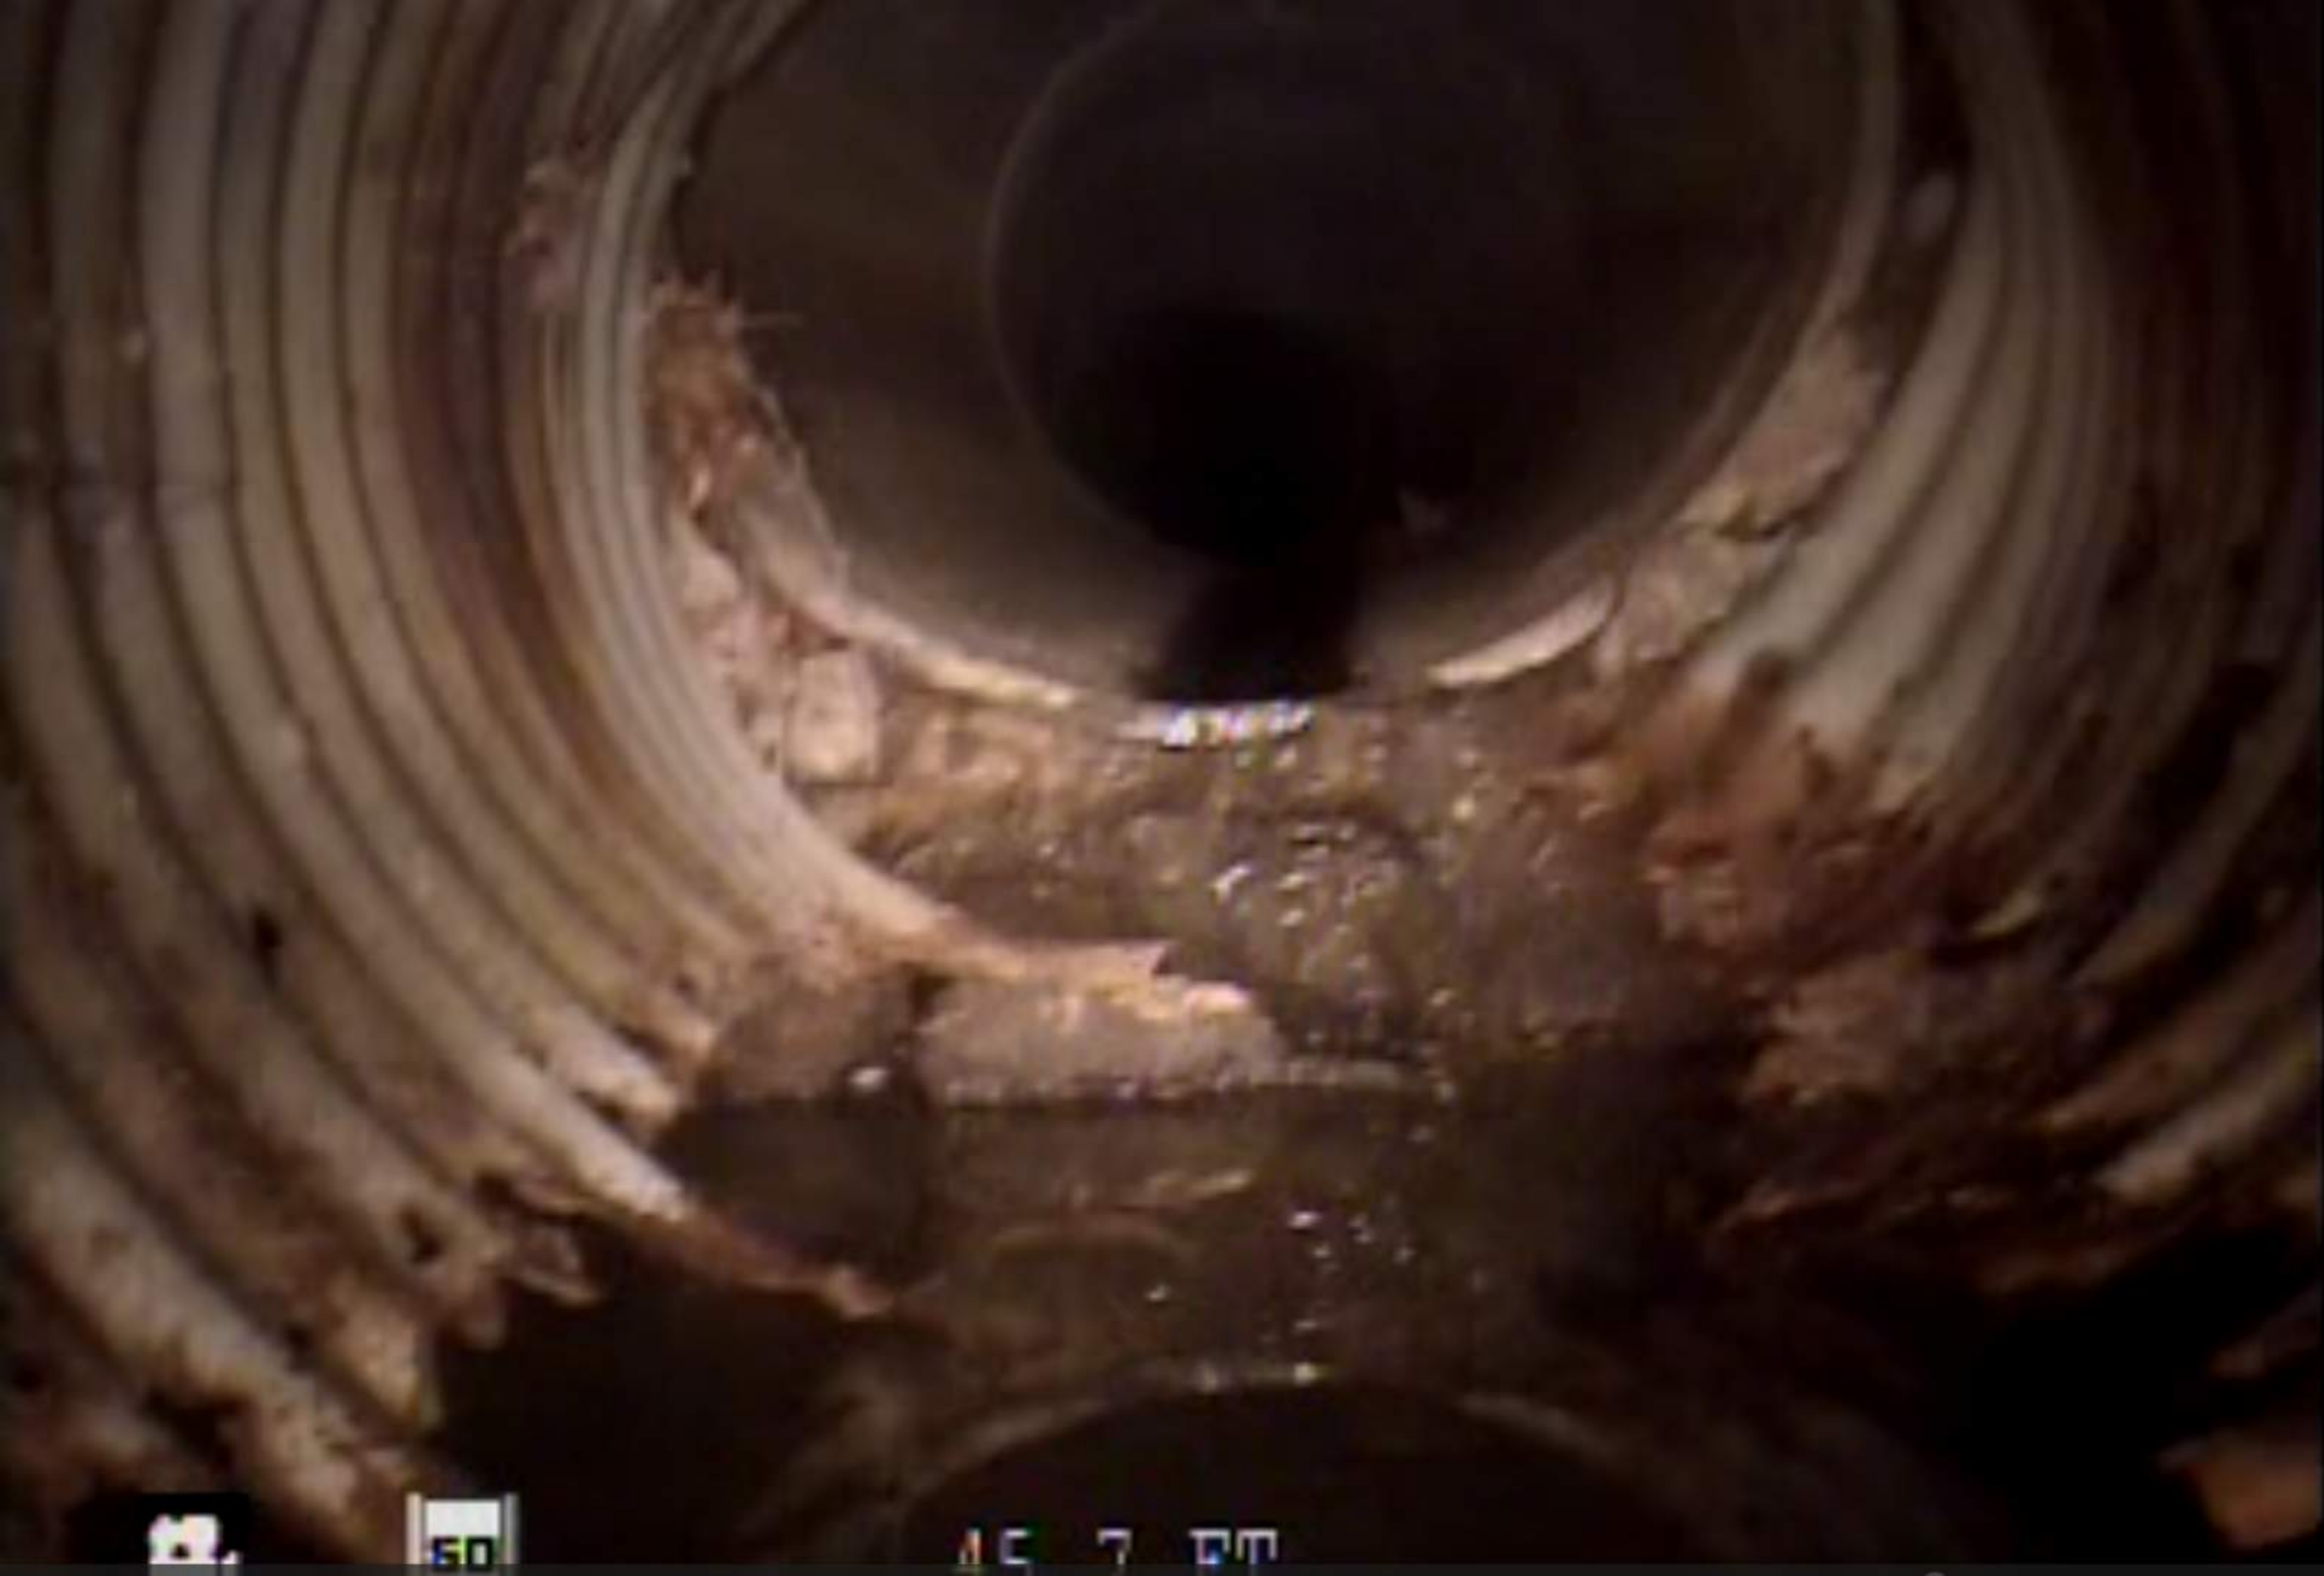
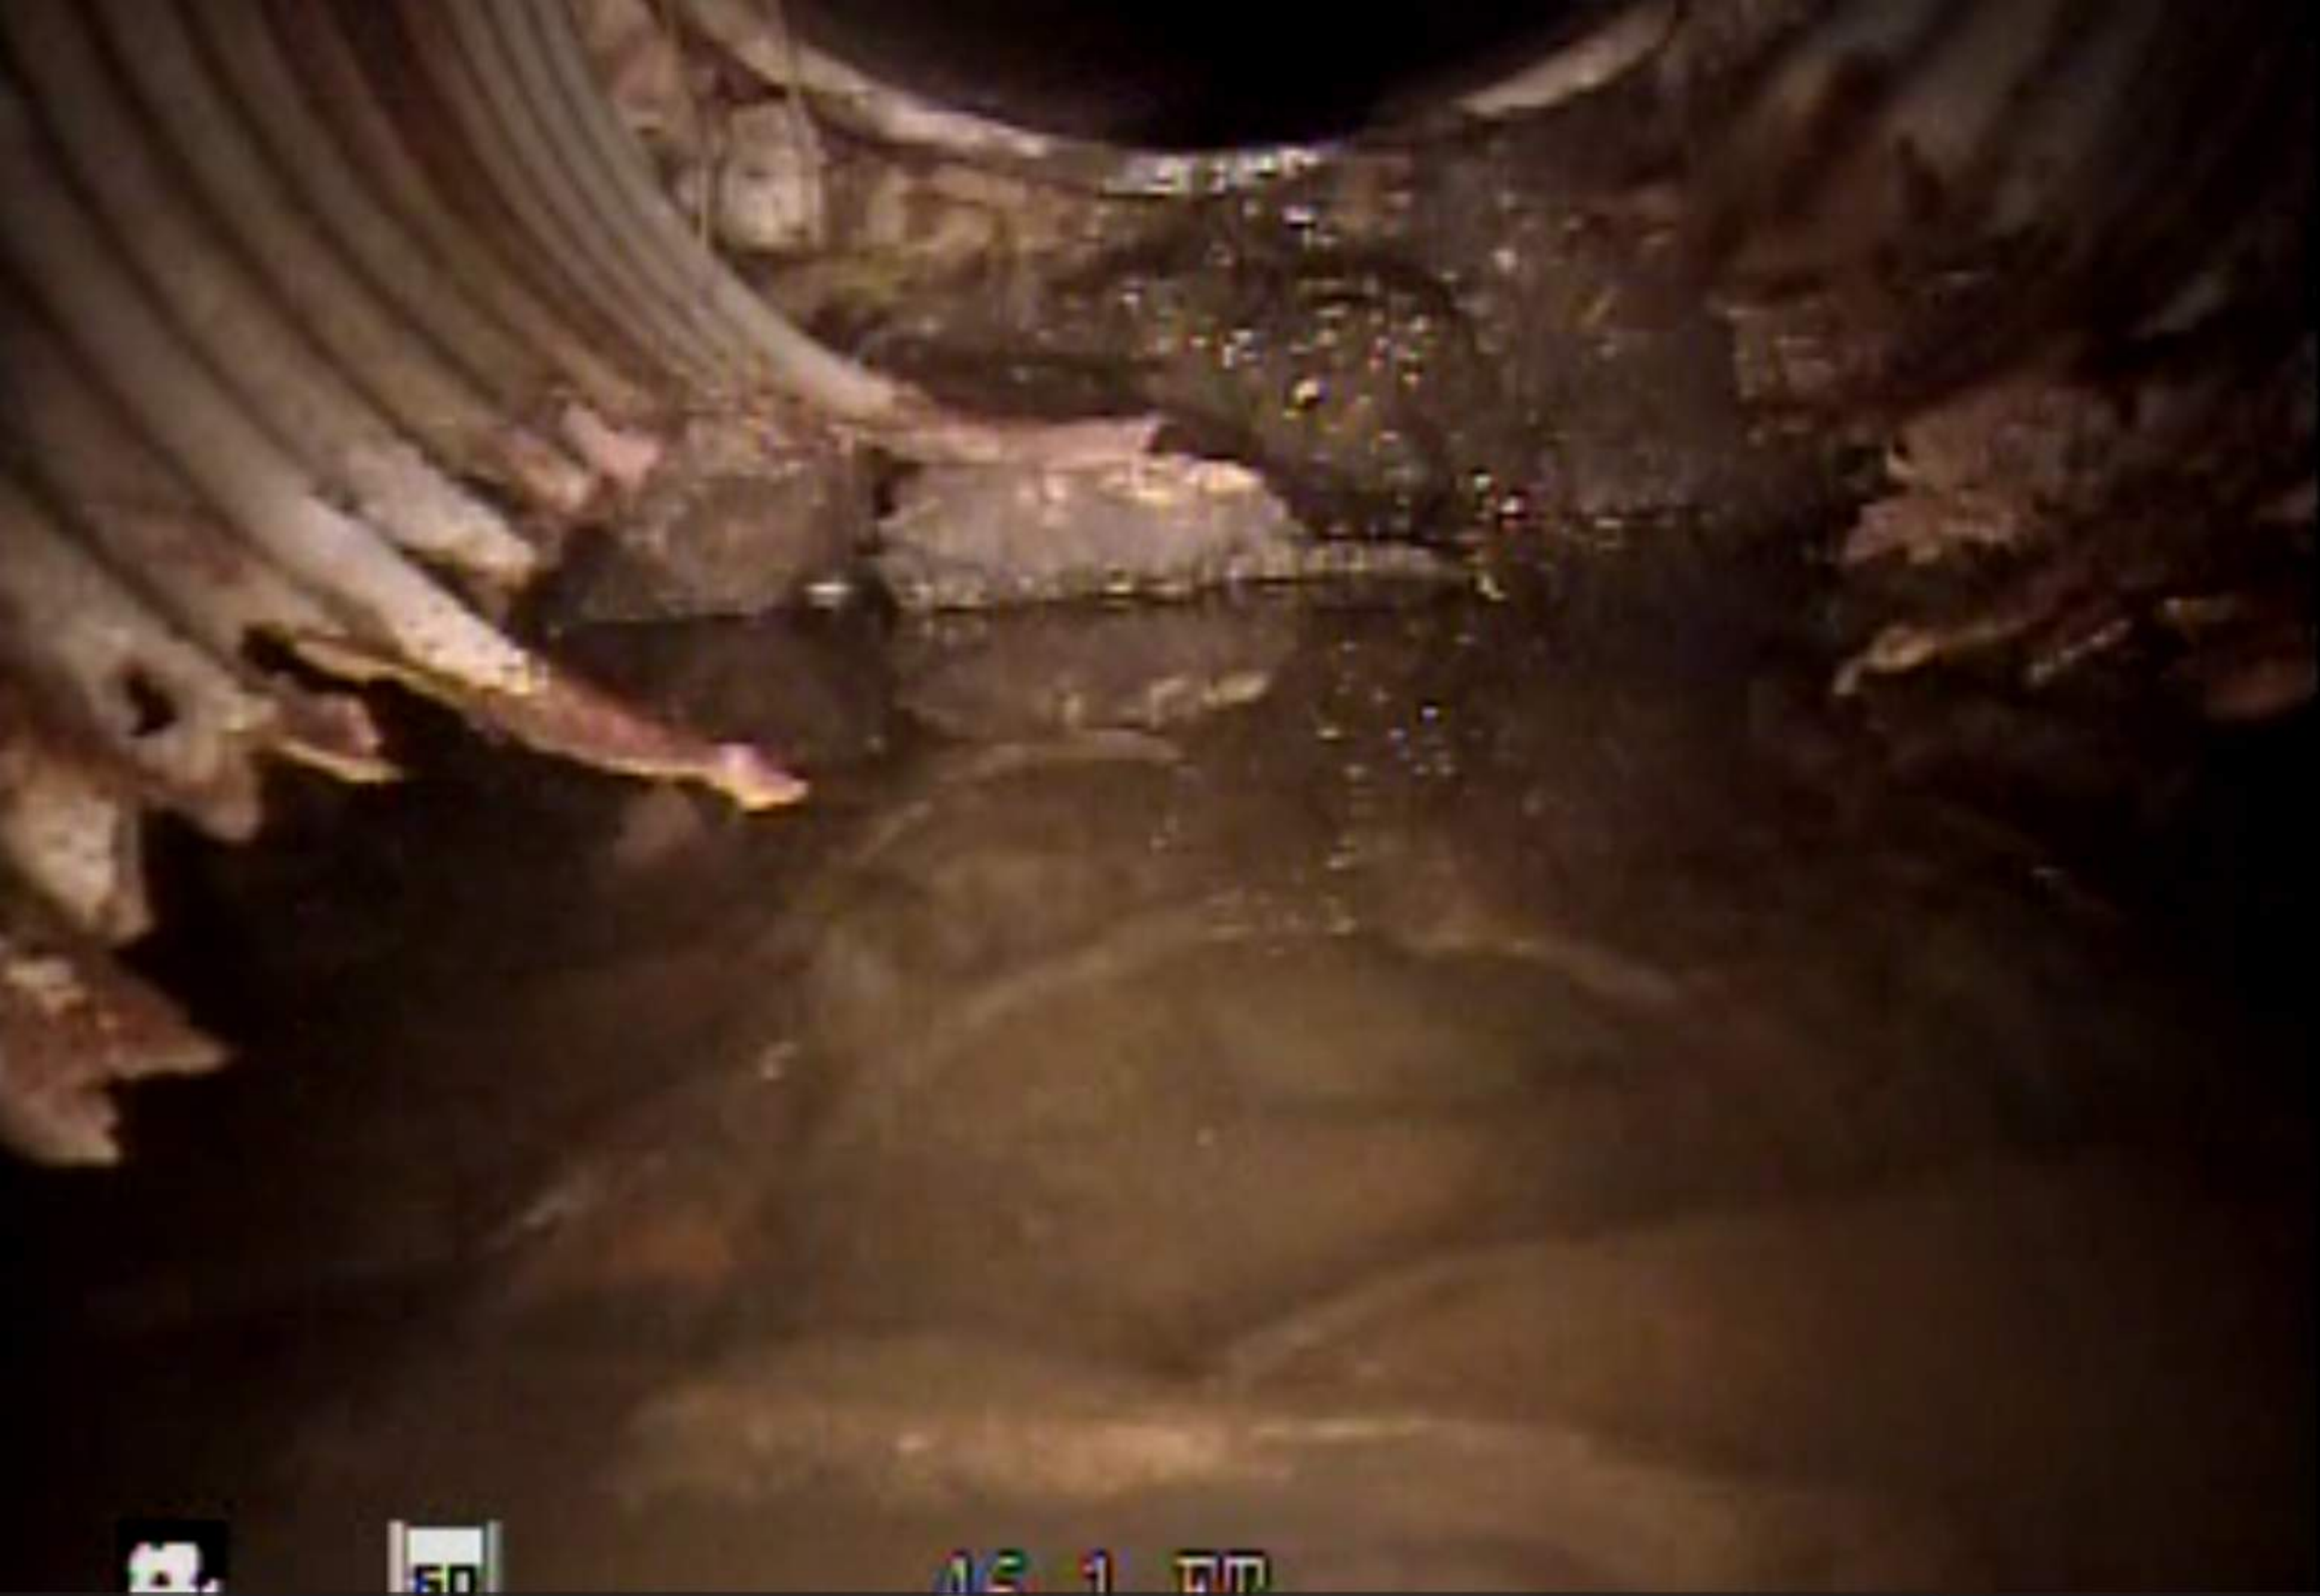
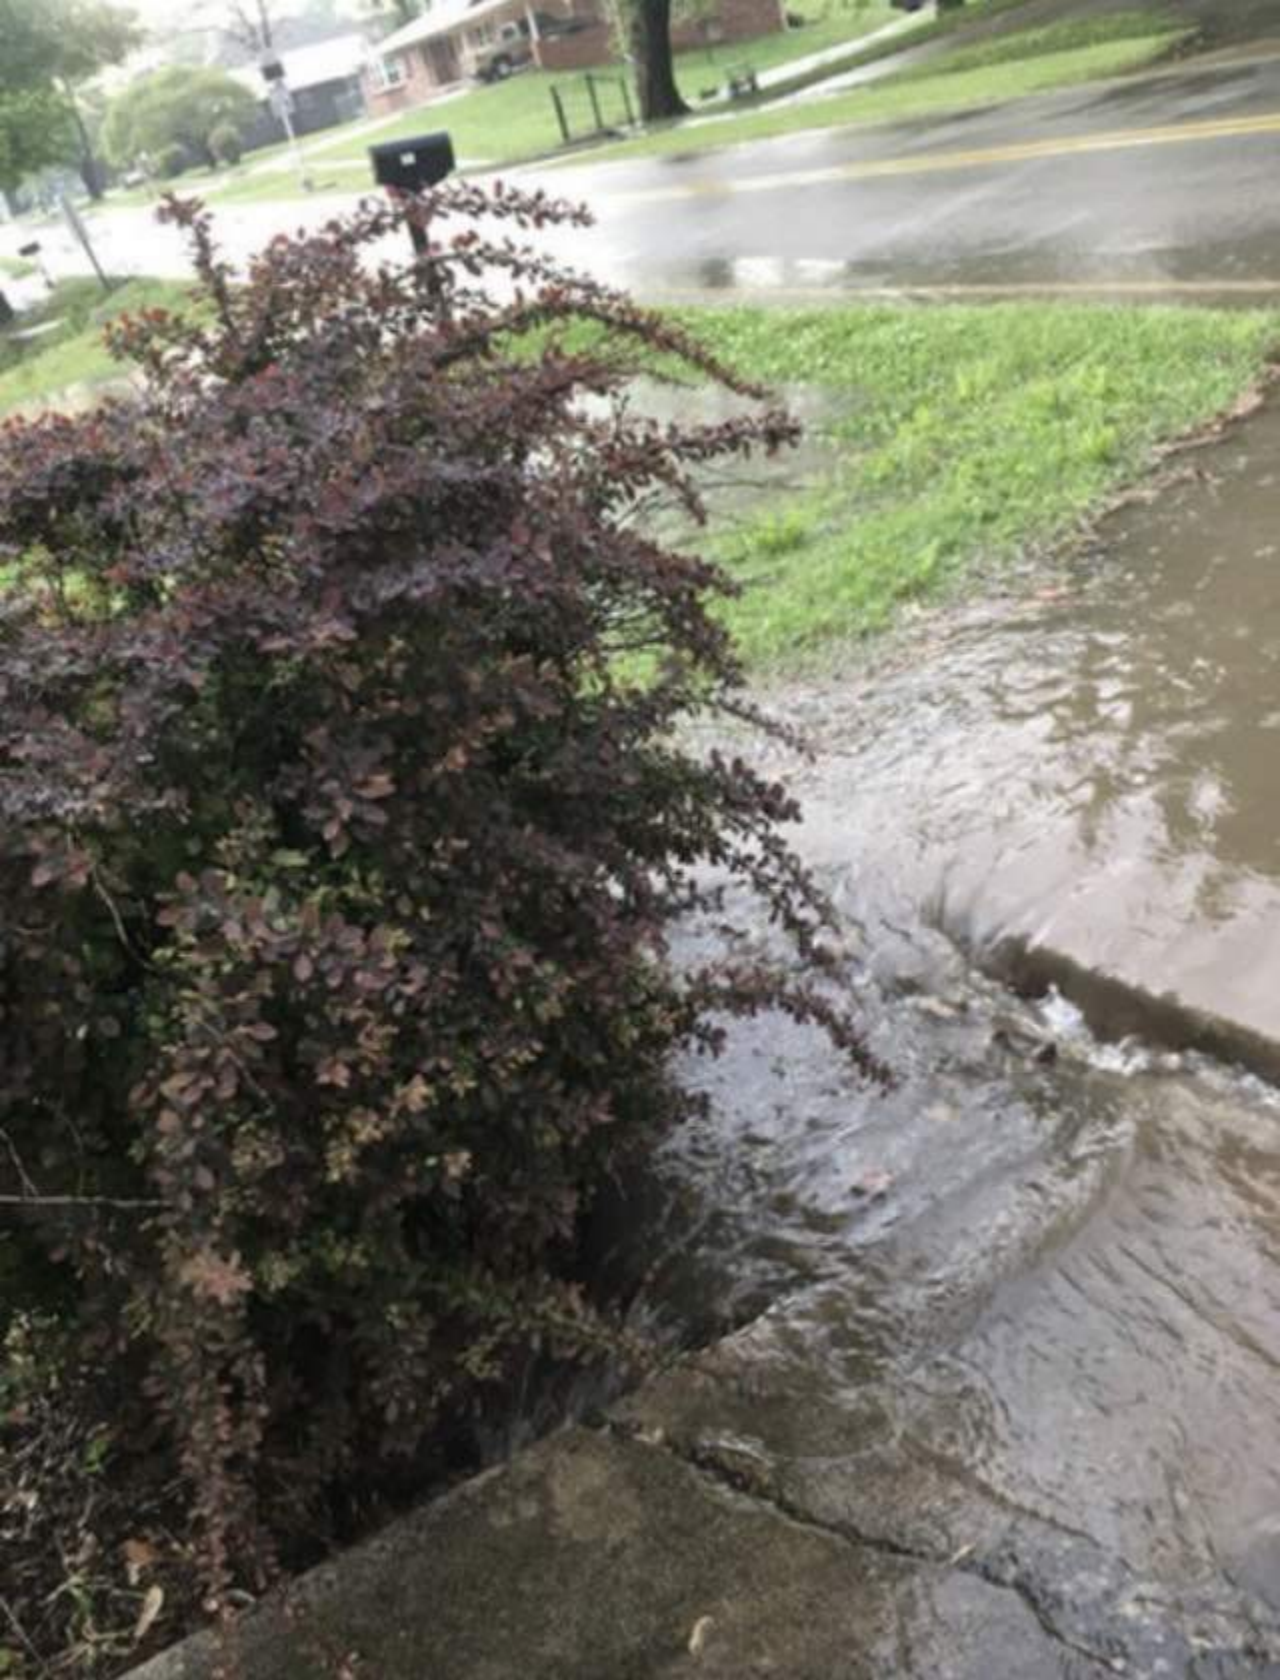
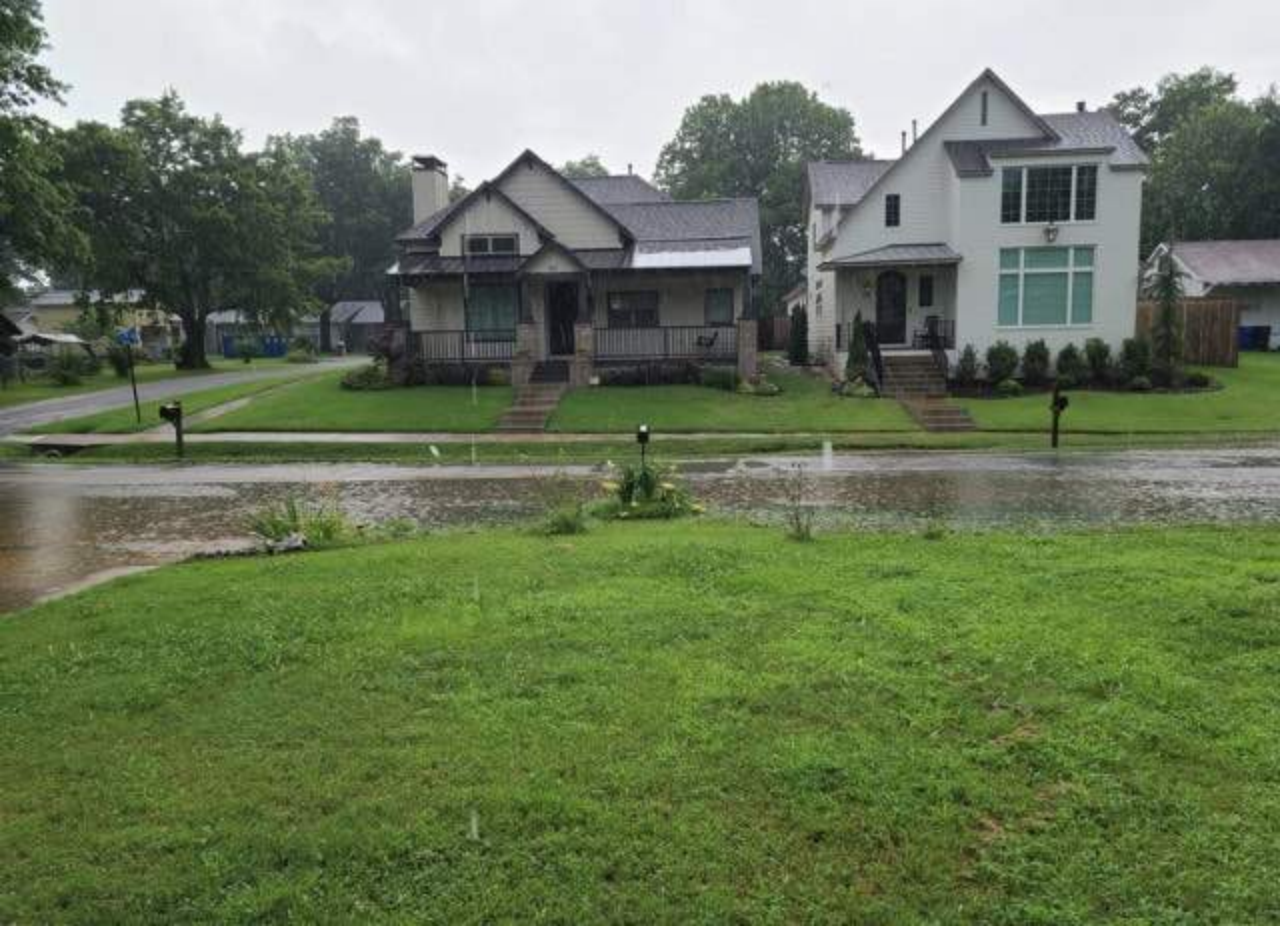
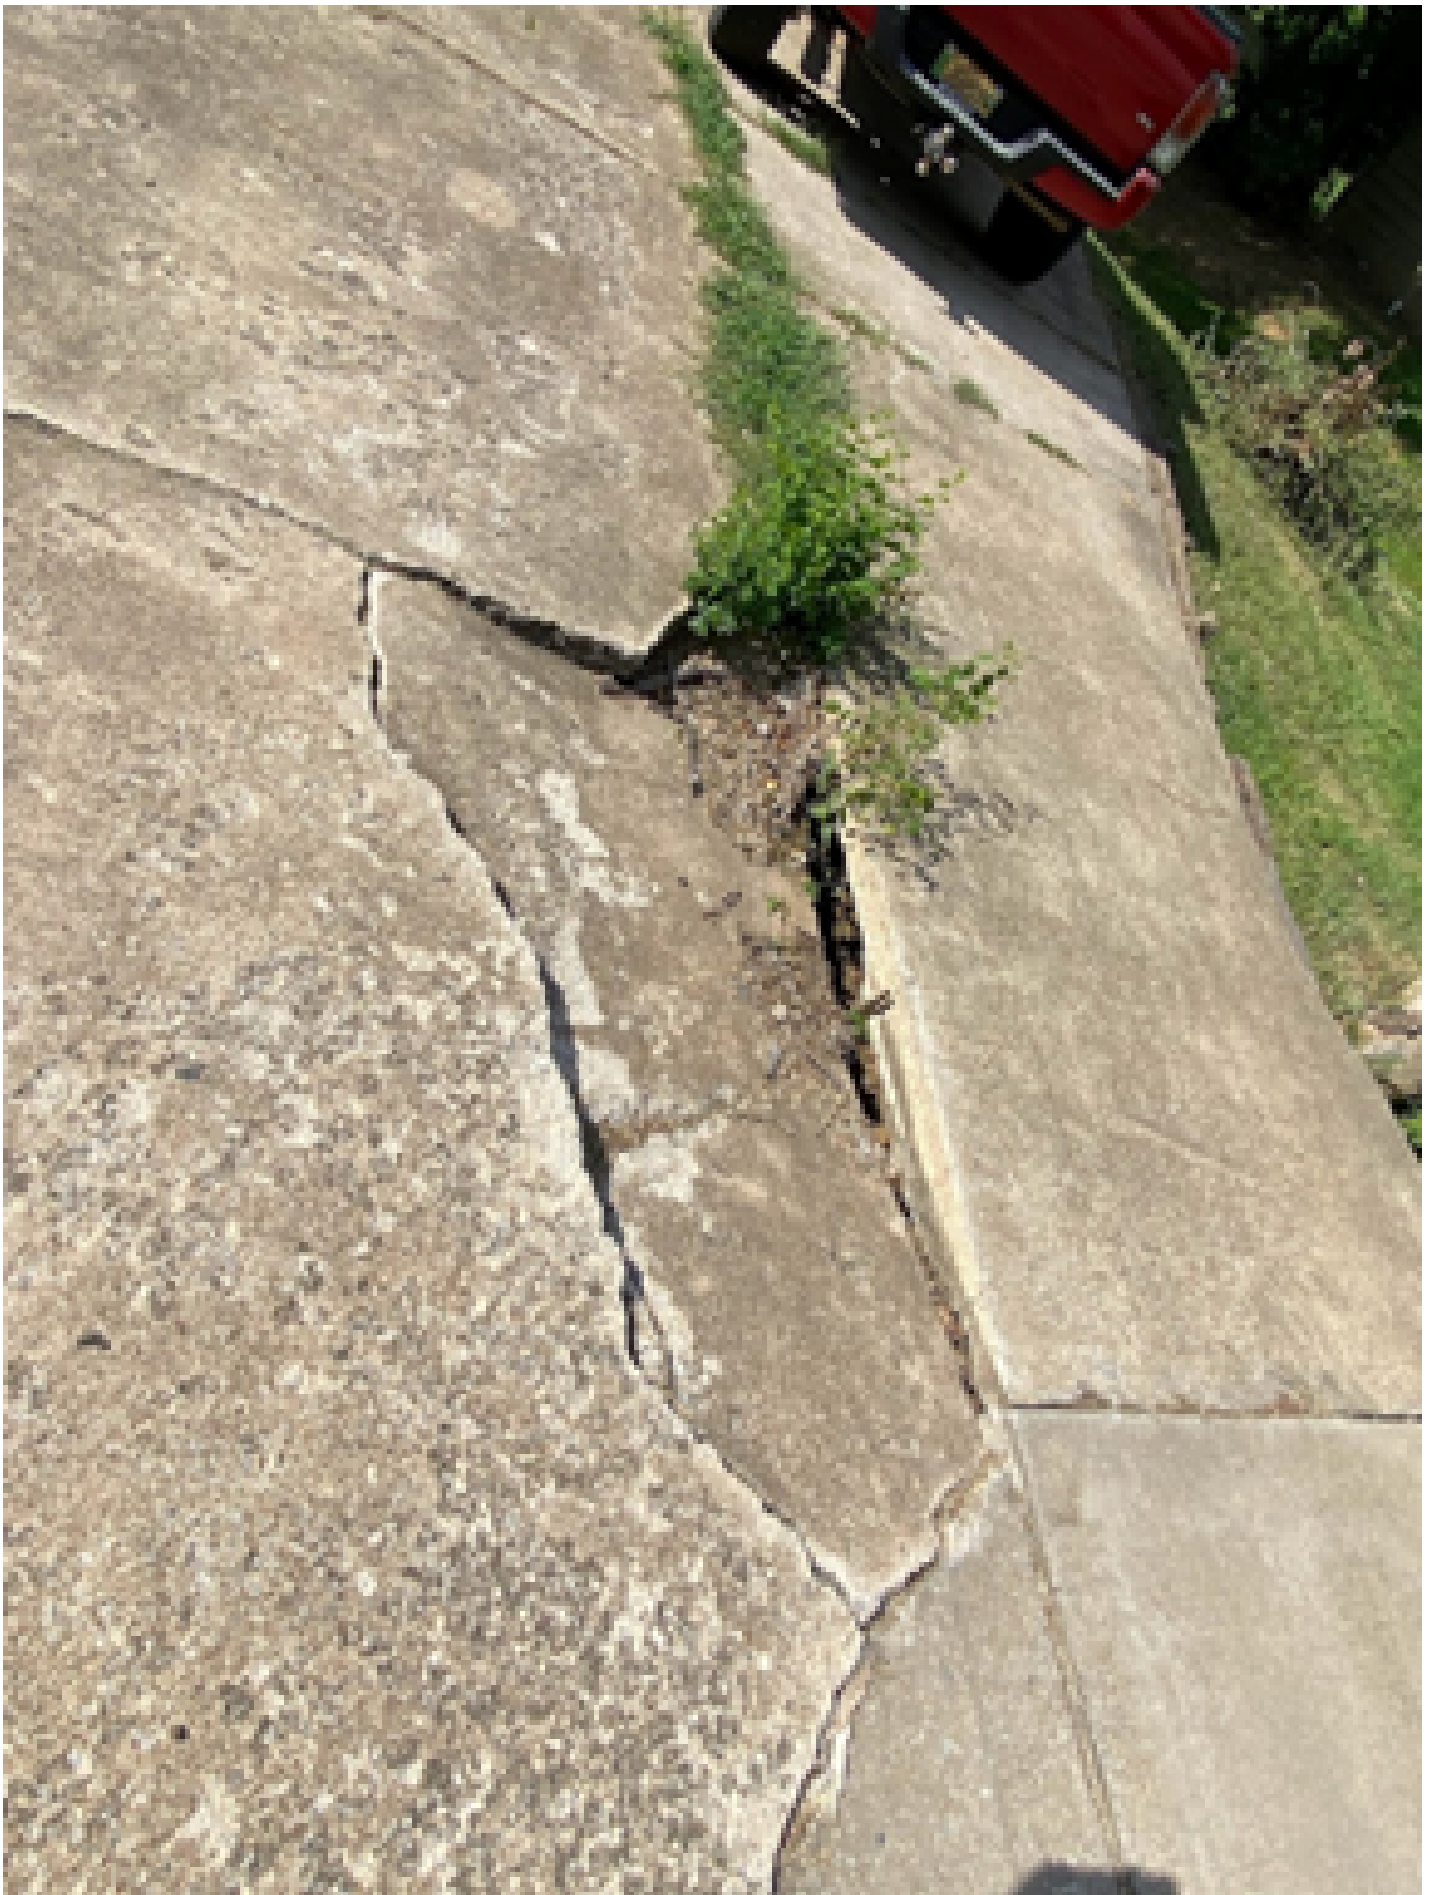
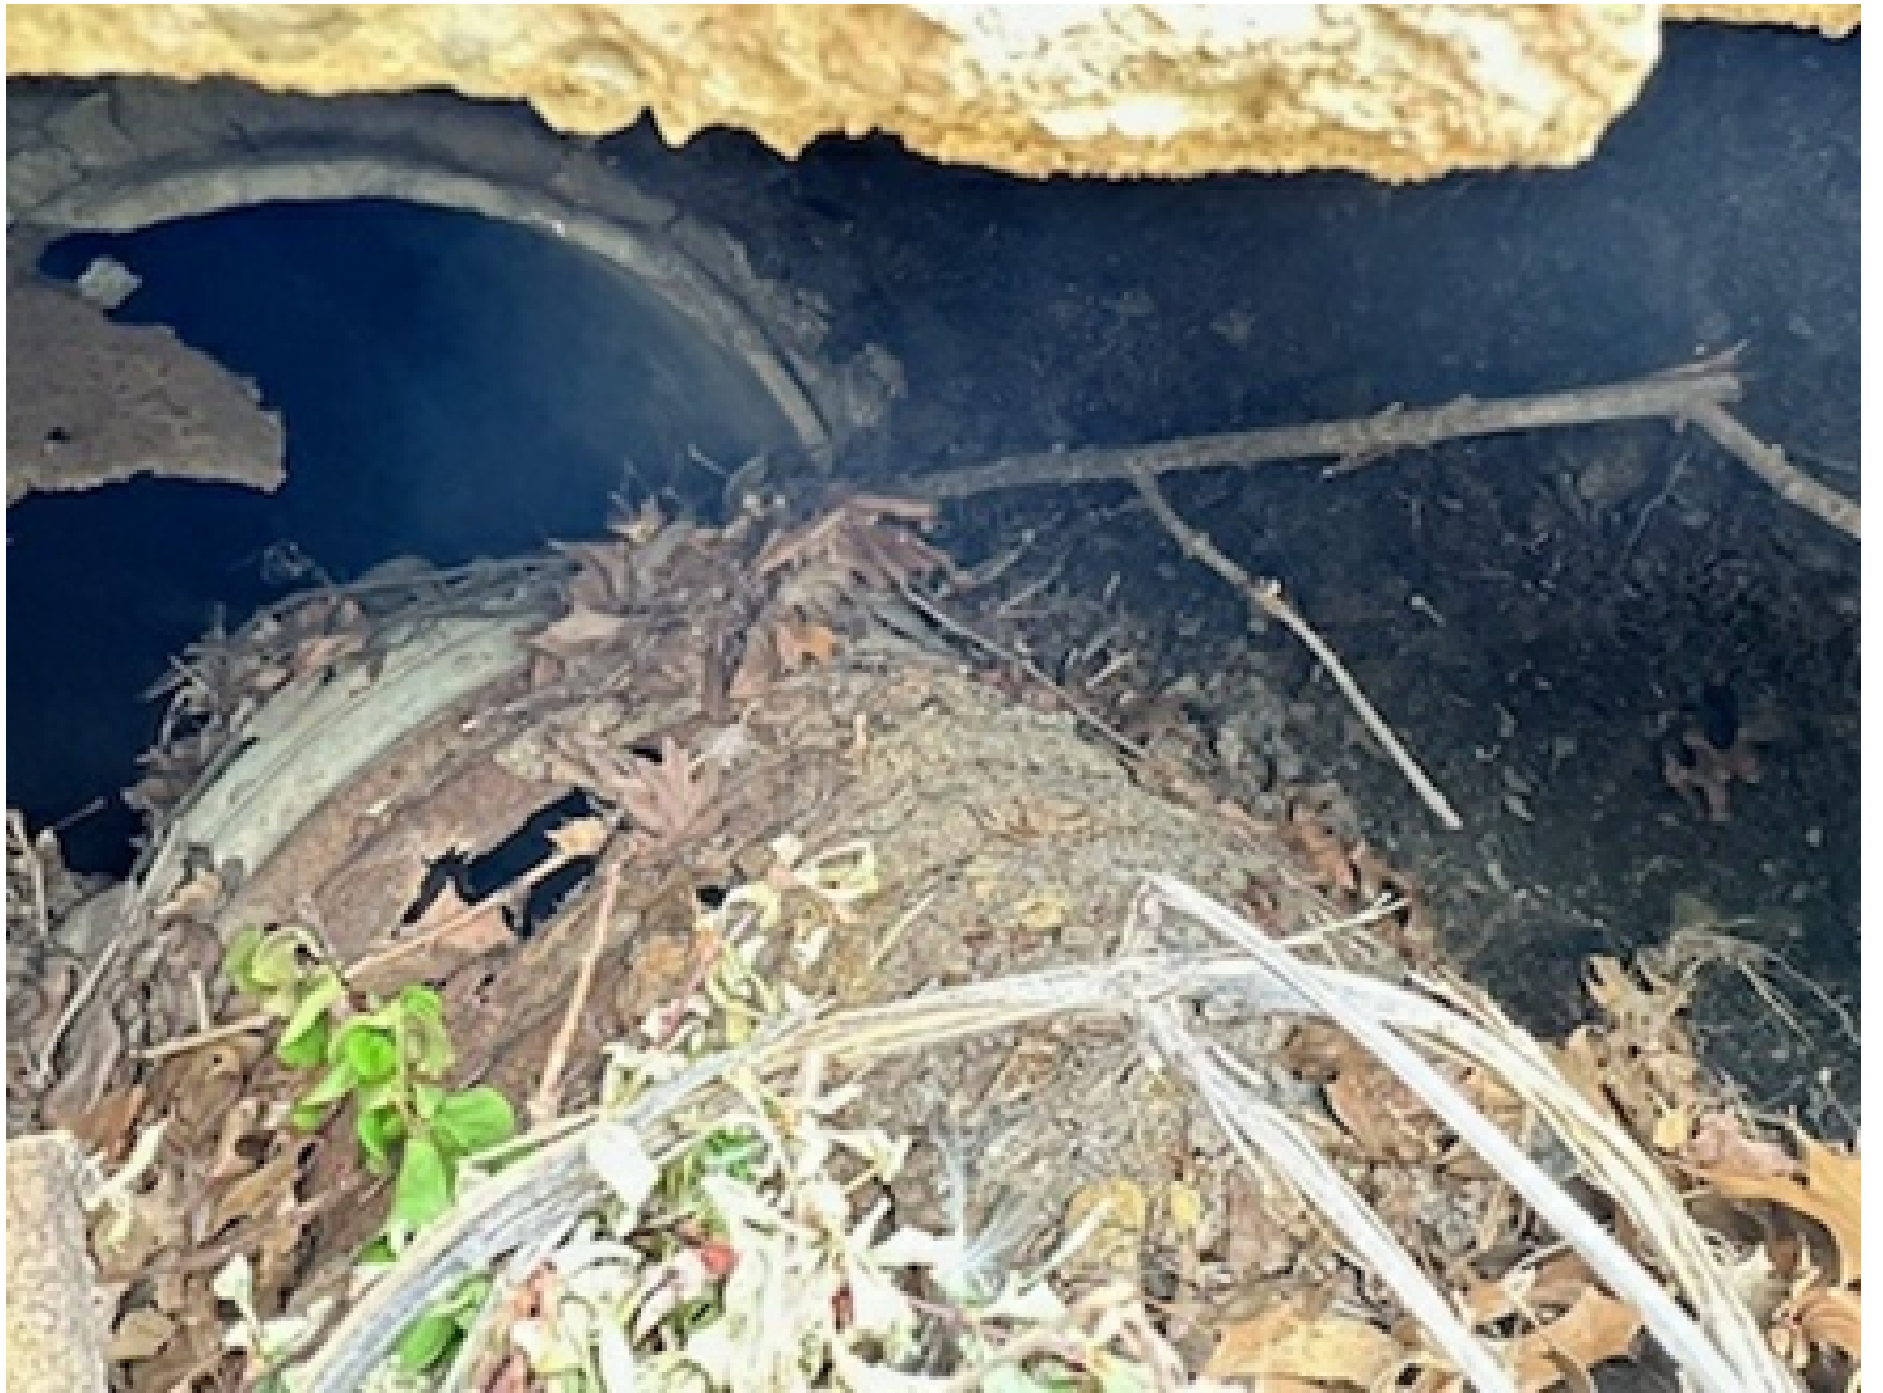
The Stormwater Division Manager inspected the site in February 2023 while it was raining. The holes were noted to be about in the same location as the storm sewer. The CMP was visible in one of the holes. Moving water was also noted in the hole. After the site visit, Streets & Stormwater sent a camera through the line. The camera showed some separation at the joints and areas where the bottom has rusted out.

Holes are forming around residential driveways on the south side of Dallas St in between 2<sup>nd</sup> St. and 4<sup>th</sup> St. Residents have contacted the City to investigate. Driveways over the storm sewer are beginning to collapse.

Replace the storm sewer from line from Haskell Park to the outfall at the tributary to East Branch Haikey Creek.
