REGISTERED LAND SURVEYOR'S INSPECTION  
PLAT AND CERTIFICATE FOR MORTGAGE  
LOAN PURPOSE

COLLINS LAND SURVEYING, INC.

Borrower: McCleary, Lois R.  
2241736-TU02

Property address: 8202 South Ash Avenue, Broken Arrow, Oklahoma

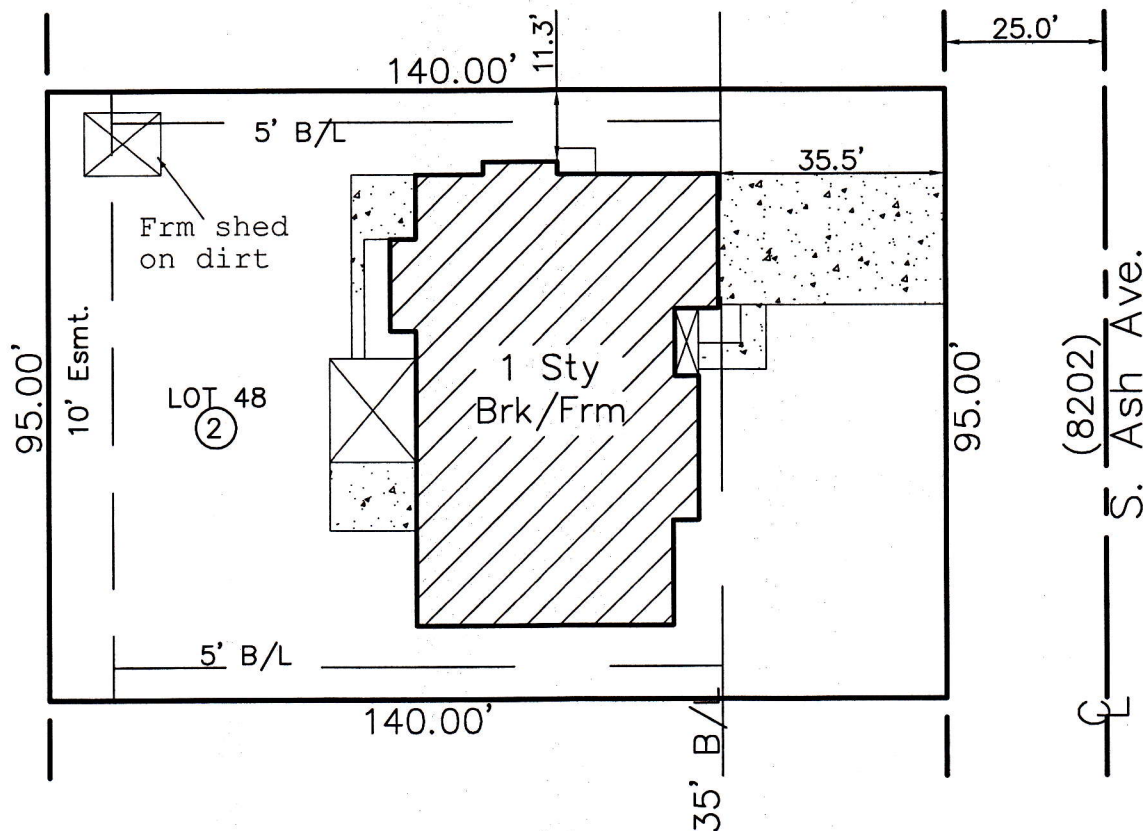
SUBJECT PROPERTY LIES WITHIN FLOOD ZONE "UNSHADED X" AN AREA OF MINIMAL FLOOD HAZARD AS SHOWN ON FIRM MAP#400236 0456L, DATED 10/16/2012.
