# City of Broken Arrow

## PROJECT REPORT

| ADDRESS / LOCATION | Liberty Trail along Creek Turnpike, west of S. Elm St. |

**Subject: Liberty Trail retaining wall evaluation – Broken Arrow, OK**

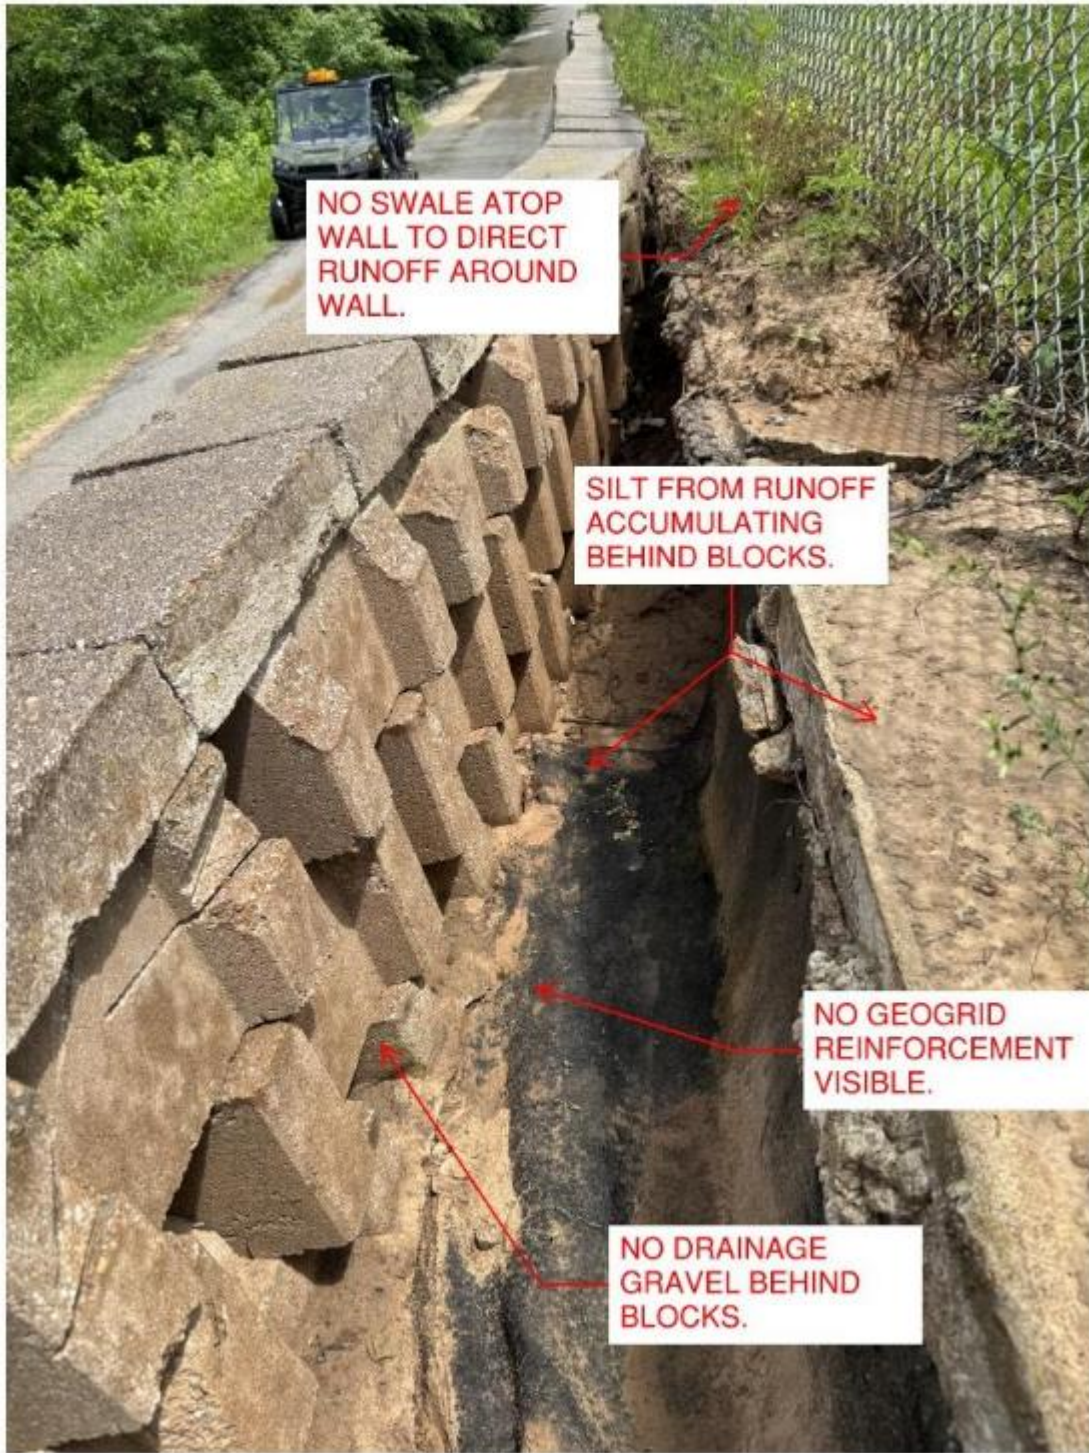
NO SWALE ATOP  
WALL TO DIRECT  
RUNOFF AROUND  
WALL.

SILT FROM RUNOFF  
ACCUMULATING  
BEHIND BLOCKS.

NO GEOGRID  
REINFORCEMENT  
VISIBLE.

NO DRAINAGE  
GRAVEL BEHIND  
BLOCKS.

- **Demolish and reconstruct** the existing wall using a segmental block retaining wall system that complies with current industry standards and best practices.
- **Reuse existing block units** that remain in good structural condition to reduce material costs.
- **Install a surface drainage swale** along the top of the wall to intercept and redirect stormwater runoff from the turnpike, thereby minimizing water accumulation behind the wall.

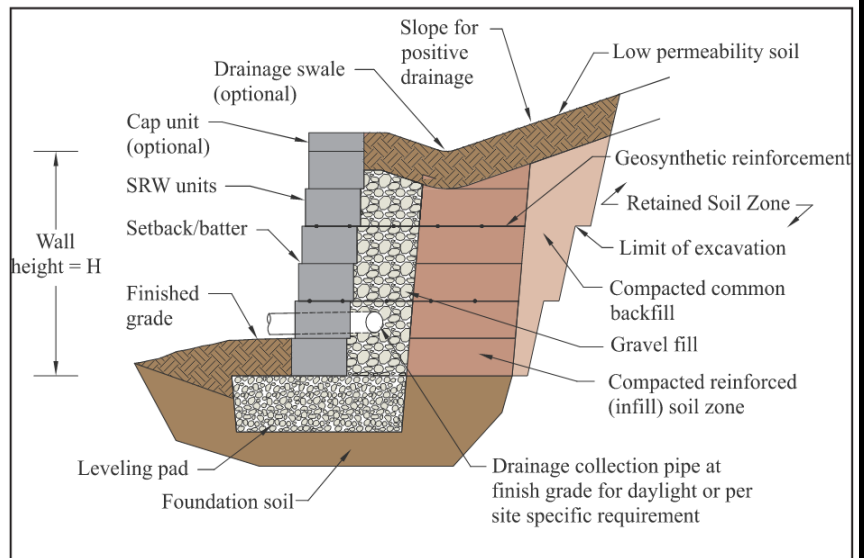
Figure 2: Typical MSE Wall

- The wall lacks essential drainage provisions such as weep holes and a 12-inch clean gravel backfill zone, both of which are standard design requirements.
- No geogrid reinforcement was observed. This is a critical omission, particularly for retaining walls exceeding 4 feet in height, as it compromises lateral earth support (see Figure 2 for a standard geogrid-reinforced wall cross-section).
