PROJECT REPORT

DATE:	04/18/24
NAME	Brian Able
ADDRESS / LOCATION	519 S Redwood Ave
WATERSHED	Haikey Creek
ESTIMATE	\$0
CASE NO.	24-009

519 S Redwood Ave is in the Union Station South subdivision, platted in 1992. The initial contact with the City of Broken Arrow stated sink holes were forming in the back yard around the sanitary sewer. The City performed an inspection and a CCTV inspection of the sewer line did not find any breaks or soil in the main. There was noted burrowing animals in the back yard.

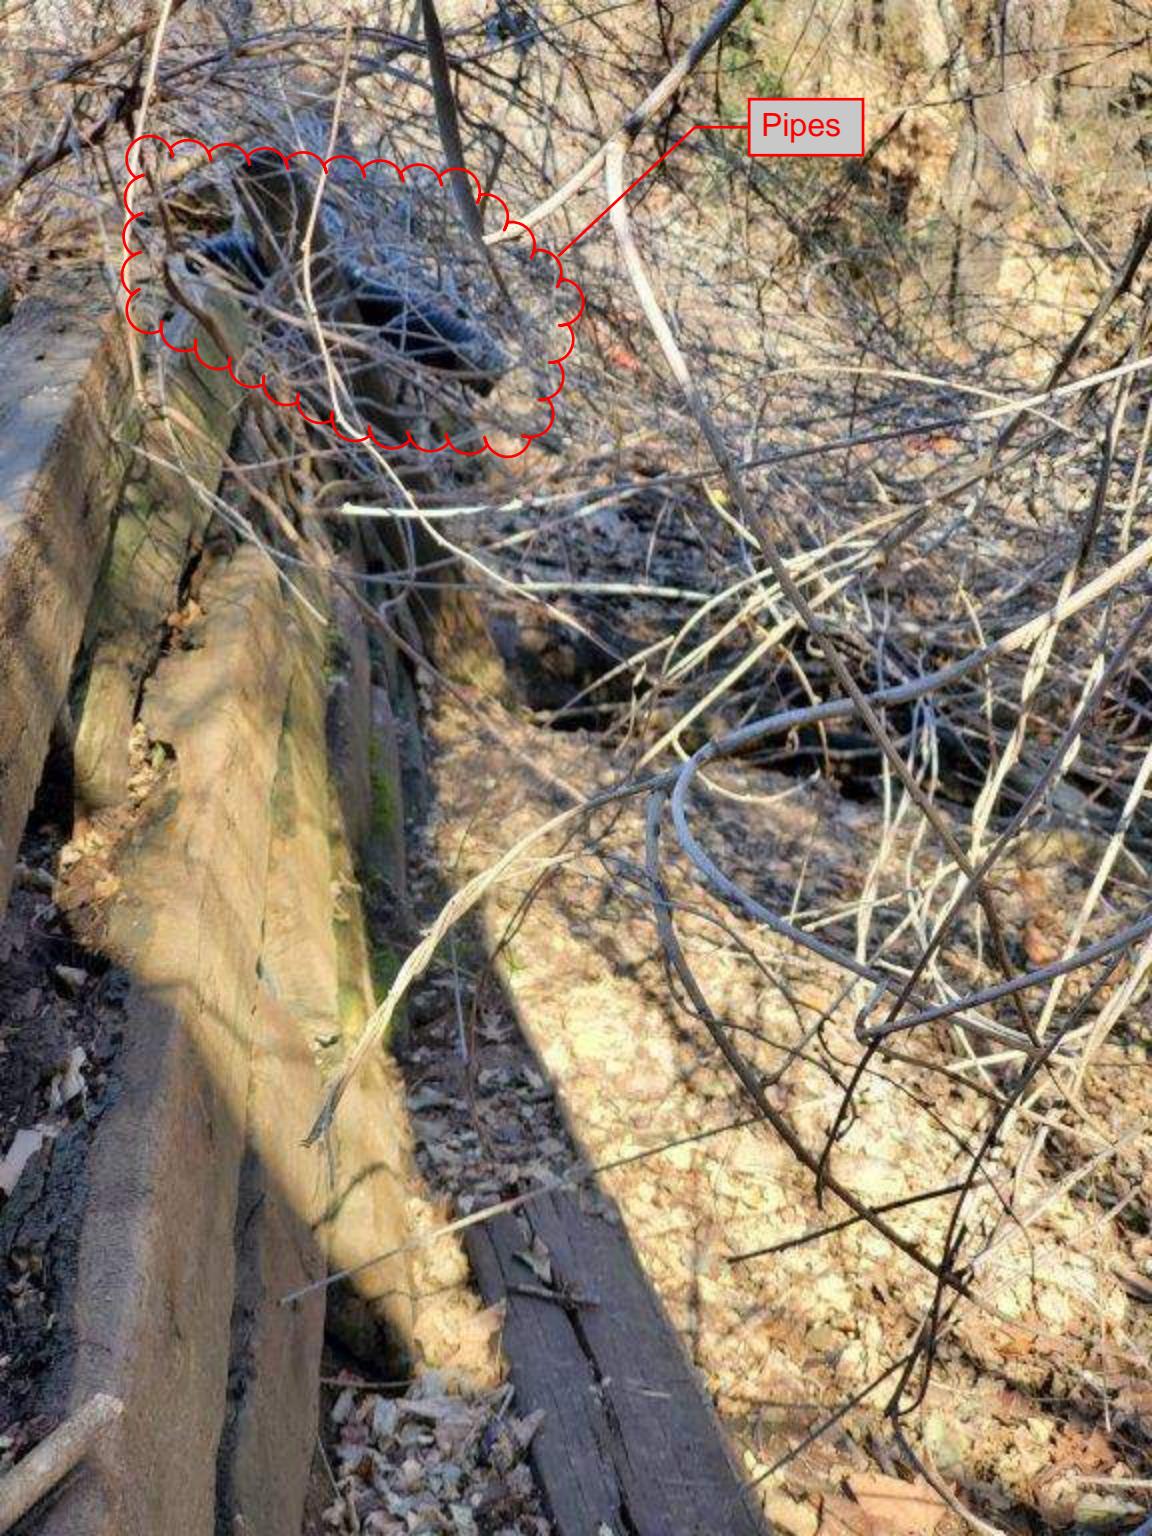
Pipes

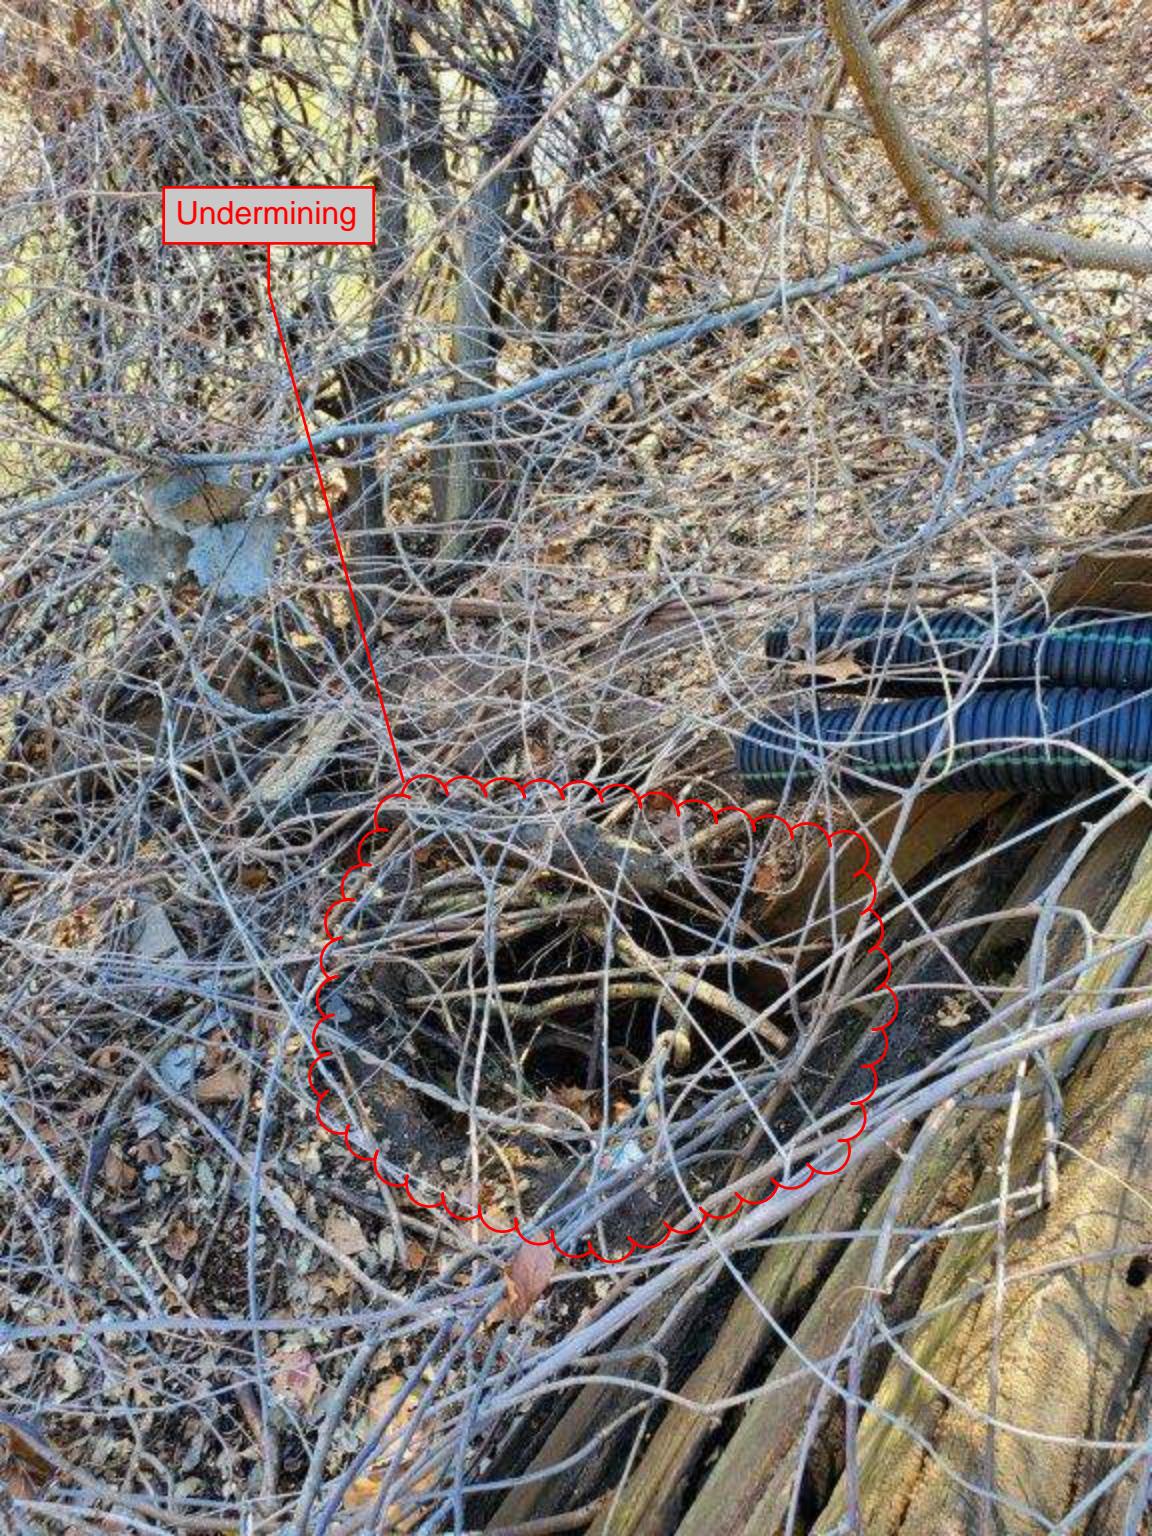
Undermining
