# City of Broken Arrow

## Drainage Advisory Committee

## PROJECT REPORT

DATE:	5/17/22
NAME	Brian Morgan
ADDRESS / LOCATION	315 West Galveston Street
WATERSHED	Haikey Creek
ESTIMATE	\$51,000.00
CASE NO.	22-004

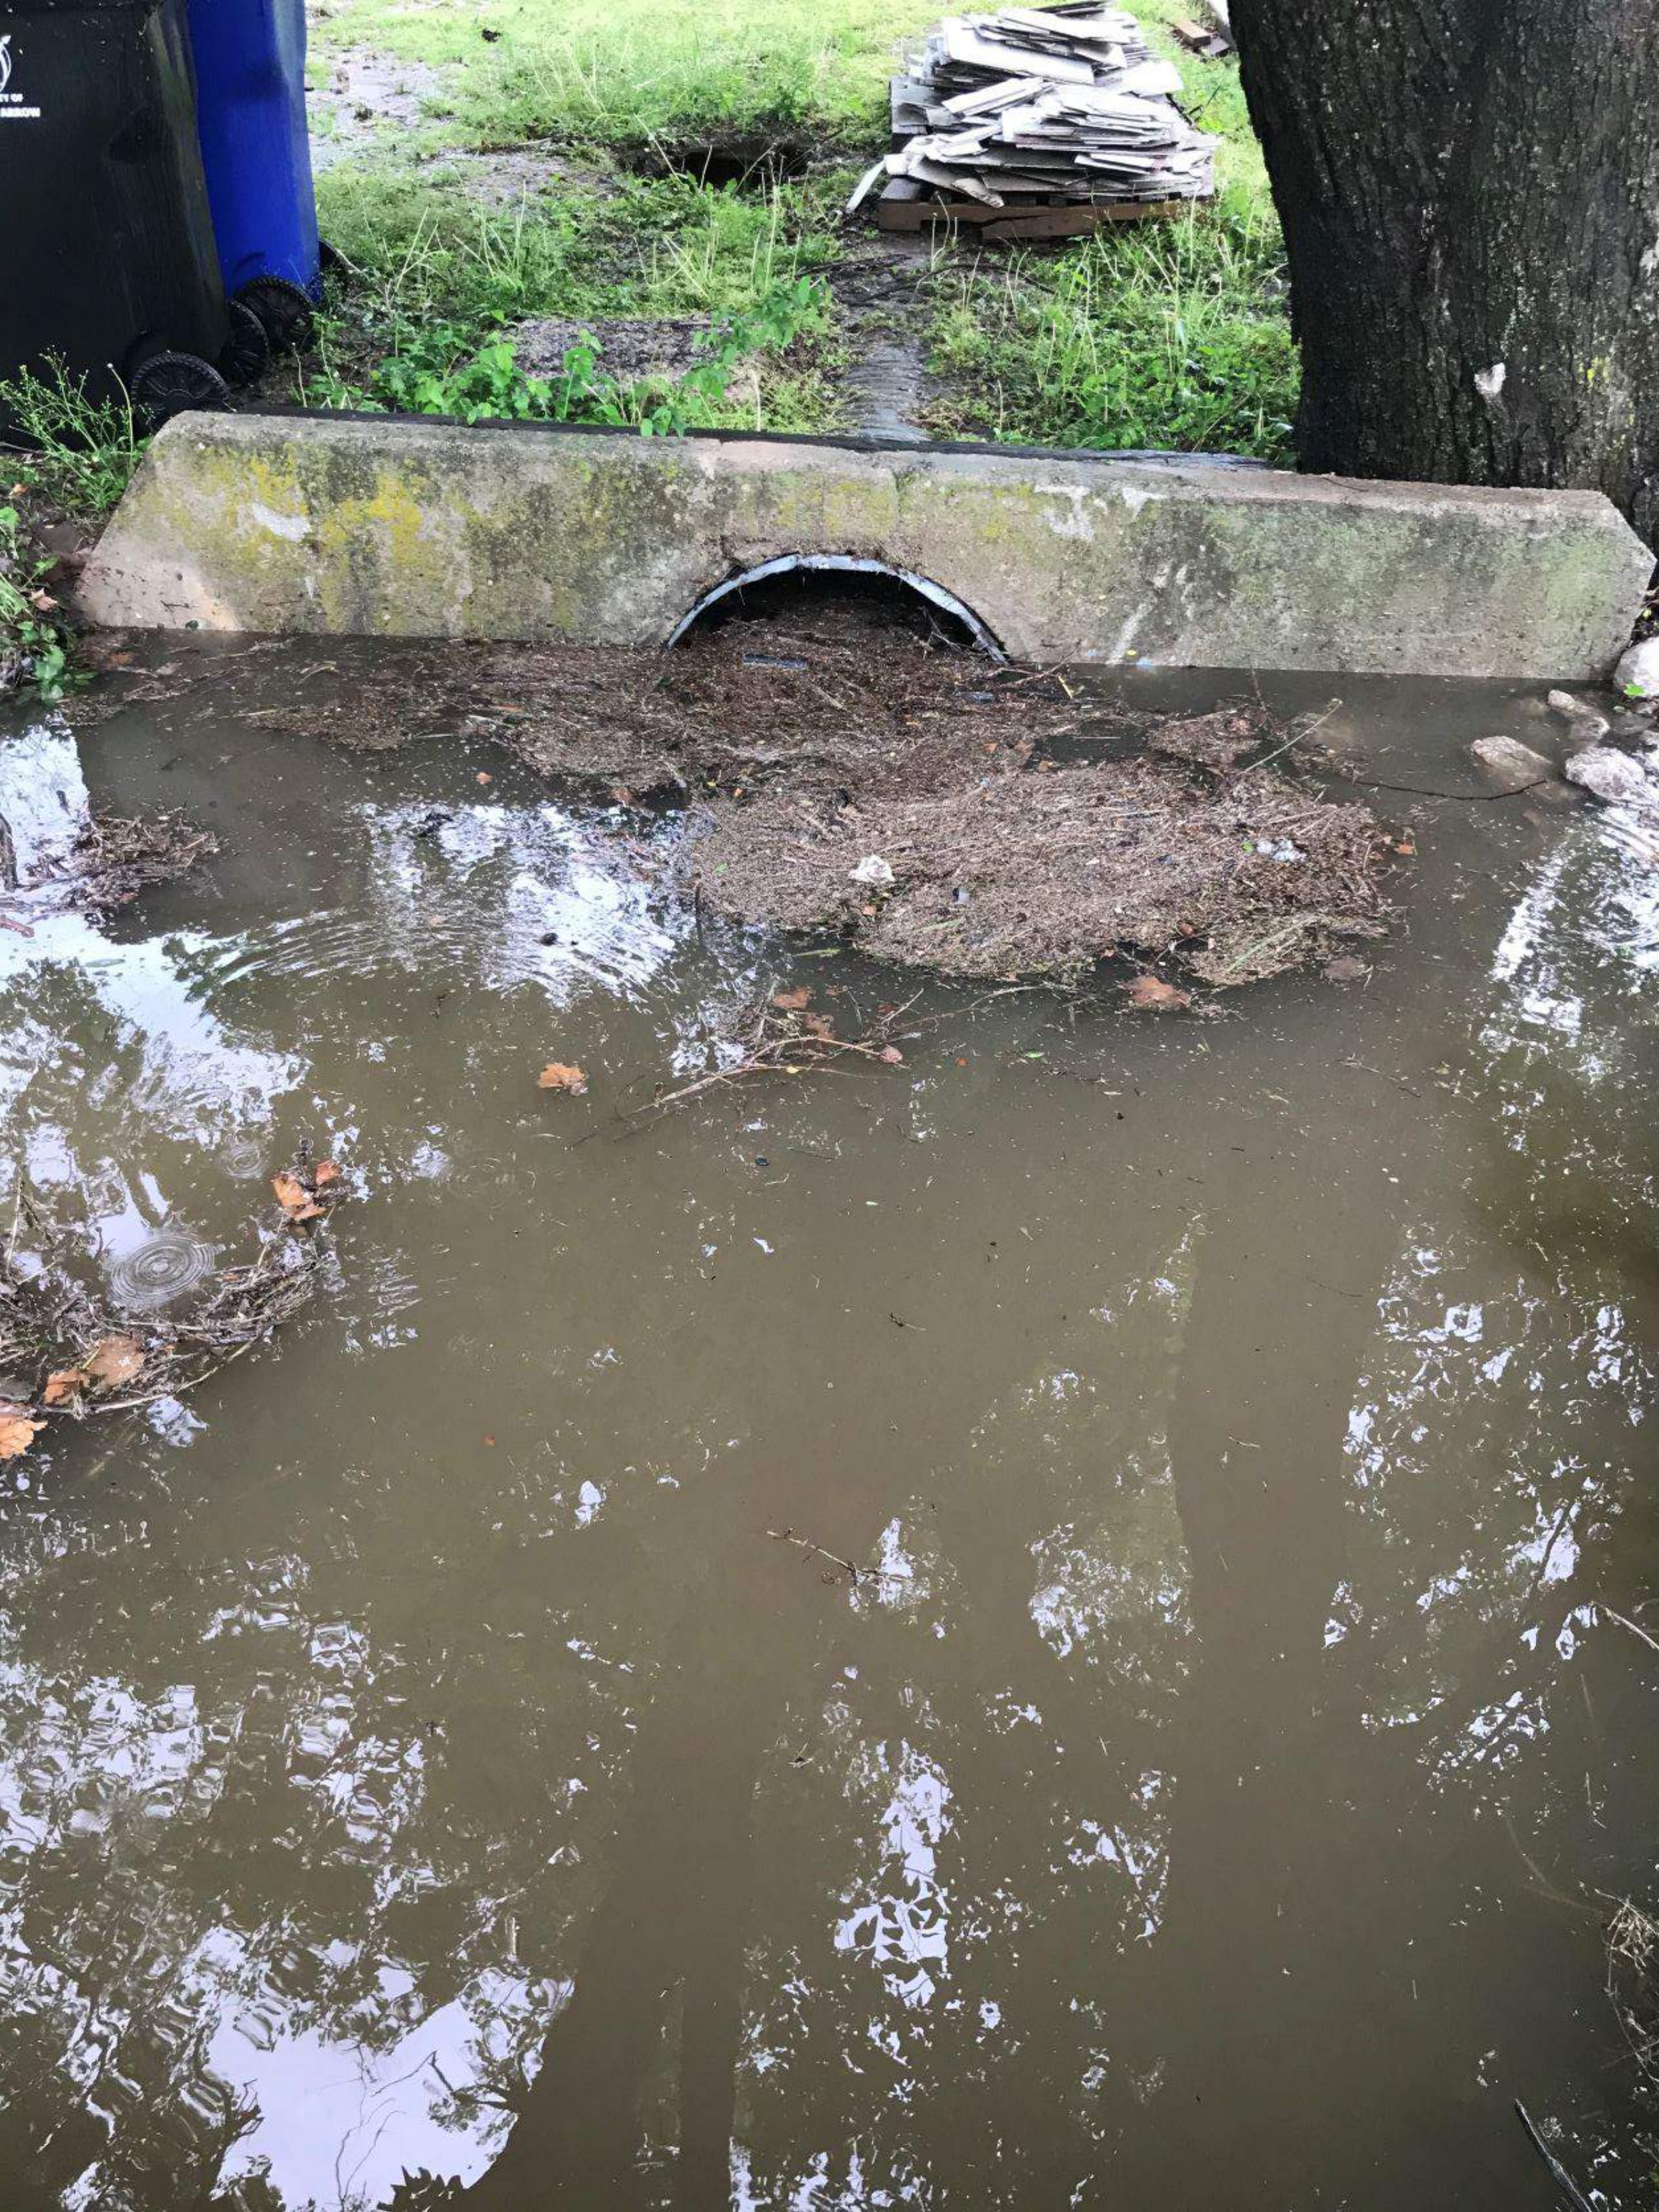
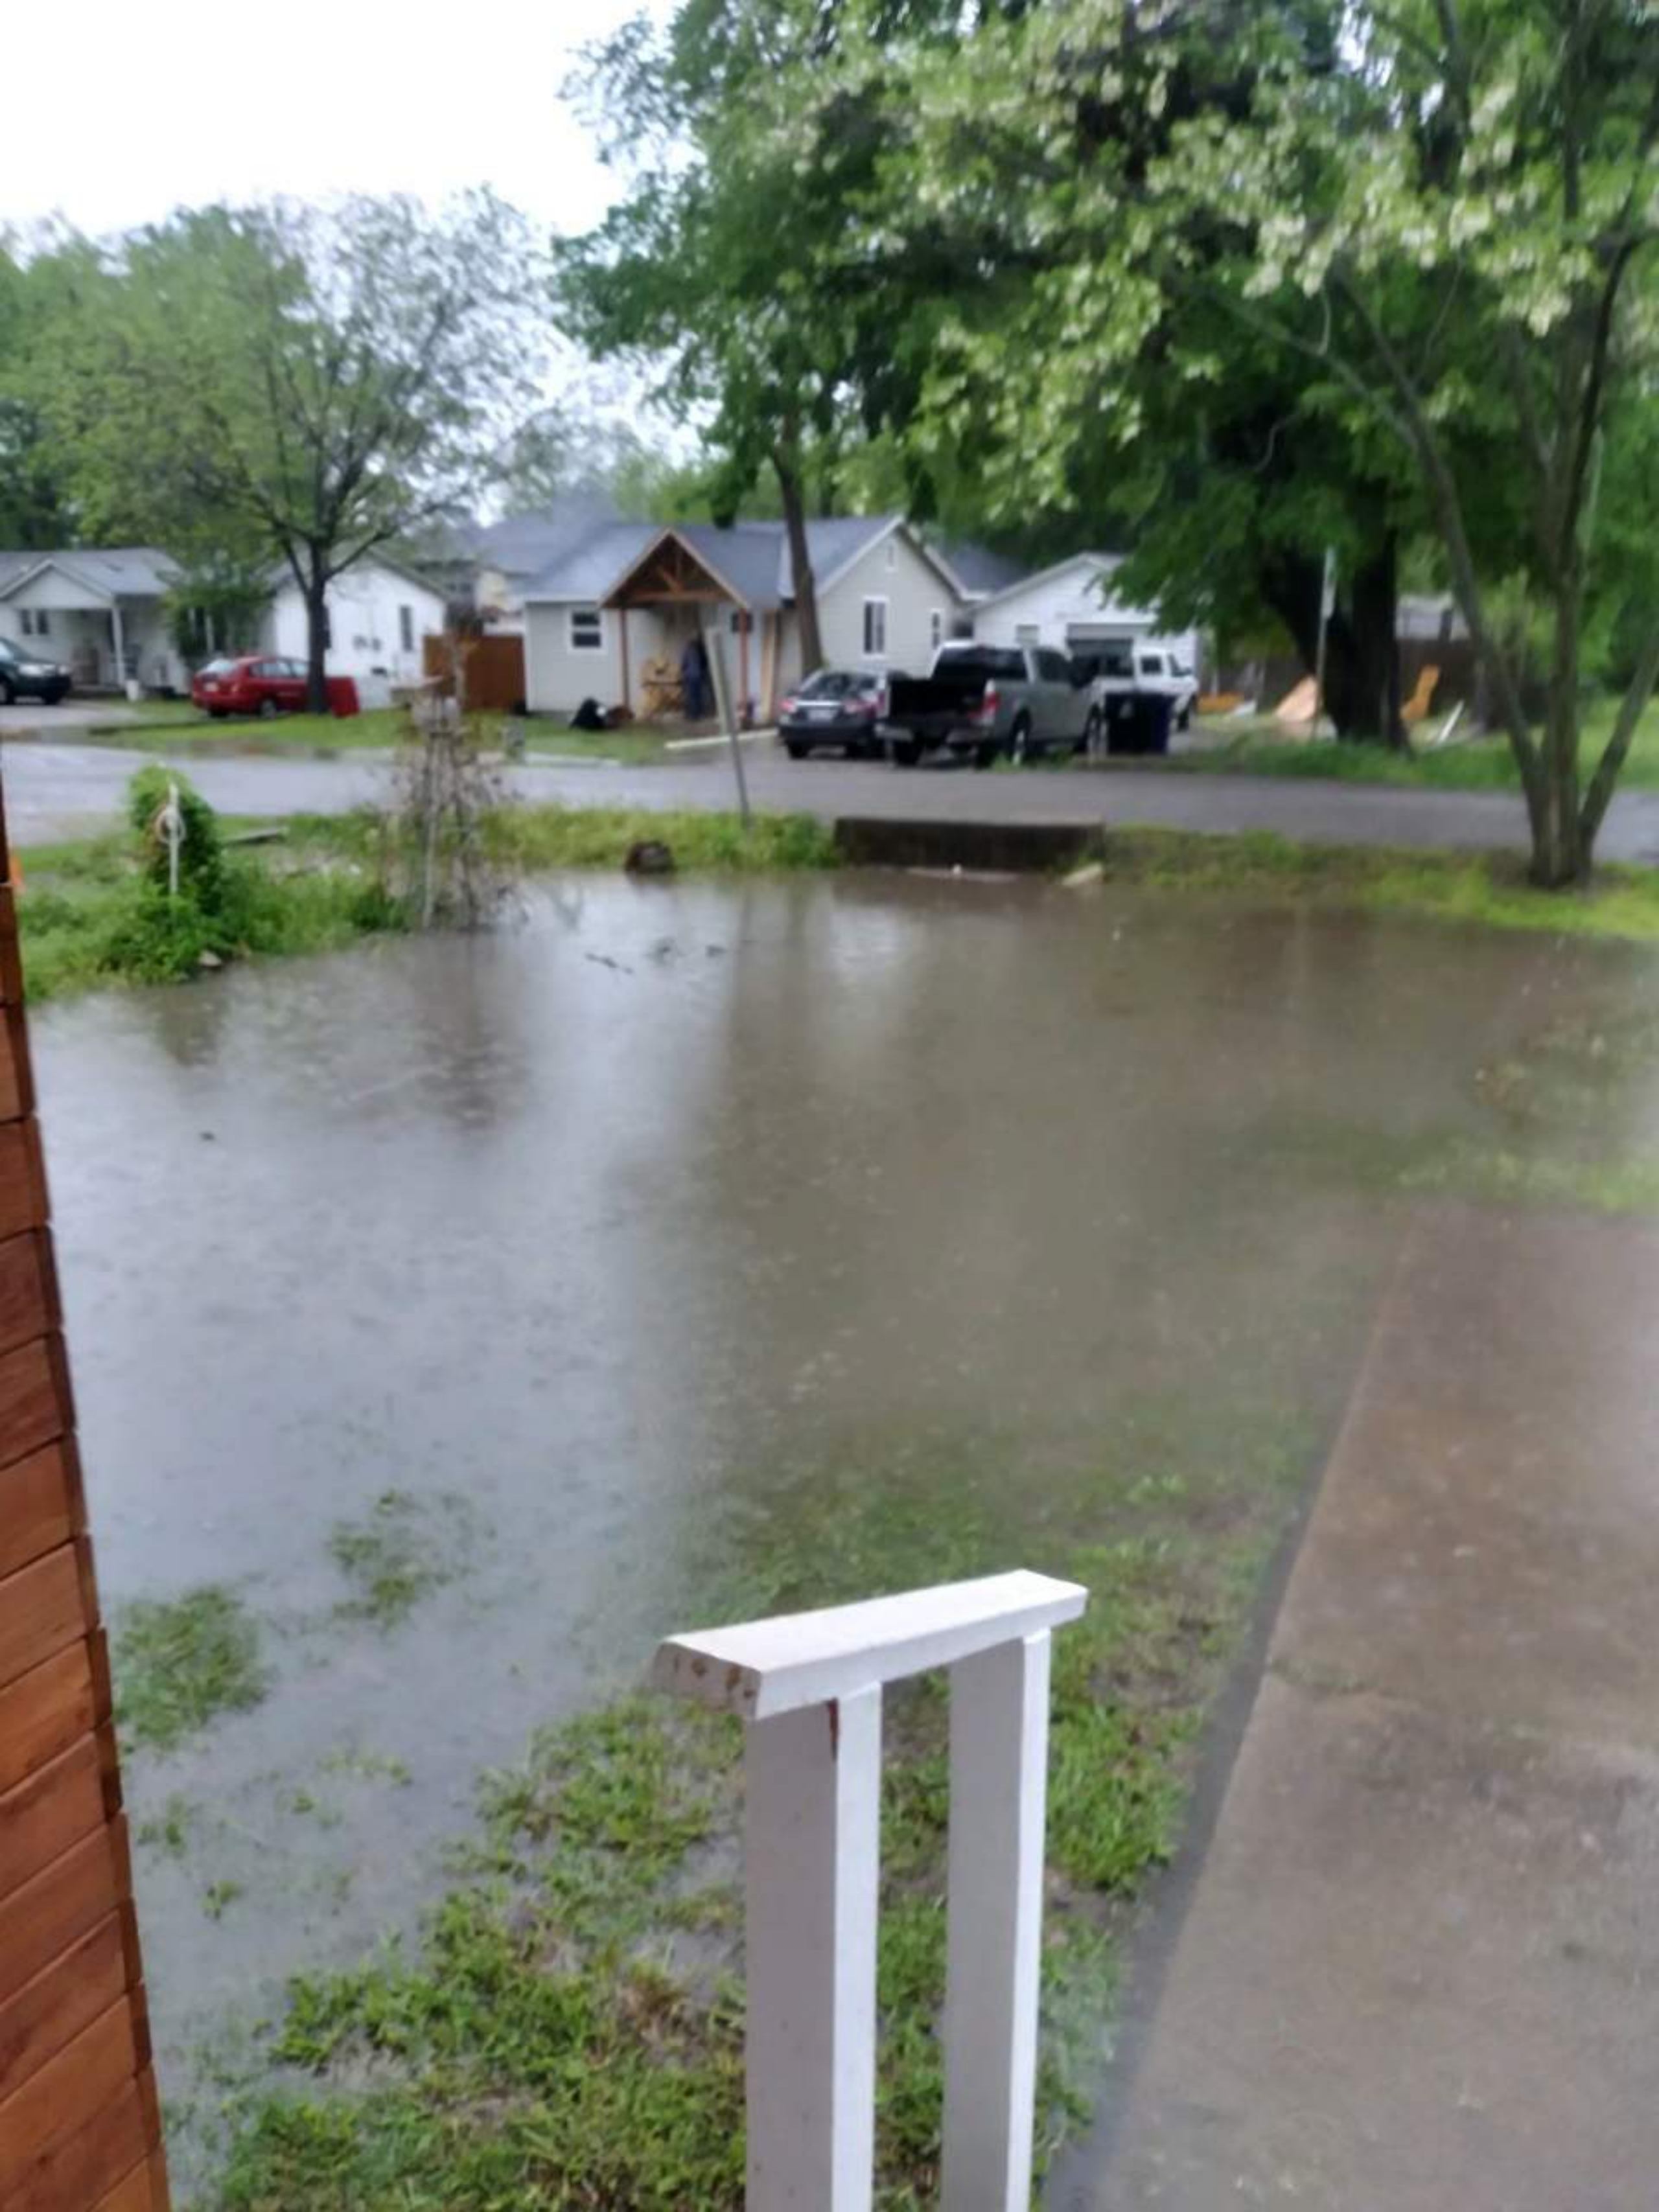
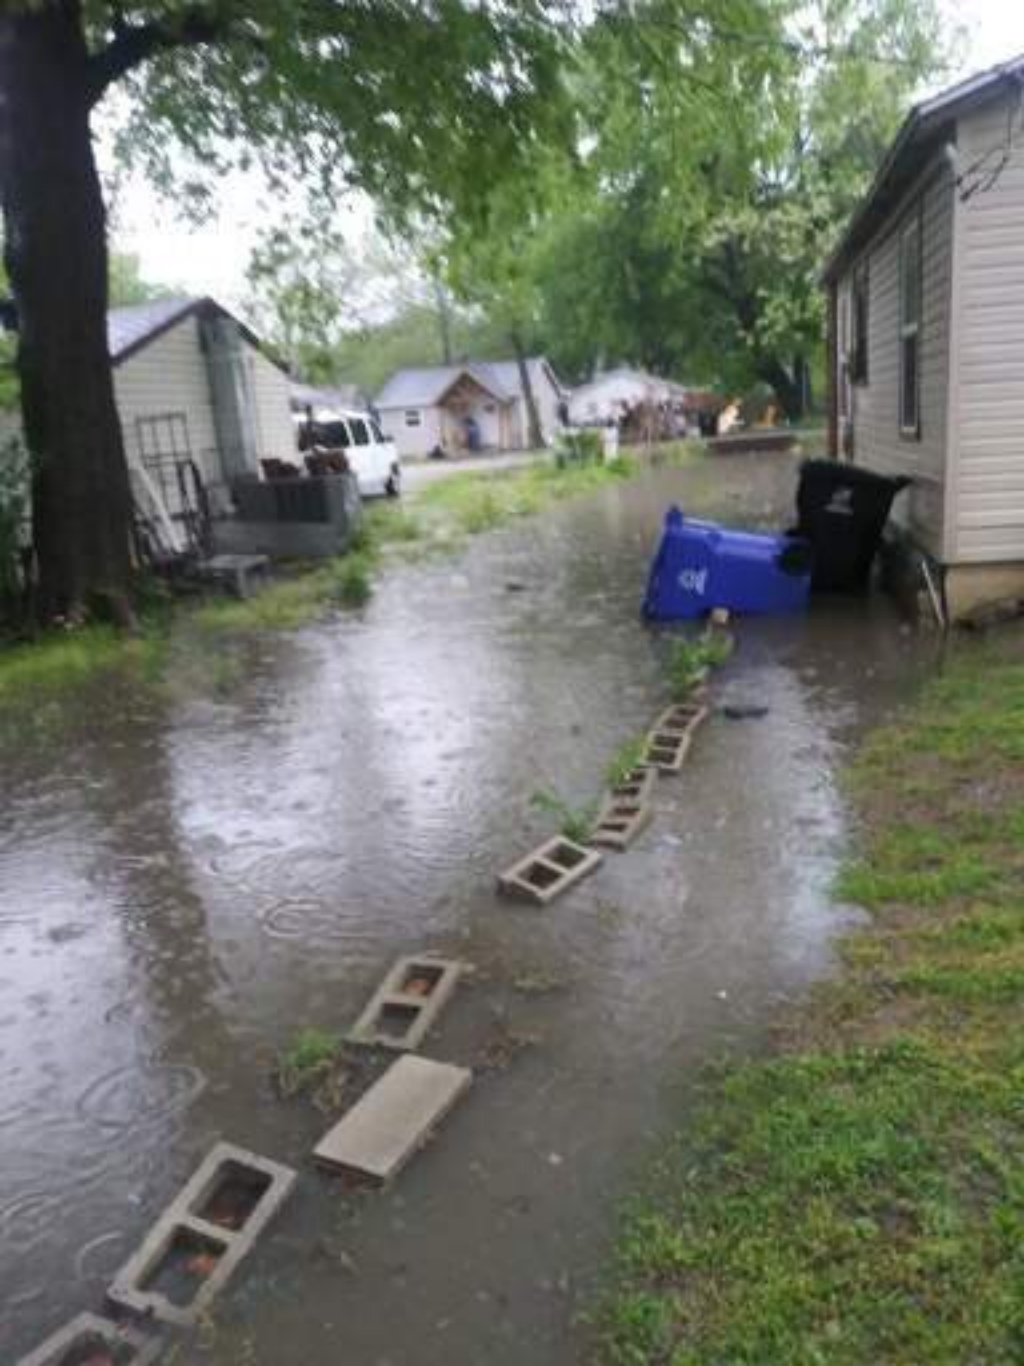
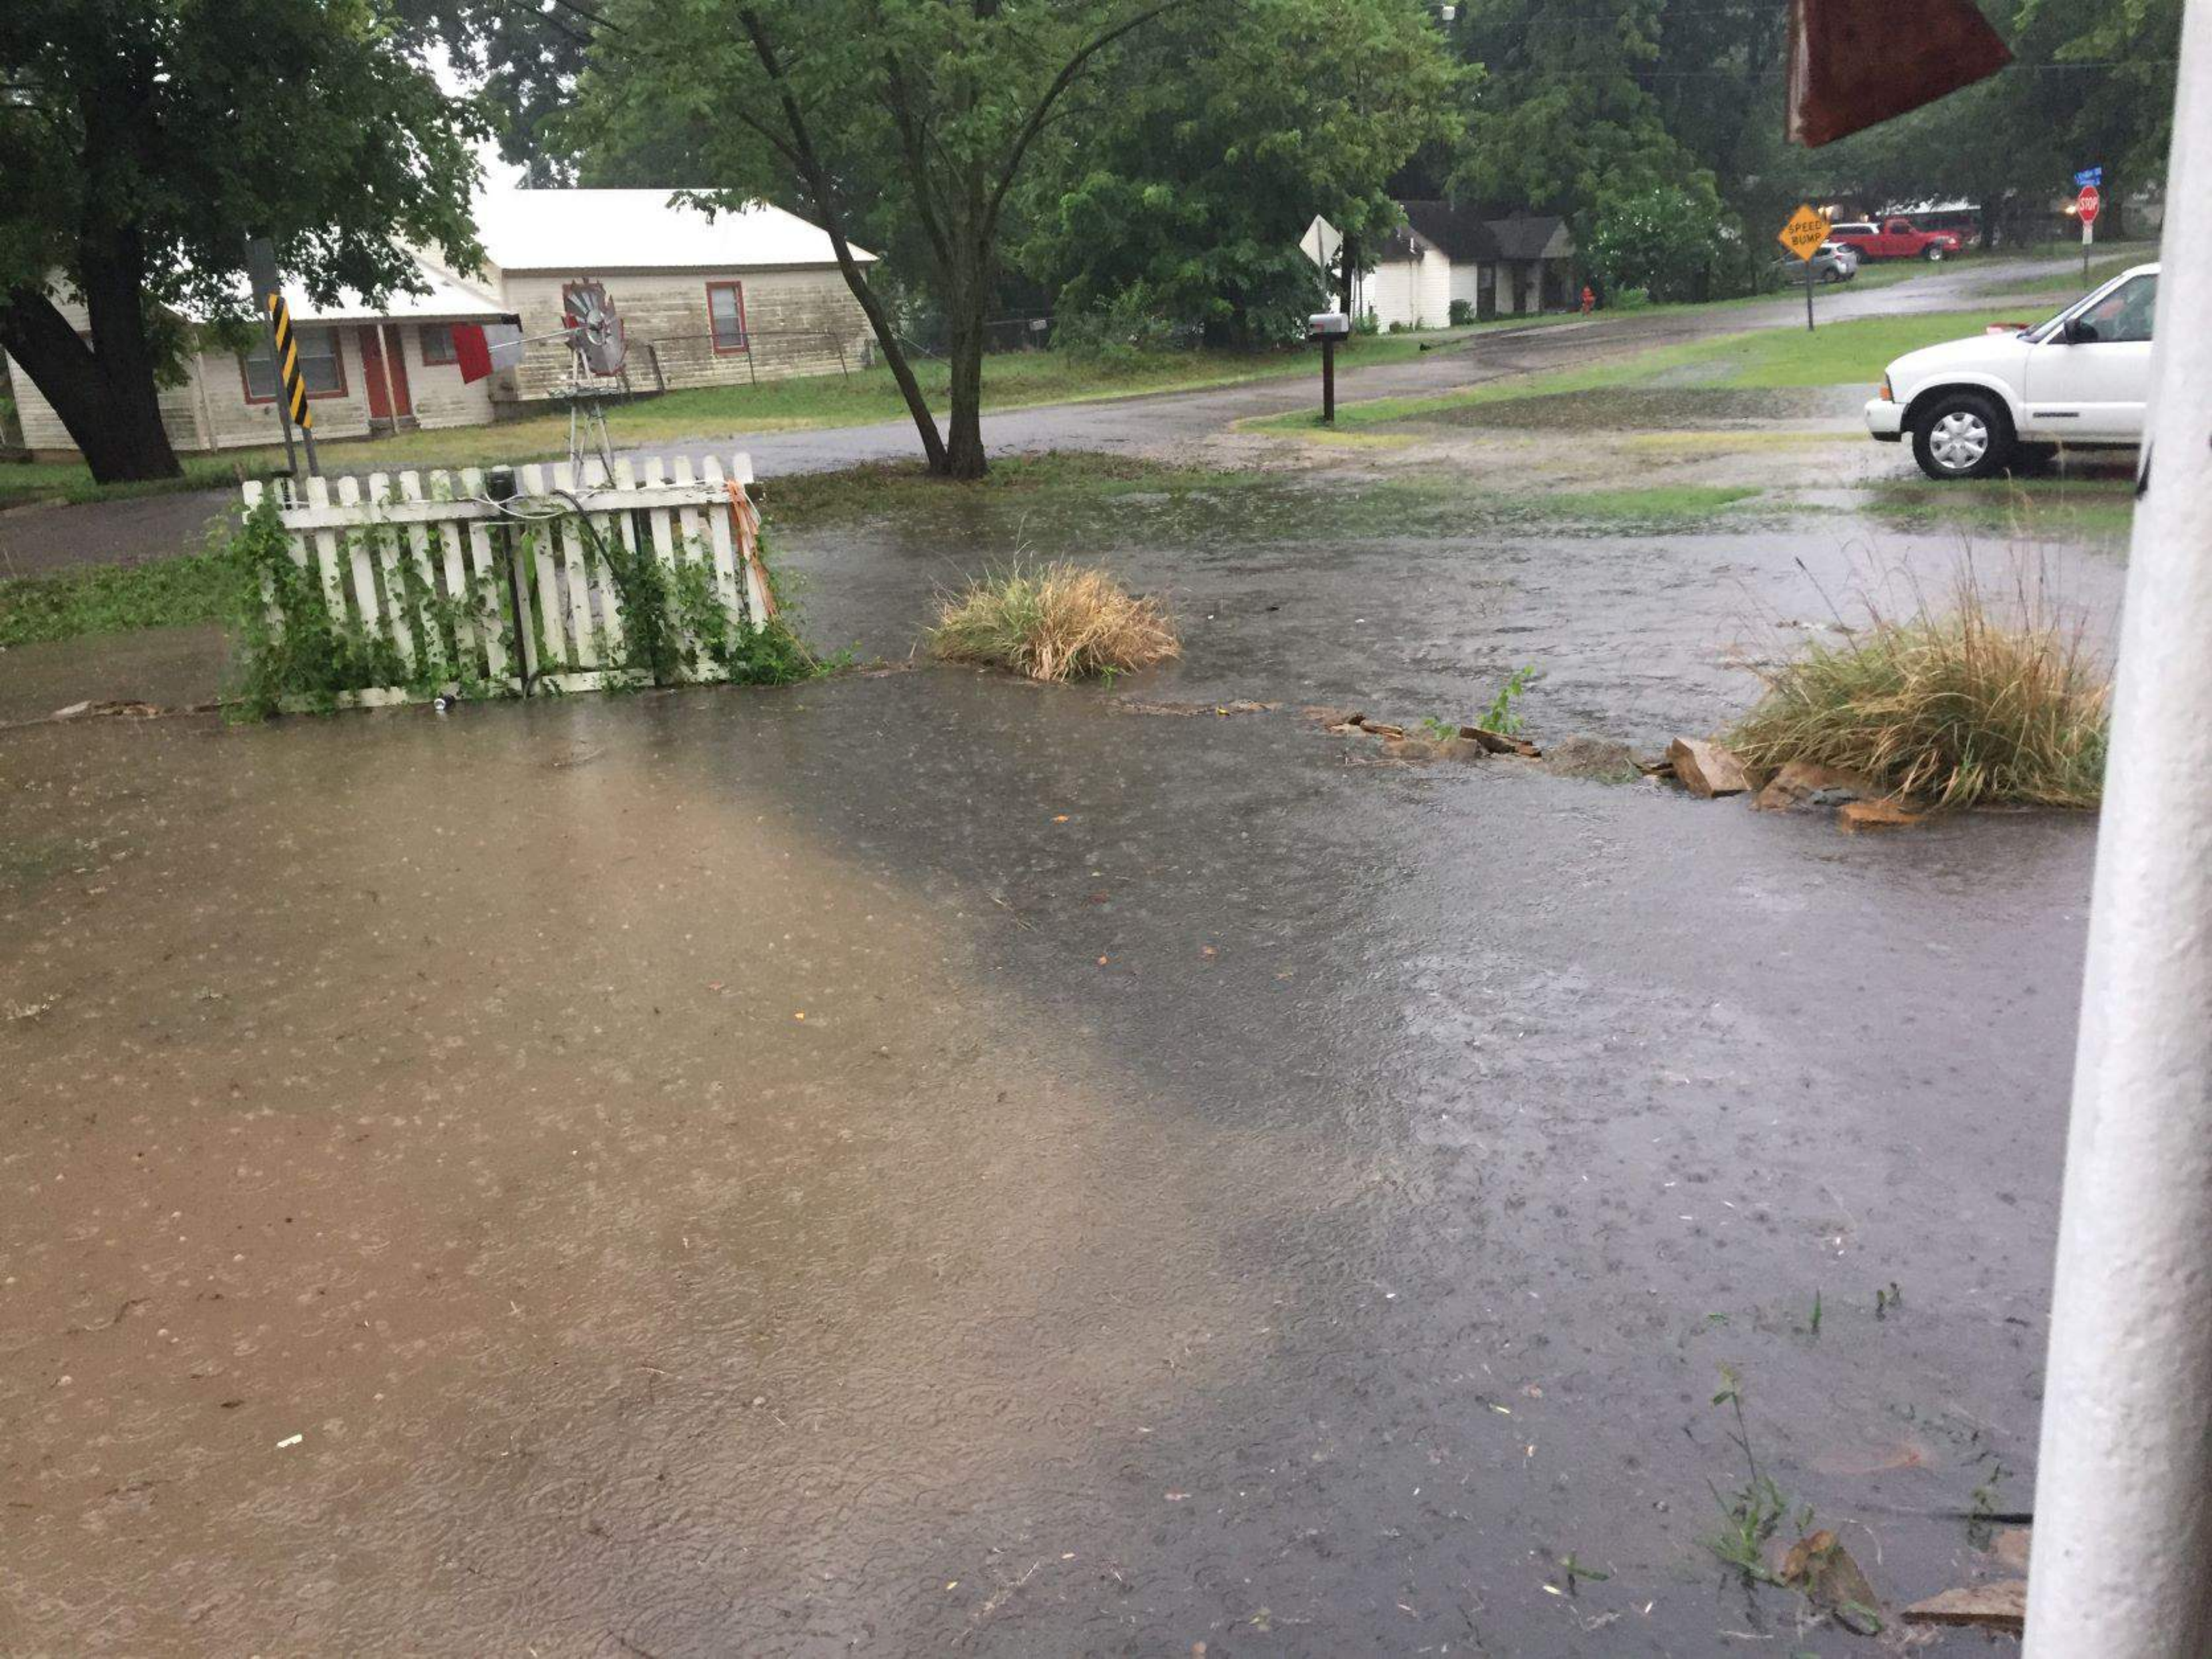
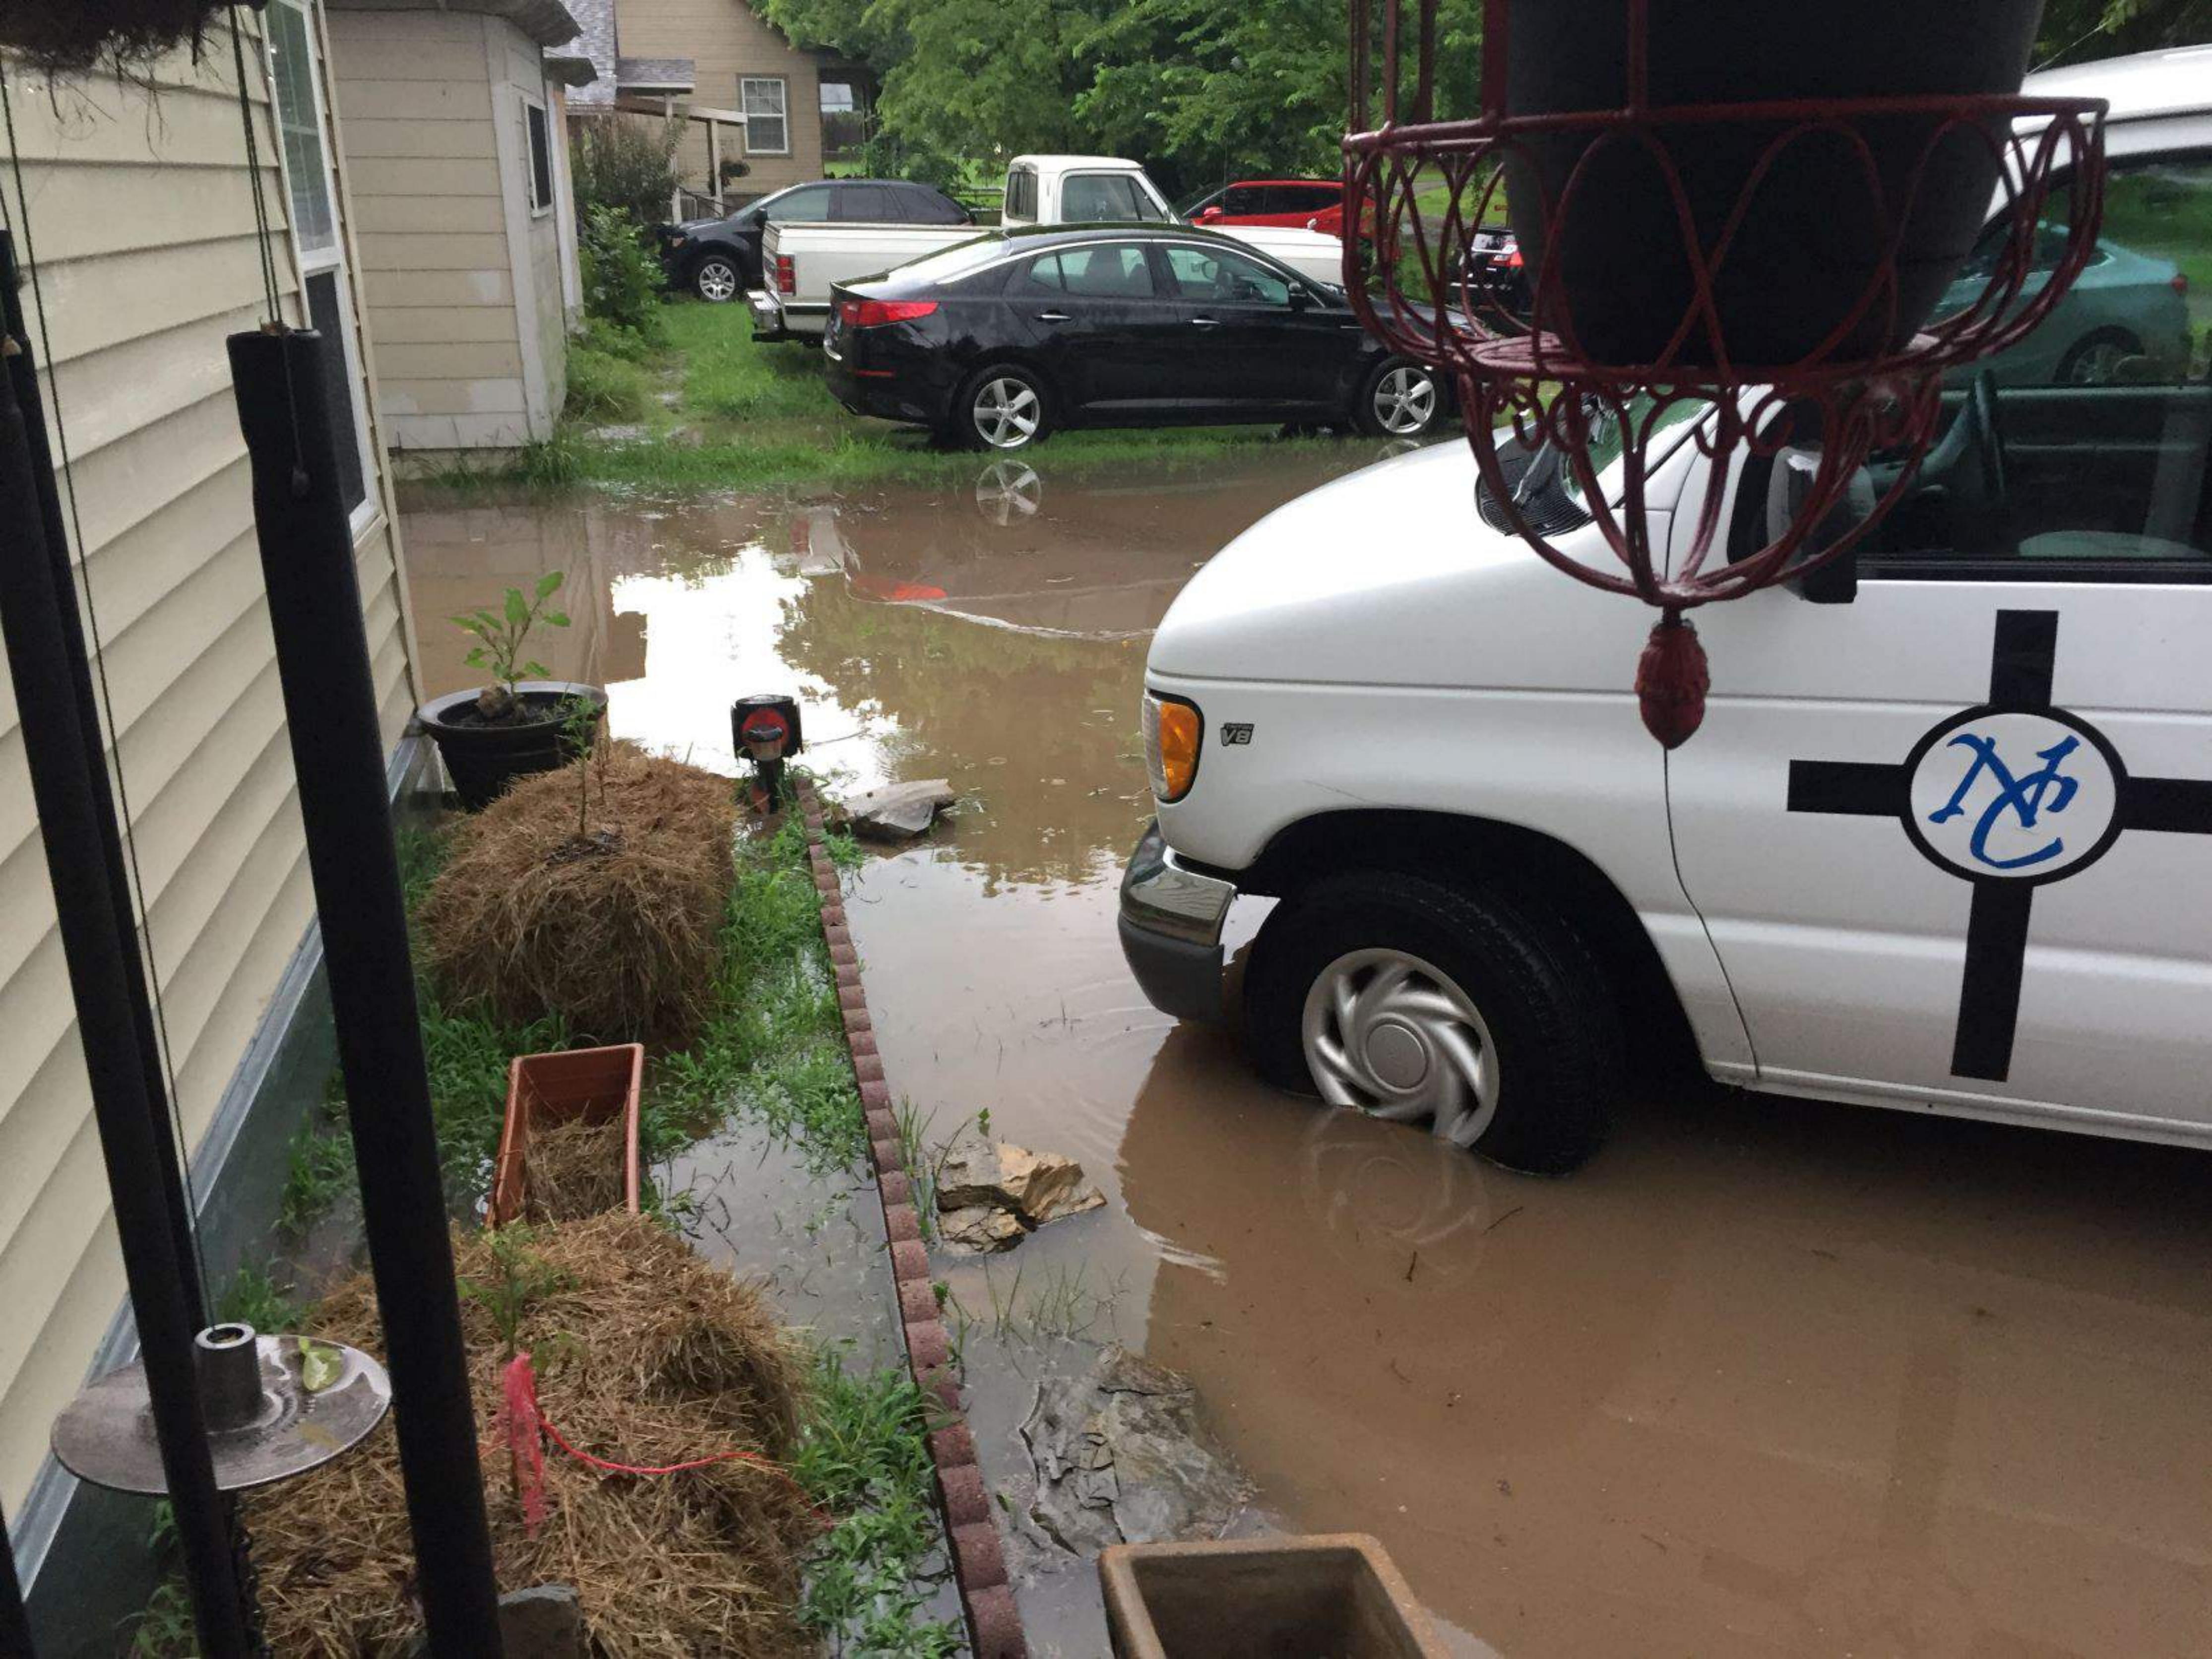
A 36 inch corrugated metal pipe (CMP) was placed in the open ditch in the late 1970's to early 1980's by a previous home owner. Over time the CMP has started to fail and is clogging. The failure is seen through multiple holes forming around the pipe. The clogging of the pipe is restricting the flow and causing localized flooding around the houses upstream of the pipe. The localized flooding is impacting traffic and the roadway has overtopped according to residents.

Corrugated pipe is deteriorating, obstructing flow of drain water. Because of this, the area floods. This includes but is not limited to the yards, driveways, crawl spaces and roads of our street (Galveston) We all love our street and area we live, but the drainage problem is a big problem every time we get a descent rain.

Staff recommend replacing the failing 36 inch CMP with a plastic 36 inch pipe as a maintenance item. This will clear the pipe and allow the water to flow downstream greatly reducing the localized flooding.

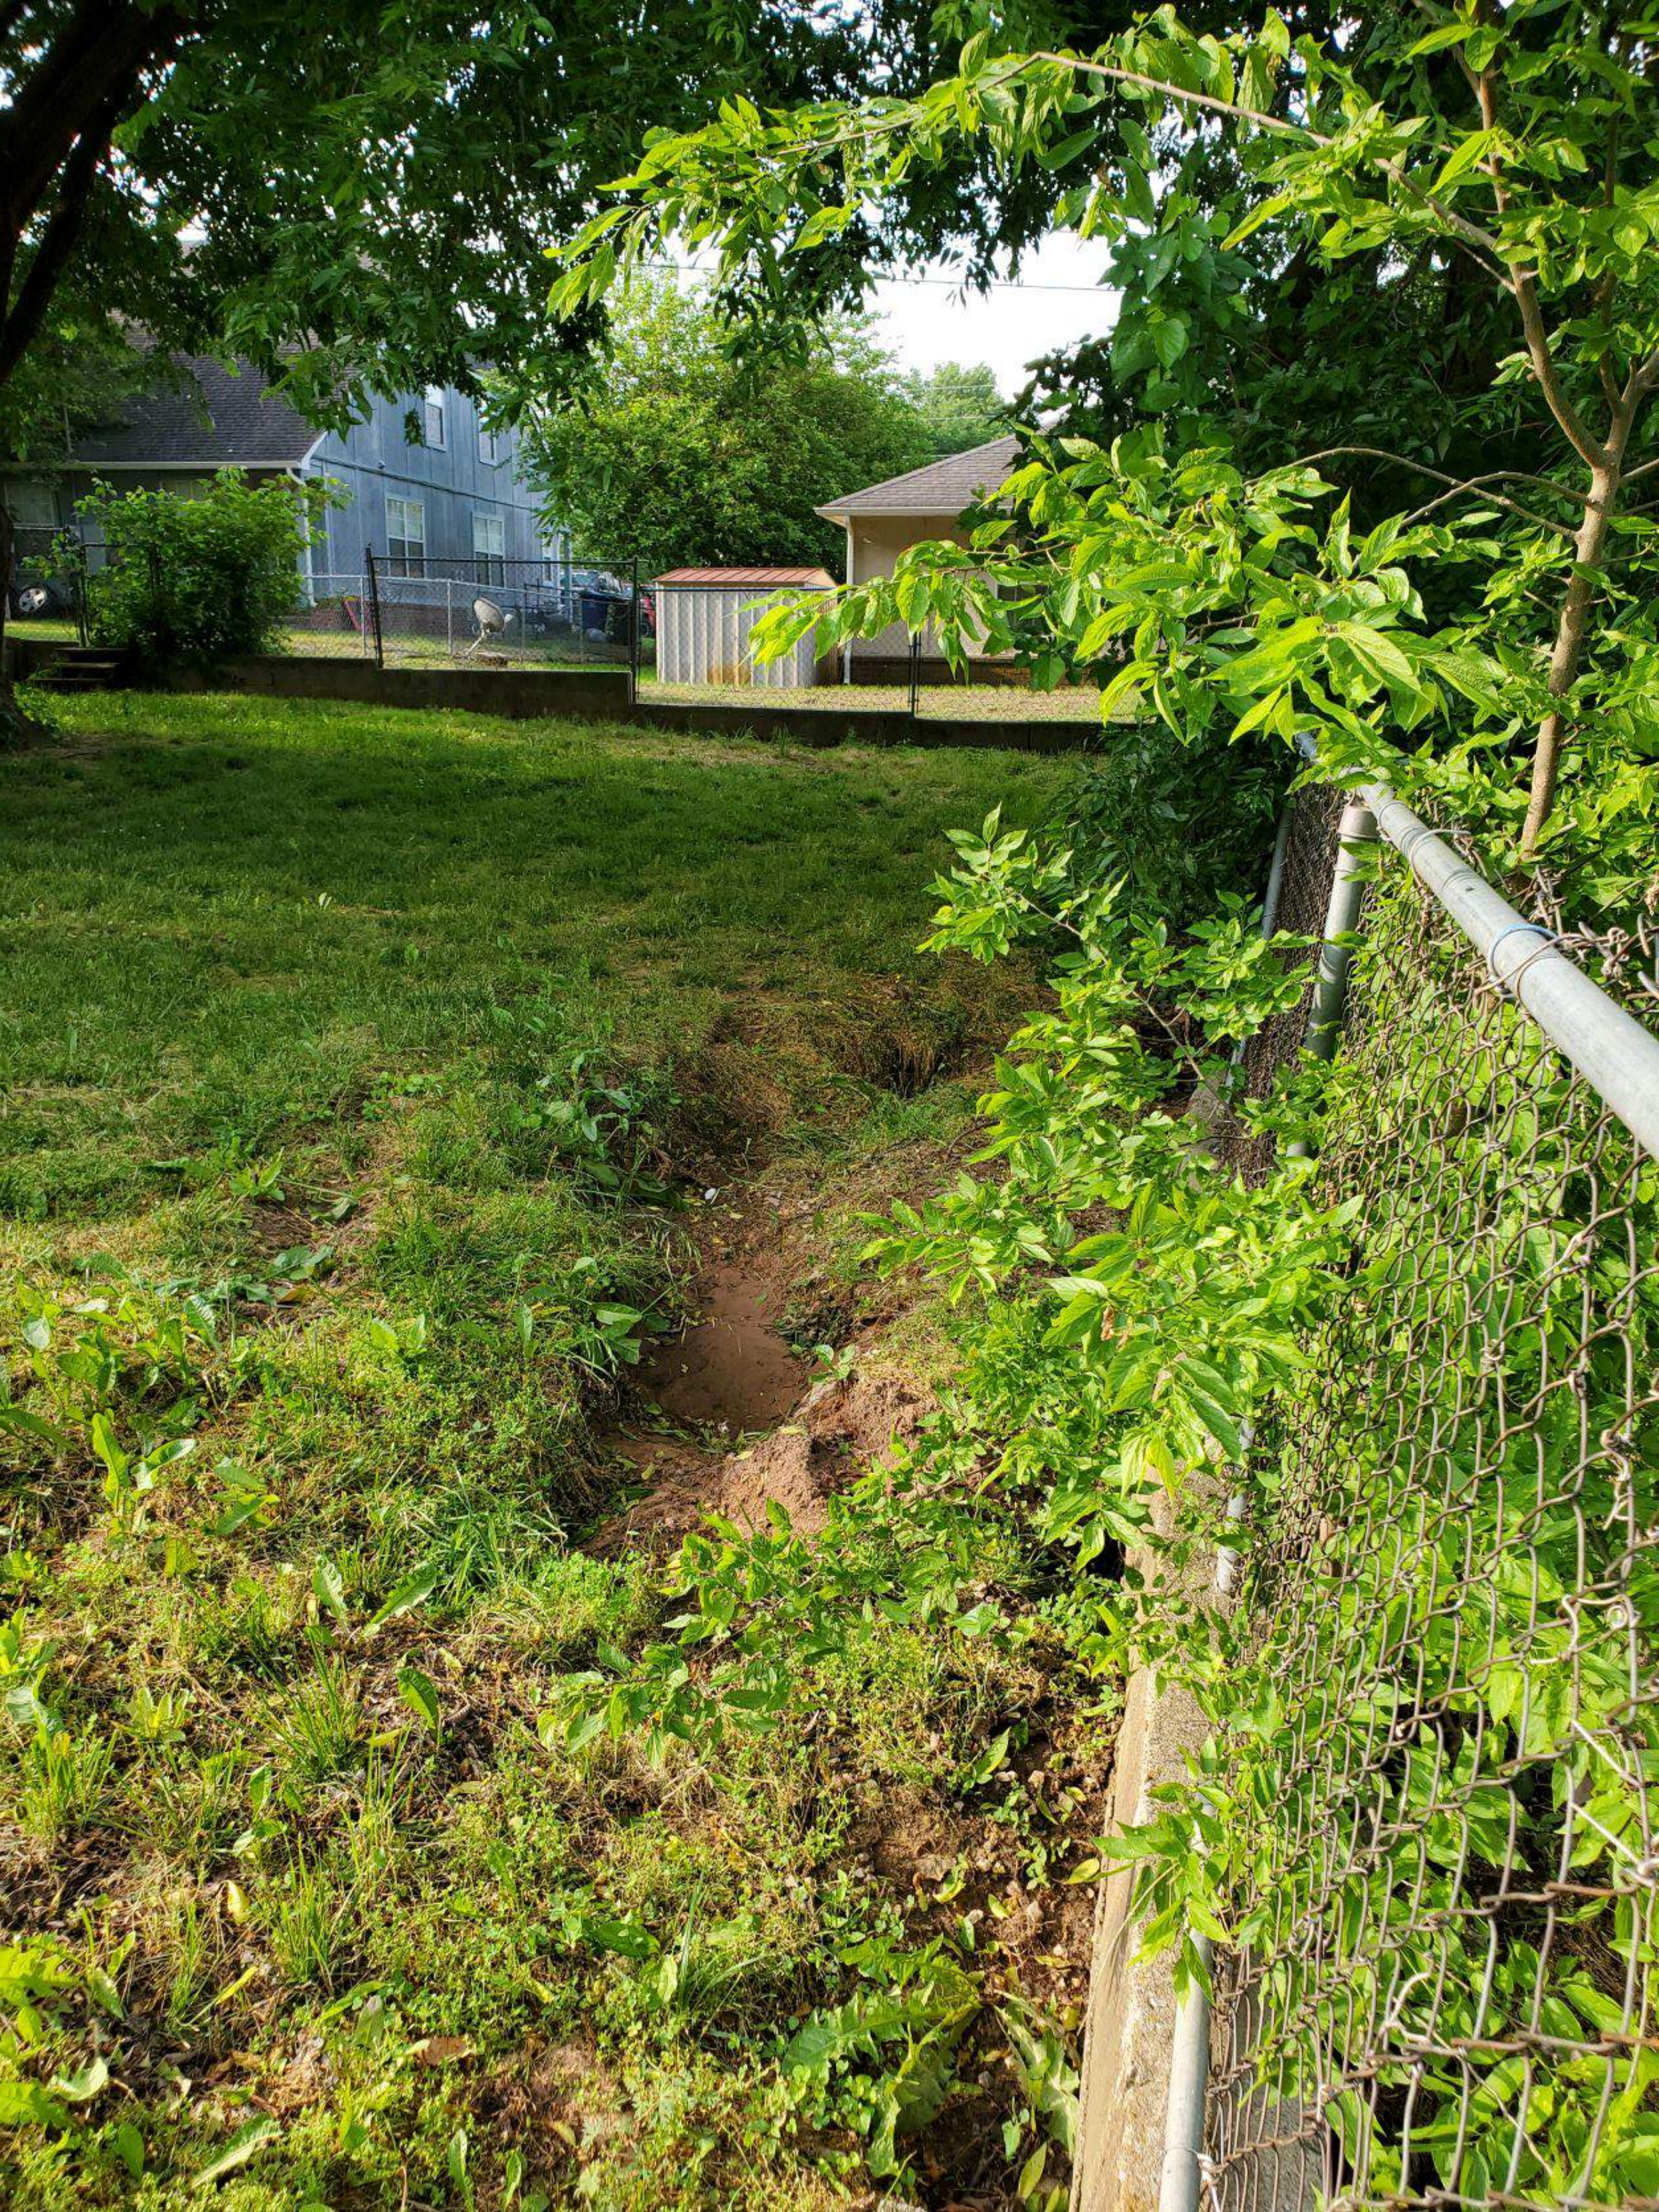
DOWNSTREAM CULVERT  
UNDER S CEDAR AVE.
