City of Broken Arrow Broken Arrow, OK

JUNE 2024

REV. OCT. 2024

Public Safety Training Campus Master Plan 2024

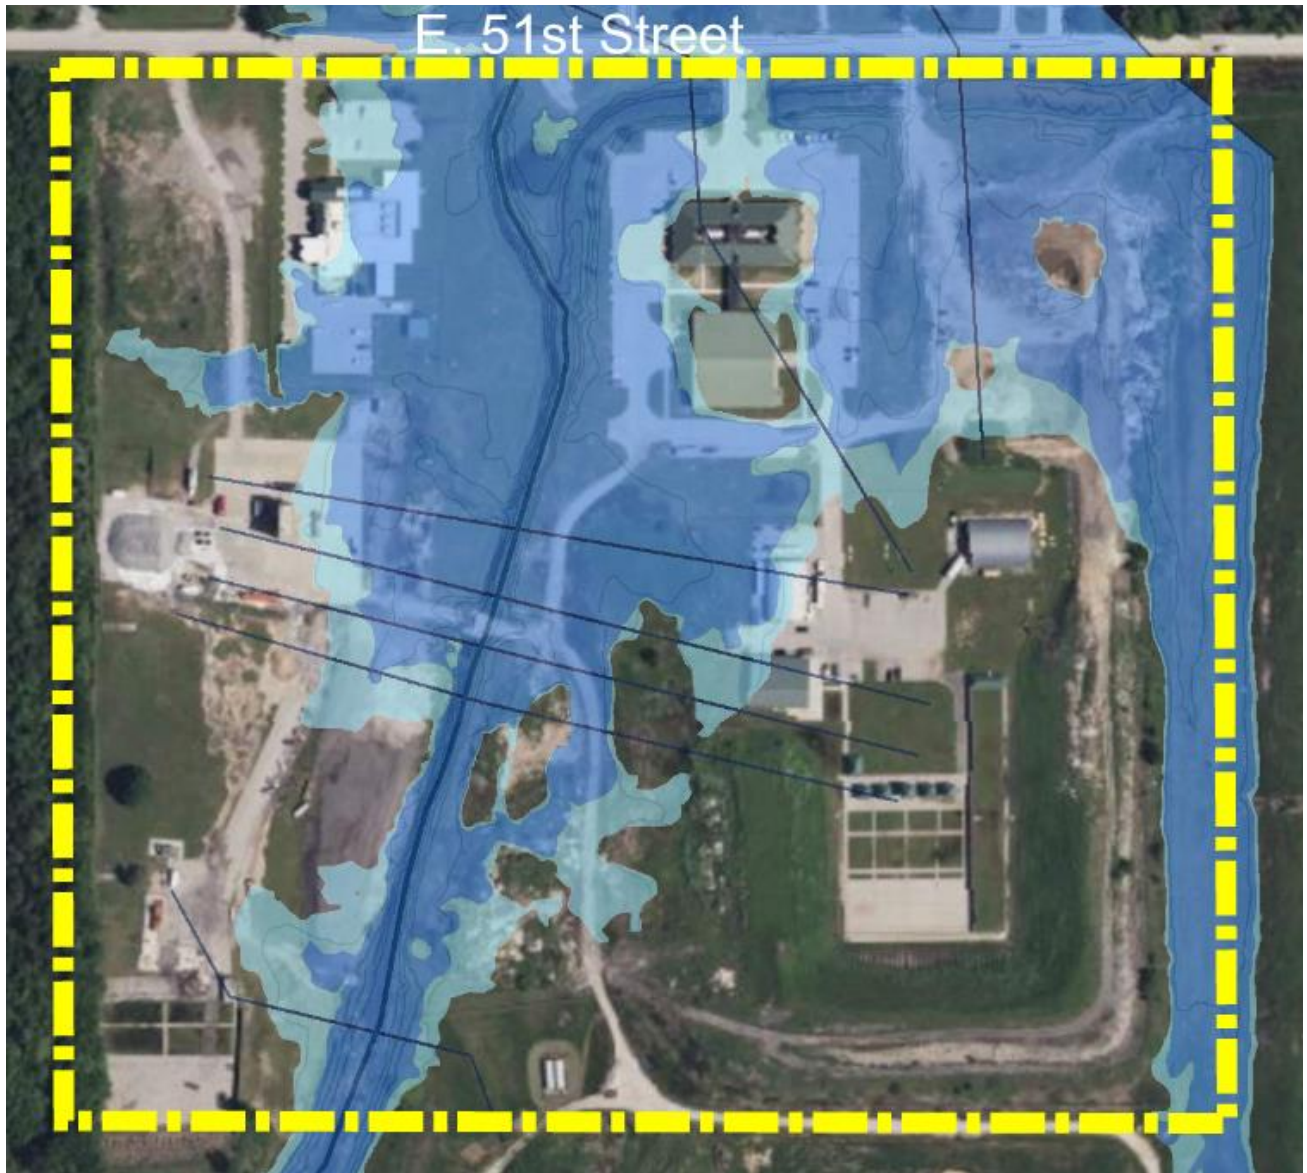
Public Safety Site Aerial w/Floodplain Overlay

As is evident in the floodplain aerial, there are “islands” of land area that are unencumbered with flood water. As further testament to this condition, the 1993 flood surrounded the two most northern buildings and flood waters covered the east parking lot to a reported depth of “just below the windows of cars in the parking lot.”

- 1) Regrading of the entire site is recommended. Regrading will also involve the removal of all debris piles as well as the berming surrounding the outdoor range. This design for this work is to be completed in conjunction with the Corp of Engineers to redefine the floodplain on site. The available land for development will inherently increase as a result of the combination of this work.

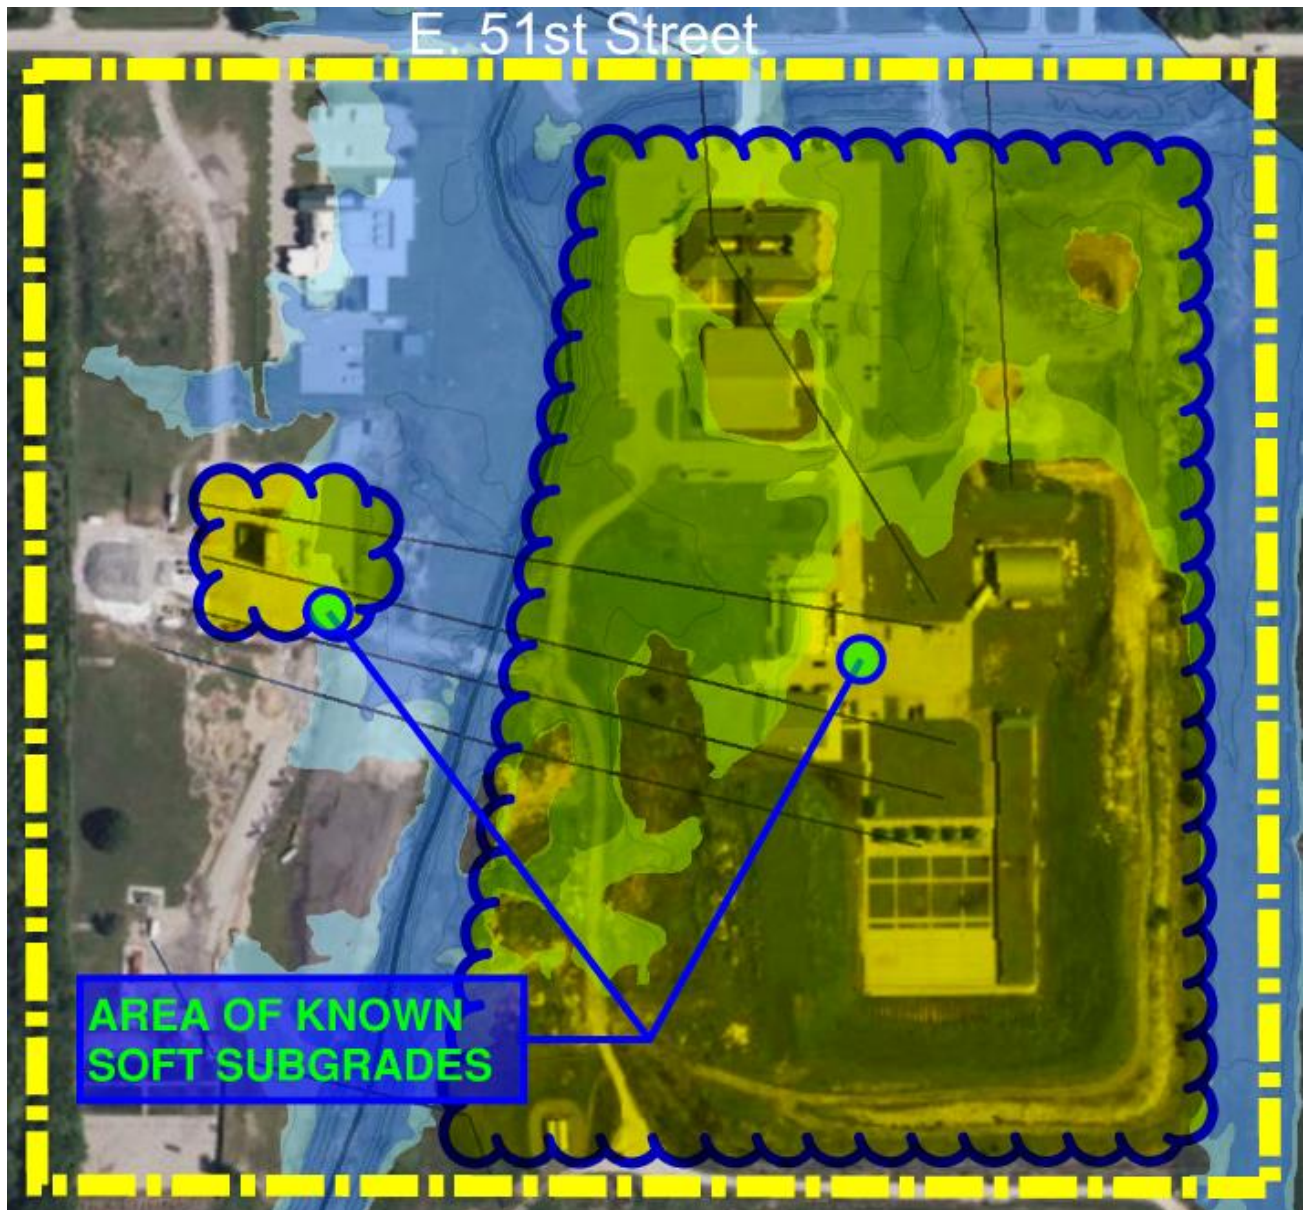
Public Safety Site Aerial w/Subgrade Soft Soils Overlay

In addition to the floodplain conditions, the area, generally to the east of the drainage way through the site, is reported to be an area that was a former “garbage dump” for the City of Broken Arrow. The subgrade condition has impacted the development of the site requiring the use of piers to assure foundation stabilization. Generally, all buildings developed and to be developed will likely need to be considered for pier foundations. It would be noted, that the soft subgrade conditions are not limited to the east side of the drainage way as the Fire Department Burn Tower, located on the west side of the drainage way, also required pier foundations to assure adequate foundation support. The “piering” of foundations is certainly not unknown in Oklahoma, but will be of particular consideration for development on this site. The graphic below provides some understanding of the area of site that likely presents soft subgrade conditions.

As the information presented by the two previous graphics created some serious reservations for the Design Team as to the viability of the Campus, a hydrology assessment of the floodplain conditions was completed by the Design Team Civil Engineer, TEP. The assessment conclusion was that there was likely a way to mitigate some of the floodplain condition sufficiently to allow for development that was either not at-risk or reduced risk from impact for flooding. Therefore, the Design Team is moving forward with development recommendations that addresses most, if not all, of the requested training elements needed by the Police Department and the Fire Department.

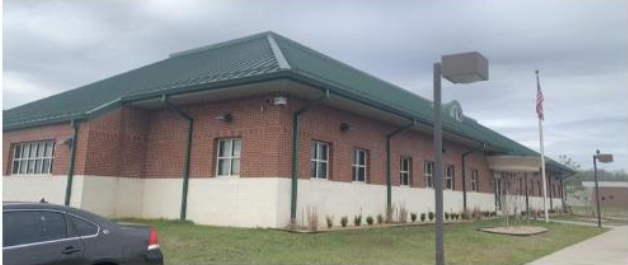
FACILITY NAME/NO.:	Phase I (Admin./Classroom)		
ADDRESS/LOCATON:	4205 E. Omaha St., Broken Arrow, OK 74014

<p>This building was one of the first facilities developed on the Public Safety Training Campus. The facility was constructed ~2005. This facility provides administrative and classroom space for the Police and Fire Departments. This facility provides ~9,600 gross square feet of space with approximately half of the space dedicated to offices and the other half dedicated to classroom and related space.</p>			
STRUCTURE			
Date of Construction	2005		
Date(s) of Renovation/Expansion	-		
Building Age	18		
Construction Type	II-B		
Building Construction	CMU Masonry, Steel Bar Joists, Cold-Formed Trusses, Structural Steel		
Building Area (SF):	~9,600		
Number of Stories:	One		
Site Area (SF & Acres):	SF: ~60,000	Acres: ~1.4	
Maximum Station Staffing Capability	11 Offices, 120 Classroom		
Seismic Protection (if required)	NA

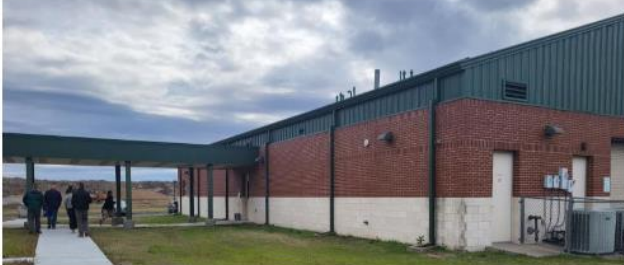
FACILITY NAME/NO.:	Phase II (Training)		
ADDRESS/LOCATON:	4205 E. Omaha St., Broken Arrow, OK 74014

<p>This building was developed in tandum to the Phase I building. The facility was constructed ~2005 as well. This facility provides office, training and fitness space for the Police and Fire Departments. However, the facility is primarily used by the FD. This facility provides ~11,600 gross sqare feet of space with approximately one half of the space dedicated to training and the balance equally used for office, fitness and support space.</p>			
STRUCTURE			
Date of Construction	2005		
Date(s) of Renovation/Expansion	-		
Building Age	18		
Construction Type	II-B		
Building Construction	PEMB w/CMU & Brick Veneer		
Building Area (SF):	~11,600		
Number of Stories:	One		
Site Area (SF & Acres):	SF: ~60,000	Acres: ~1.4	
Maximum Station Staffing Capability	4 Offices, 30 Classroom, 300 Assembly, 15 Fitness

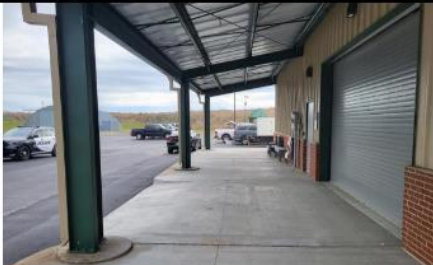
FACILITY NAME/NO.:	Phase III (Training)		
ADDRESS/LOCATON:	4205 E. Omaha St., Broken Arrow, OK 74014

<p>This building was developed for use by the PD for training. The facility was constructed ~2018. This facility provides classroom, mat room/simulations room training and gun cleaning space for the Police Departments. This facility provides ~3,330 gross square feet of space.</p>			
STRUCTURE			
Date of Construction	2018		
Date(s) of Renovation/Expansion	-		
Building Age	5		
Construction Type	II-B		
Building Construction	PEMB w/Brick Veneer & Metal Panel		
Building Area (SF):	~3,330		
Number of Stories:	One		
Site Area (SF & Acres):	SF: 12,000	Acres: 0.3	
Maximum Station Staffing Capability	xx Classroom, xx Fitness		
Seismic Protection (if required)	NA		
Category IV Conformance (if required)	NA		
ICC 500 Conformance (if applicable)	NA		
Hardened Space / Storm Shelter	<input type="checkbox"/> Yes	<input checked="" type="checkbox"/> No

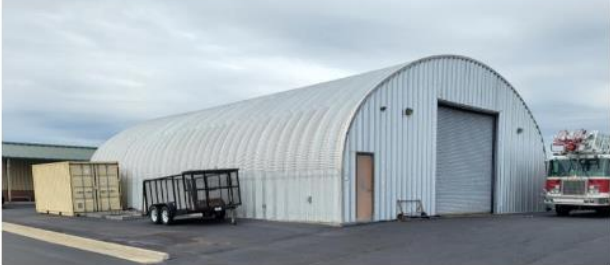
FACILITY NAME/NO.:	PD/FD Storage		
ADDRESS/LOCATON:	4205 E. Omaha St., Broken Arrow, OK 74014

<p>This building was developed for storage use by the PD and the FD. The facility was constructed ~2010. This facility provides interior storage for each departments needs. This facility provides ~3,200 gross sqare feet of space.</p>			
STRUCTURE			
Date of Construction	2010		
Date(s) of Renovation/Expansion	-		
Building Age	13		
Construction Type	II-B		
Building Construction	Quonset w/Galvanized Metal Panel		
Building Area (SF):	~x,xxx		
Number of Stories:	One		
Site Area (SF & Acres):	SF: 10,000	Acres: 0.3	
Maximum Station Staffing Capability	xx Storage		
Seismic Protection (if required)	NA		
Category IV Conformance (if required)	NA		
ICC 500 Conformance (if applicable)	NA		
Hardened Space / Storm Shelter	<input type="checkbox"/> Yes	<input checked="" type="checkbox"/> No	
Generator	<input type="checkbox"/> Yes	<input checked="" type="checkbox"/> No

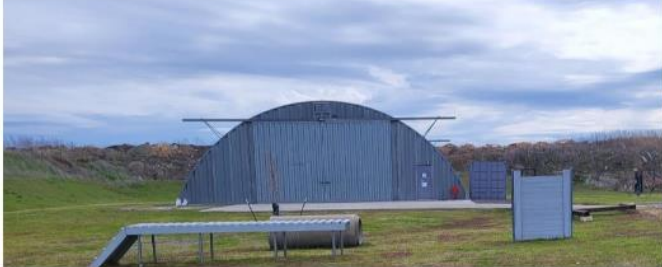
FACILITY NAME/NO.:	Shoot House		
ADDRESS/LOCATON:	4205 E. Omaha St., Broken Arrow, OK 74014

<p>This building was developed for fire arms scenario training for the PD. The facility was constructed ~2009. This facility provides interior fire arms training and scenario-based training. This facility provides ~4,360 gross square feet of space.</p>			
STRUCTURE			
Date of Construction	2009		
Date(s) of Renovation/Expansion	-		
Building Age	14		
Construction Type	II-B		
Building Construction	Quonset w/Galvanized Metal Panel		
Building Area (SF):	~4,360		
Number of Stories:	One		
Site Area (SF & Acres):	SF: ~x,xxx	Acres: ~0.x	
Maximum Station Staffing Capability	xx		
Seismic Protection (if required)	NA		
Category IV Conformance (if required)	NA		
ICC 500 Conformance (if applicable)	NA		
Hardened Space / Storm Shelter	<input type="checkbox"/> Yes	<input checked="" type="checkbox"/> No	
Generator	<input type="checkbox"/> Yes	<input checked="" type="checkbox"/> No

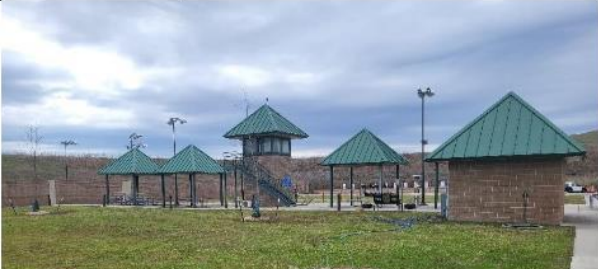
FACILITY NAME/NO.:	Firing Range		
ADDRESS/LOCATON:	4205 E. Omaha St., Broken Arrow, OK 74014

The existing range does not have adequate drainage and often is unusable as a result of ponding water. The armory building has floor drains but the building has been flooded as a result of excessive ground water conditions. The facility is currently using a portable generator for power as the normal power is experiencing service issues; source of service issues is unknown.

<p>This Range and series of buildings were developed for fire arms scenario training for the PD. The facility was constructed ~2009. This facility provides outdoor fire arms training and scenario-based training. The facility provides 18, 50-yard and 4, 100-yard positions. The two ranges are separated by a 8' high CMU wall. The 50-yard range provides; 1) Armory, 2) Shelters (4) and 3) Range Tower. The 100-yard range provides a shelter.</p>			
STRUCTURE			
Date of Construction	2009		
Date(s) of Renovation/Expansion	-		
Building Age	14		
Construction Type	NA		
Building Construction	Armory-CMU, Shelter-Prefinished Metal, Tower-CMU		
Building Area (SF):	NA		
Number of Stories:	One		
Site Area (SF & Acres):	SF: ~82,200	Acres: ~2.0	
Maximum Station Staffing Capability	NA		
Seismic Protection (if required)	NA

- 2) Replace the existing outdoor range with an indoor range. The indoor range proposed by the Design Team includes both a 50-yard and 100-yard ranges. The removal of the existing range makes this land available for other uses and addresses the flooding and unstable subgrade conditions that existing at the current range.

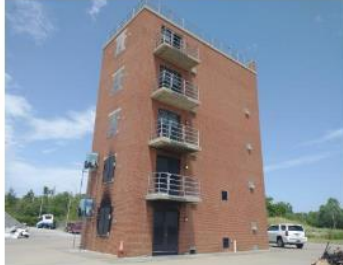
FACILITY NAME/NO.:	Burn Tower		
ADDRESS/LOCATON:	4205 E. Omaha St., Broken Arrow, OK 74014

<p>The Training Tower is a Class A burn building with 5 levels with approximately 780 SF per floor resulting in a total of 3,900 SF plus roof deck. The facility was constructed ~2010. This facility provides both indoor and outdoor scenario training. The building is constructed with load-bearing CMU and cast-in-place concrete floors and roof deck. The buiding was recently inspected by a structural engineer and found to be in good structural condition.</p>			
STRUCTURE			
Date of Construction	2010		
Date(s) of Renovation/Expansion	-		
Building Age	23		
Construction Type	1A		
Building Construction	Load-Bearing CMU w/CIP Concrete Floors/Roof		
Building Area (SF):	780 SF/Floor; 5 levels plus roof		
Number of Stories:	5		
Site Area (SF & Acres):	SF: ~10,000	Acres: ~0.25	
Maximum Station Staffing Capability	NA

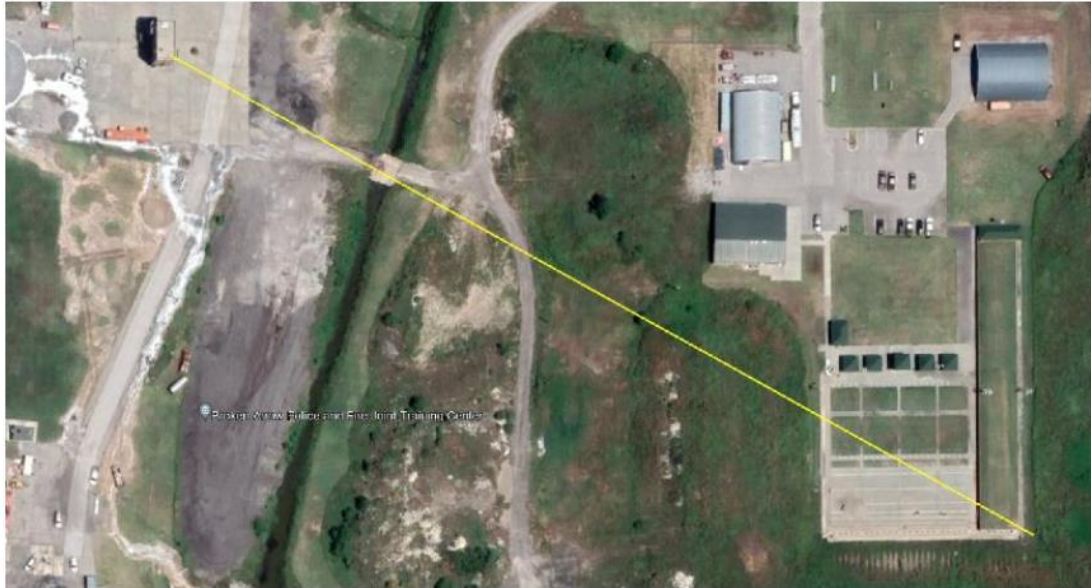
- A. Image below shows path of bullets from fire training tower to the sniper target at the SE corner of the rifle range.
