LAY-DOWN YARD PUD

D & B

Case number: PUD-002550-2025 and
BAZ-002374-2025

**Laydown Yard
4600 E Gary St
Broken Arrow, OK 74014
Wagoner County**

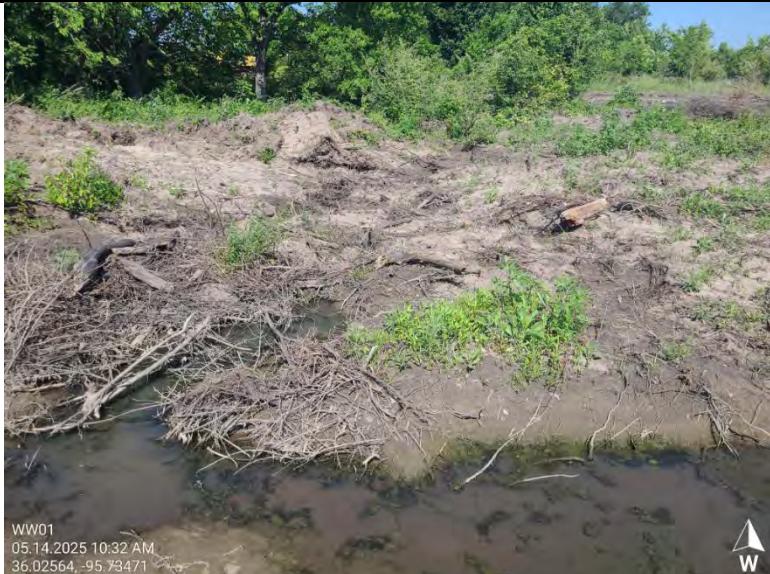
Photograph 4

LOCATION: WW01

Notes: Example of earthwork activities potentially altering turbidity, flow rate, and flow path by sediment deposition.

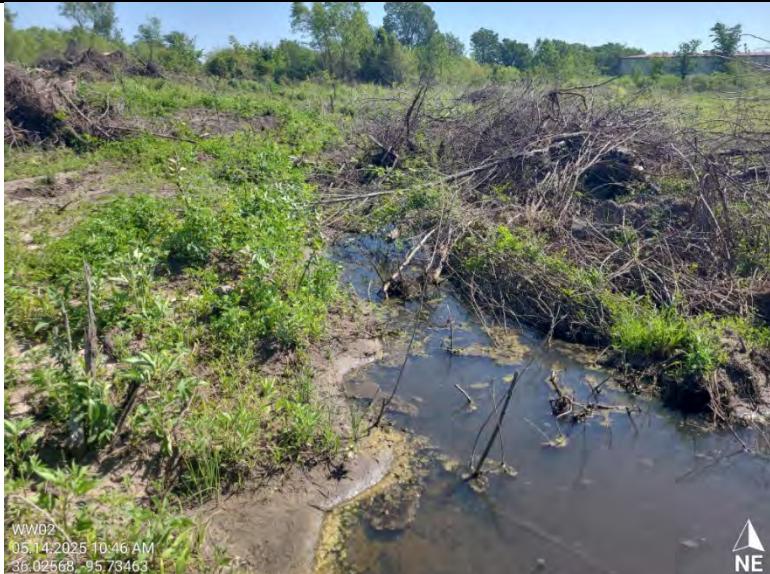
**Photograph 5**

LOCATION: WW02

Notes: Intermittent stream with sediment bed. Facing upstream.

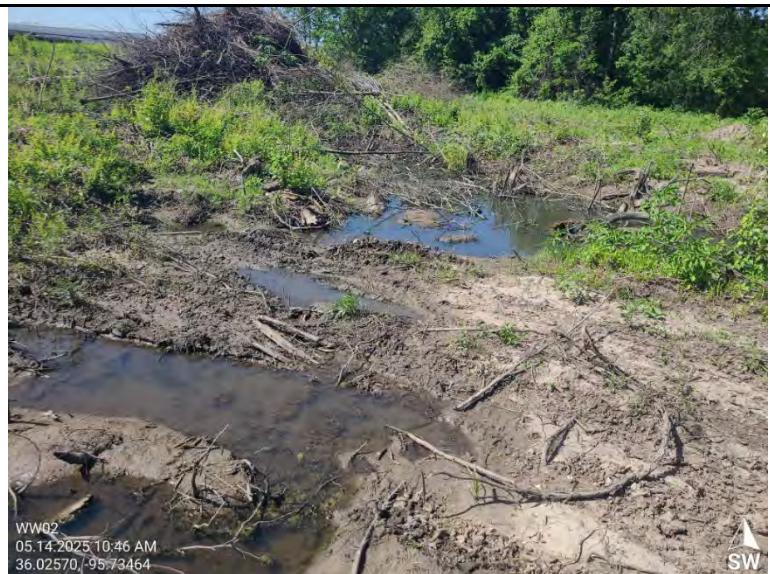
**Photograph 6**

LOCATION: WW02

Notes: Example of vehicle traffic impact potentially altering turbidity, flow rate, and flow path. Facing downstream.

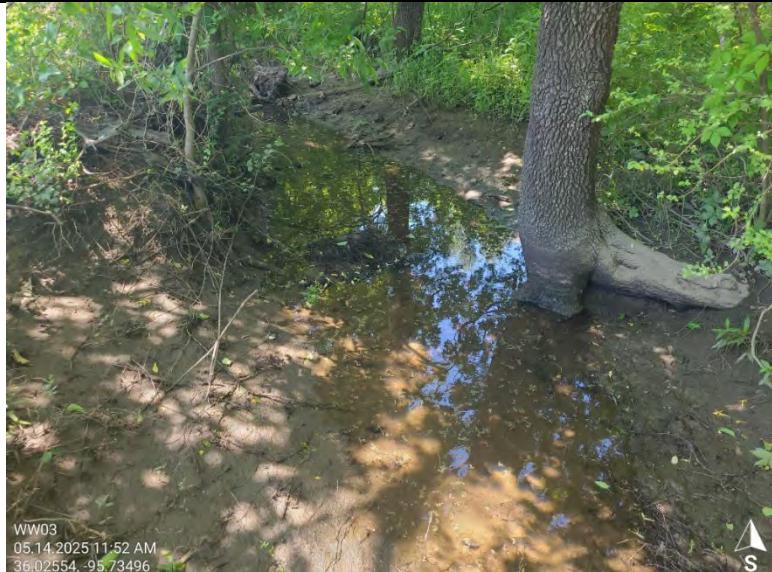
Photograph 7

LOCATION: WW03

Notes: Intermittent stream with sediment bed. Facing downstream.

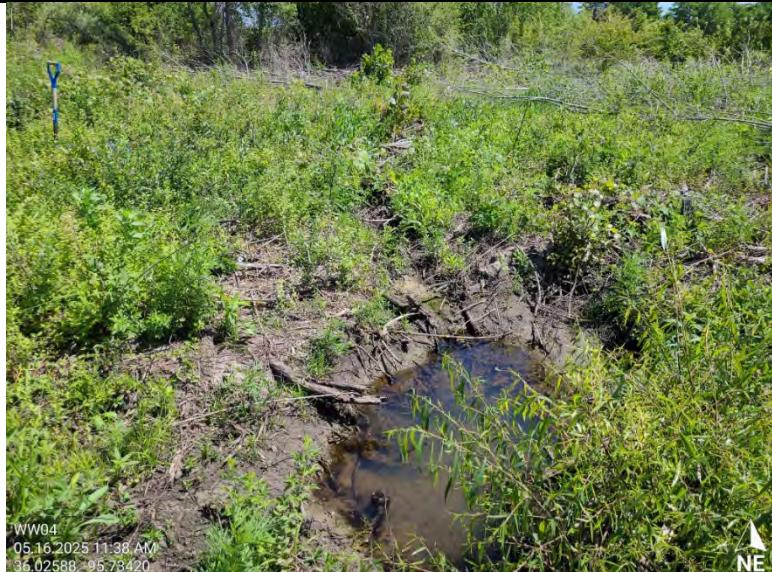
**Photograph 8**

LOCATION: WW04

Notes: Ephemeral stream with intermittent OHWM. Facing upstream.

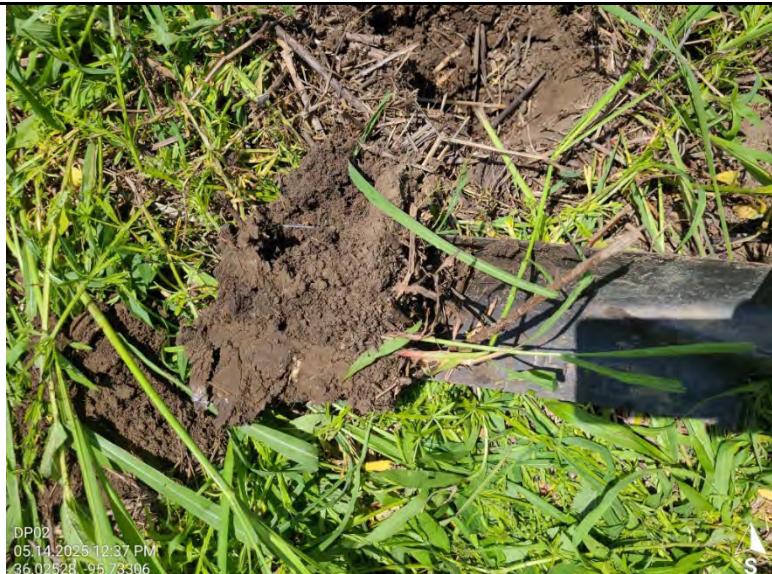
**Photograph 12**

LOCATION: DP02

Notes: Soil sample. No evidence of hydric soil observed.

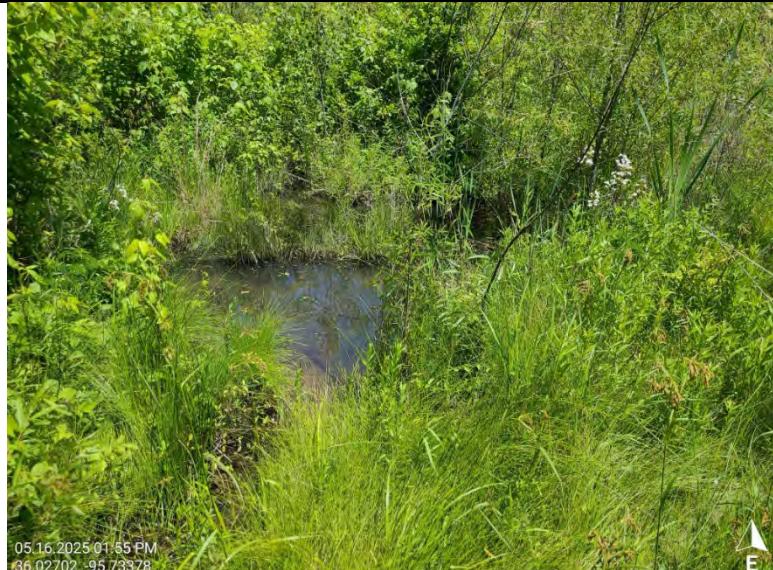
Photograph 19

LOCATION: WET03-PFO and DP06

Notes: DP06 met all three wetland criteria. WET03-PFO is adjacent to active construction and impacted sewage release on its southeastern extent. Photo taken from northern extent.

WET03-PFO is a forested wetland within the northern portion of the Project. Dominant vegetation consists of black willow, common spike-rush, and poison ivy. Other vegetation consists of American elm, American sycamore (*Platanus occidentalis*), late boneset (*Eupatorium serotinum*), and Japanese honeysuckle. Standing water and saturation were observed and confirmed from aerial imagery were observed. The southwestern portion of WET03-PFO has been impacted by the ongoing wastewater utility construction and sewage spill. During the May 2025 survey, the ROW between WET03-PFO and WB01 was graded, potentially filled, and installed with construction matting. These observations

At the time of the May 2025 survey, there was construction on the municipal wastewater utility right of way that transects the Project. The right of way was graded, cleared of all vegetation, and construction matting was placed over areas between WET03-PFO and WB01. Earthwork activities were evident in areas adjacent to the right of way, altering the soils, vegetation community, and hydrology. Pooling was observed in areas and is shown in the photolog (**Appendix D**) and in **Figure 5**. The construction foreman indicated that the wastewater pipeline failed, resulting in a sewage release to the immediate area. The amount and extent of sewage release had not been determined at the time of the May 2025 survey. The approximate extent of sewage release footprint shown on **Figure 5** was determined by odor and presence of algae in areas of pooling, but the footprint has not been confirmed. Given accessibility was restricted due to avoid untreated sewage and active construction, the extent of WET03-PFO within the potential sewage release footprint was visually estimated from a safe distance and further refined with aerial imagery. These conditions classify WET03-PFO as an Atypical Situation. The presence of wetland hydrology and hydrophytic vegetation were confirmed, but soil samples were not feasible to define the entire extent of WET03-PFO.

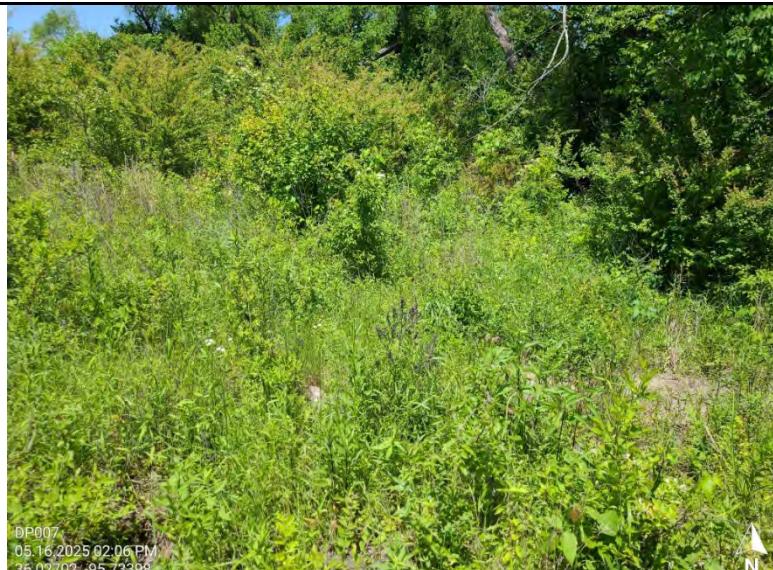
**Photograph 21**

LOCATION: DP07

Notes: DP07 is upland reference data point for WET03-PFO.

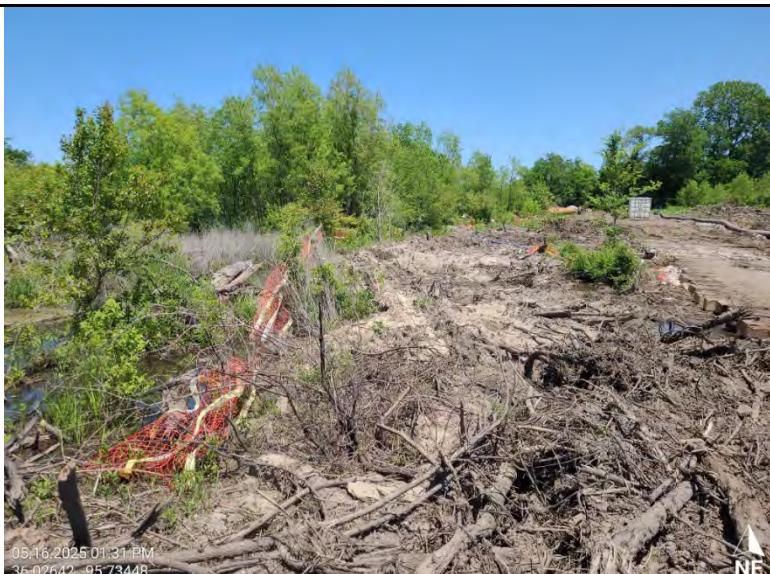
**Photograph 27**

LOCATION: Central portion of Project and WET03-PFO

Notes: Sewer line right-of-way (ROW) active construction and portion of WET03-PFO.
