City of Broken Arrow

Drainage Advisory Committee

PROJECT REPORT

DATE:	03/13/2026
NAME	Scott Ross, Julie Ross
ADDRESS / LOCATION	14400 E. 131 st St
WATERSHED	Aspen Creek
ESTIMATE	\$75,000.00
CASE NO.	26-007

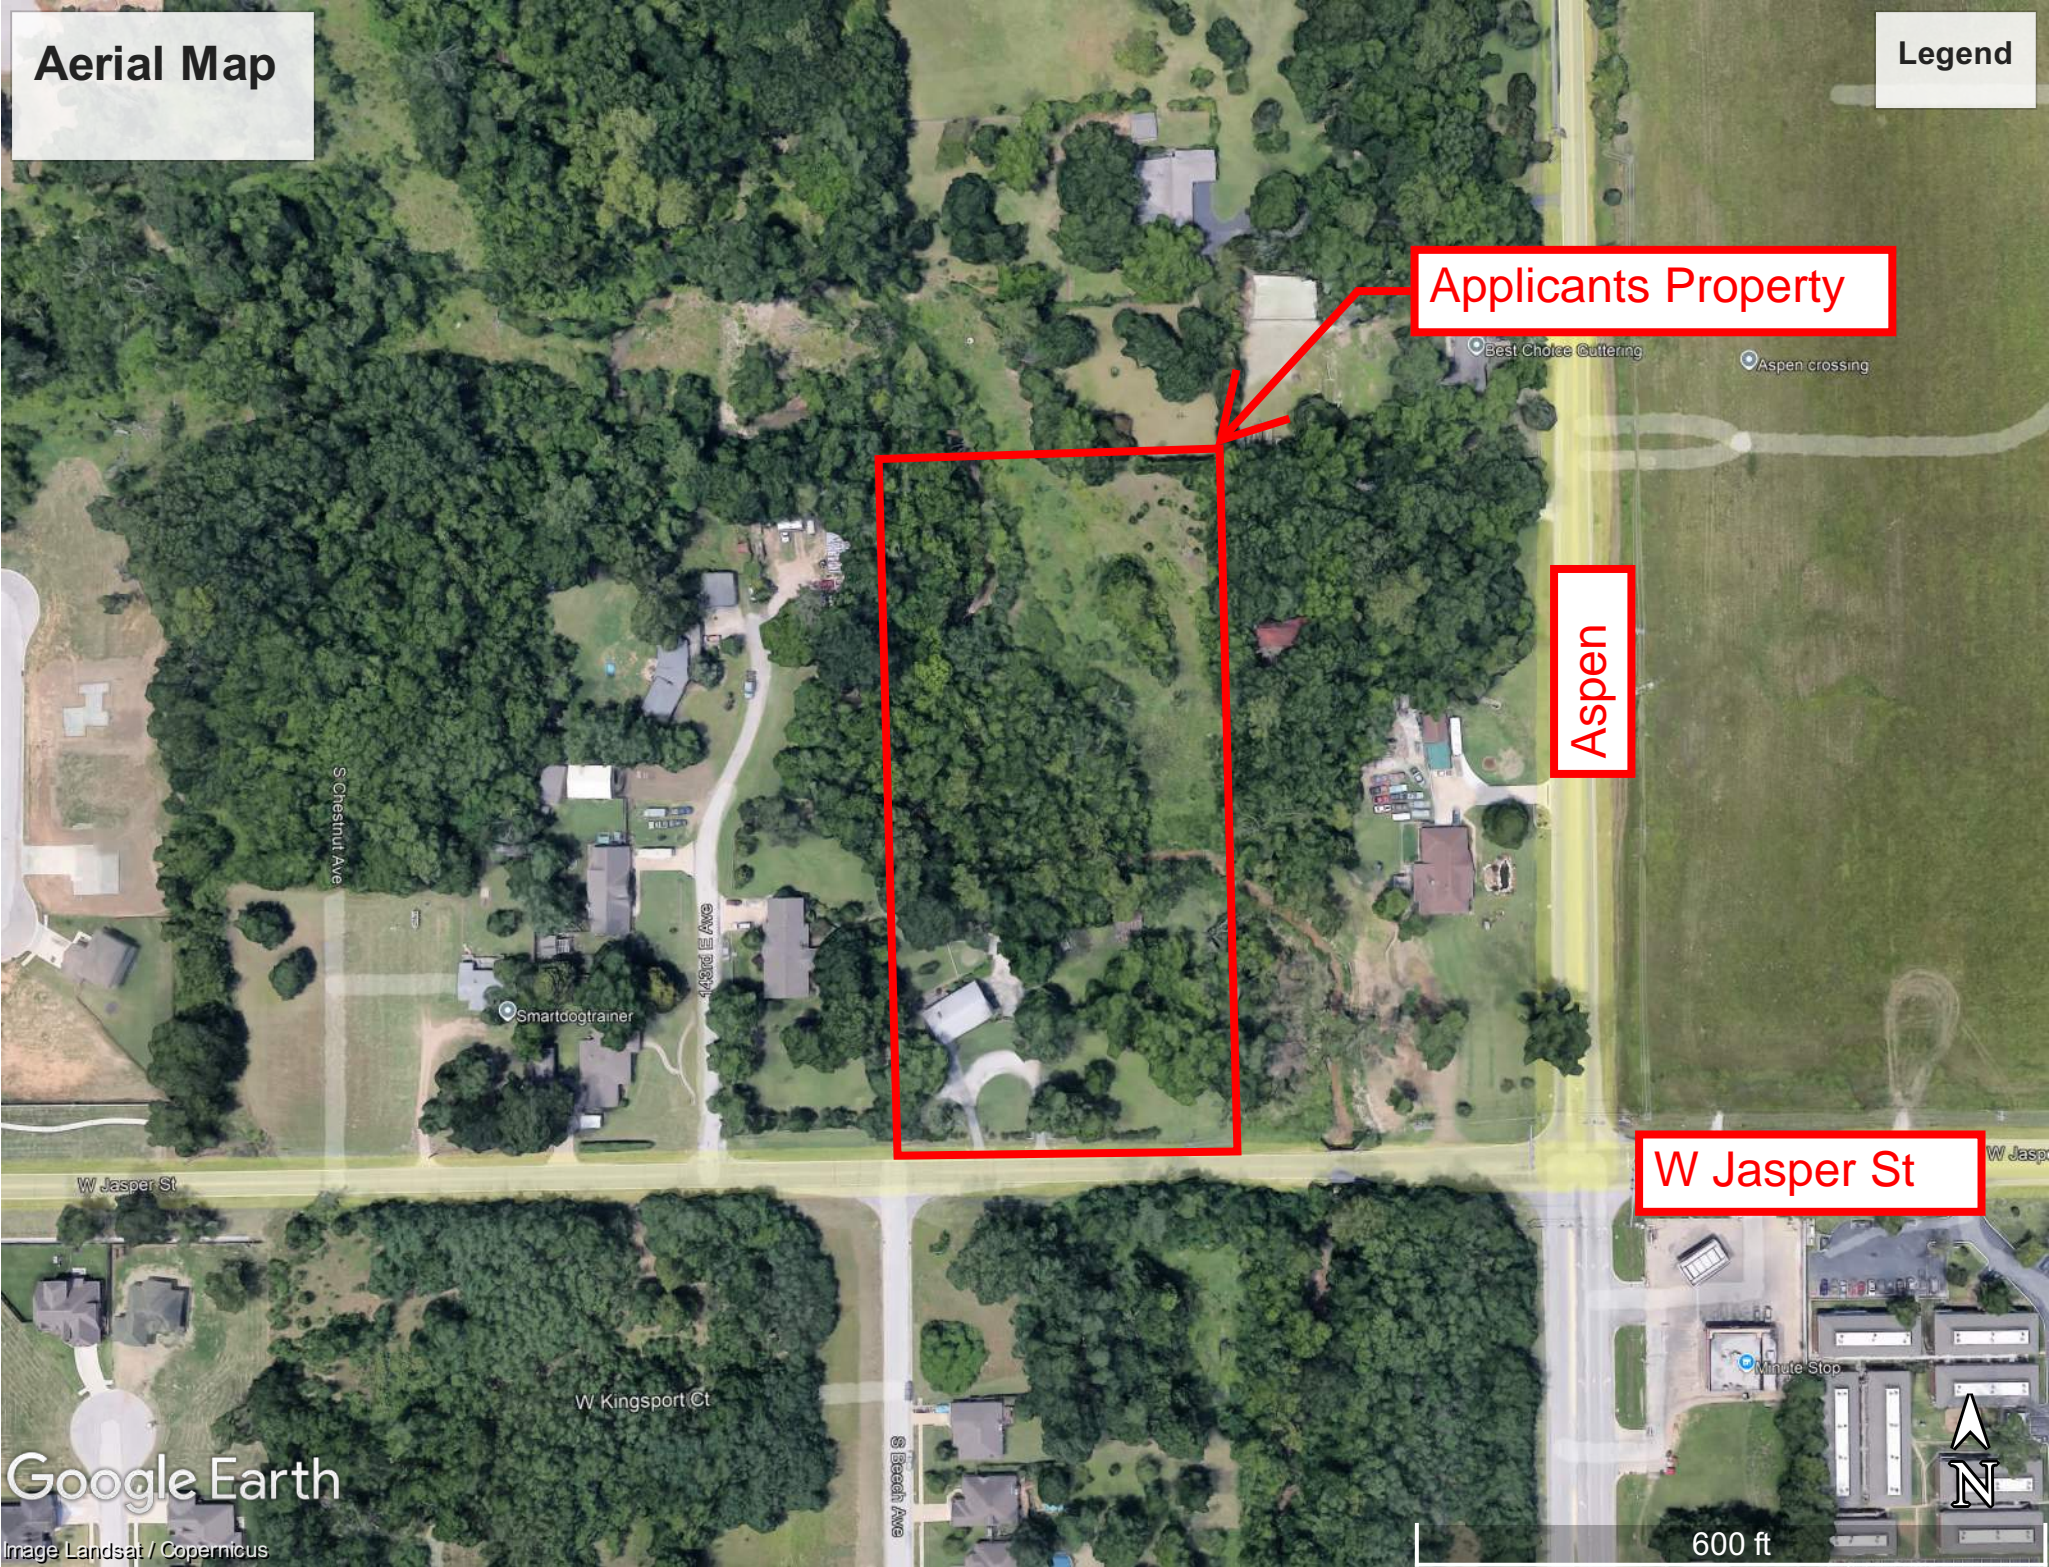
Aerial Map

Applicants Property

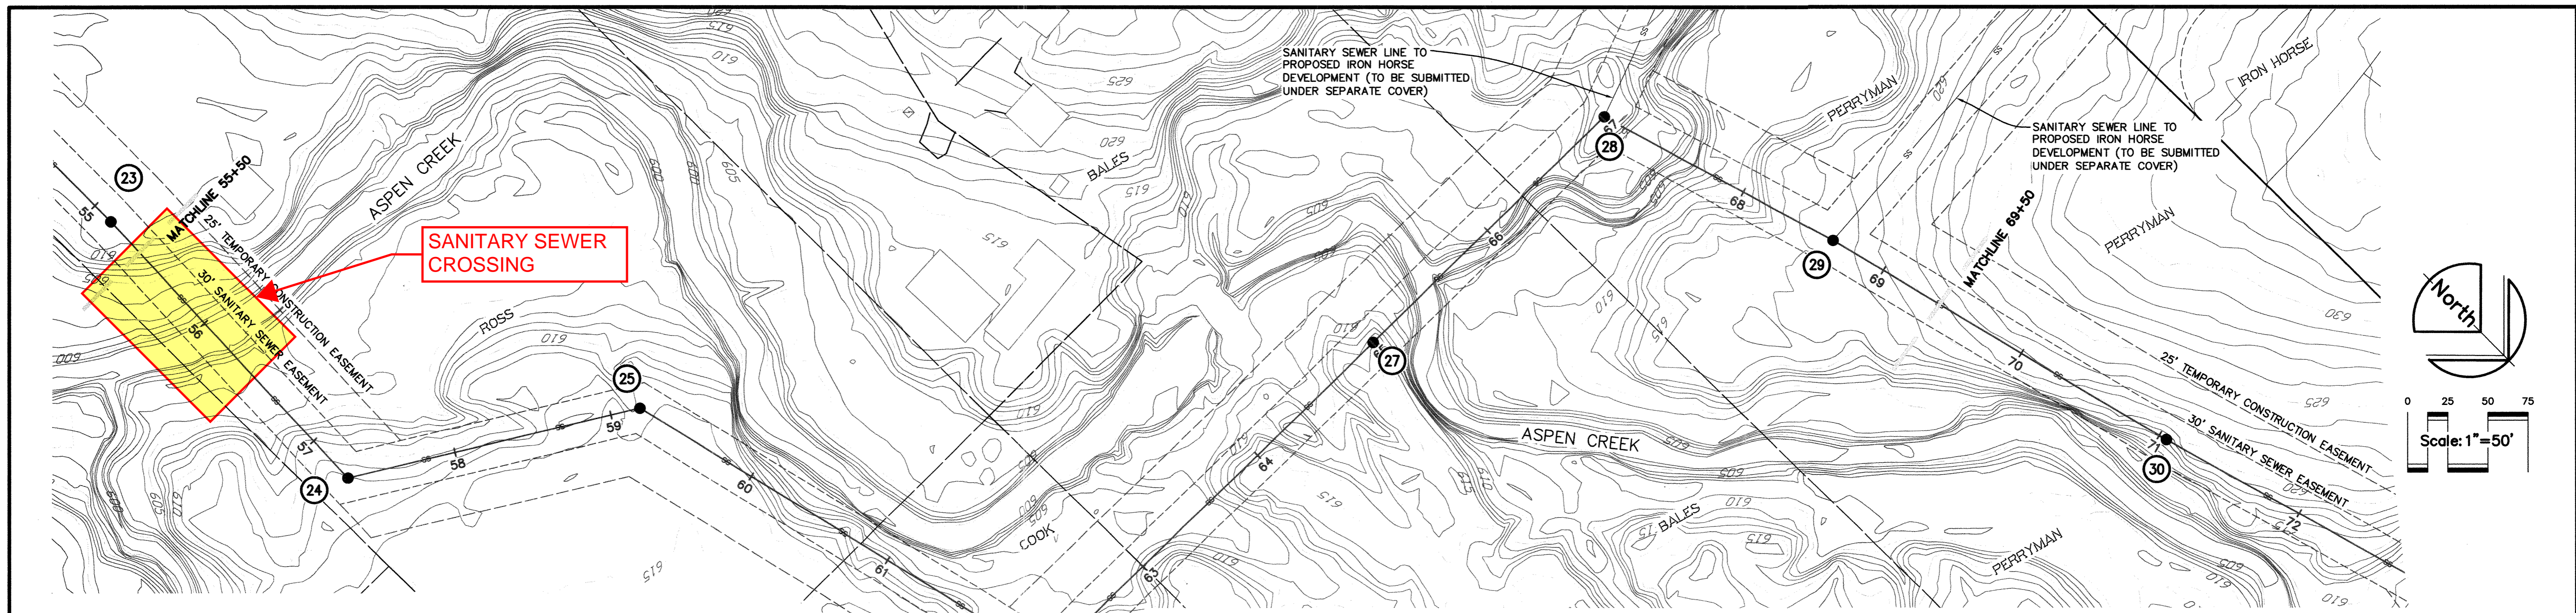
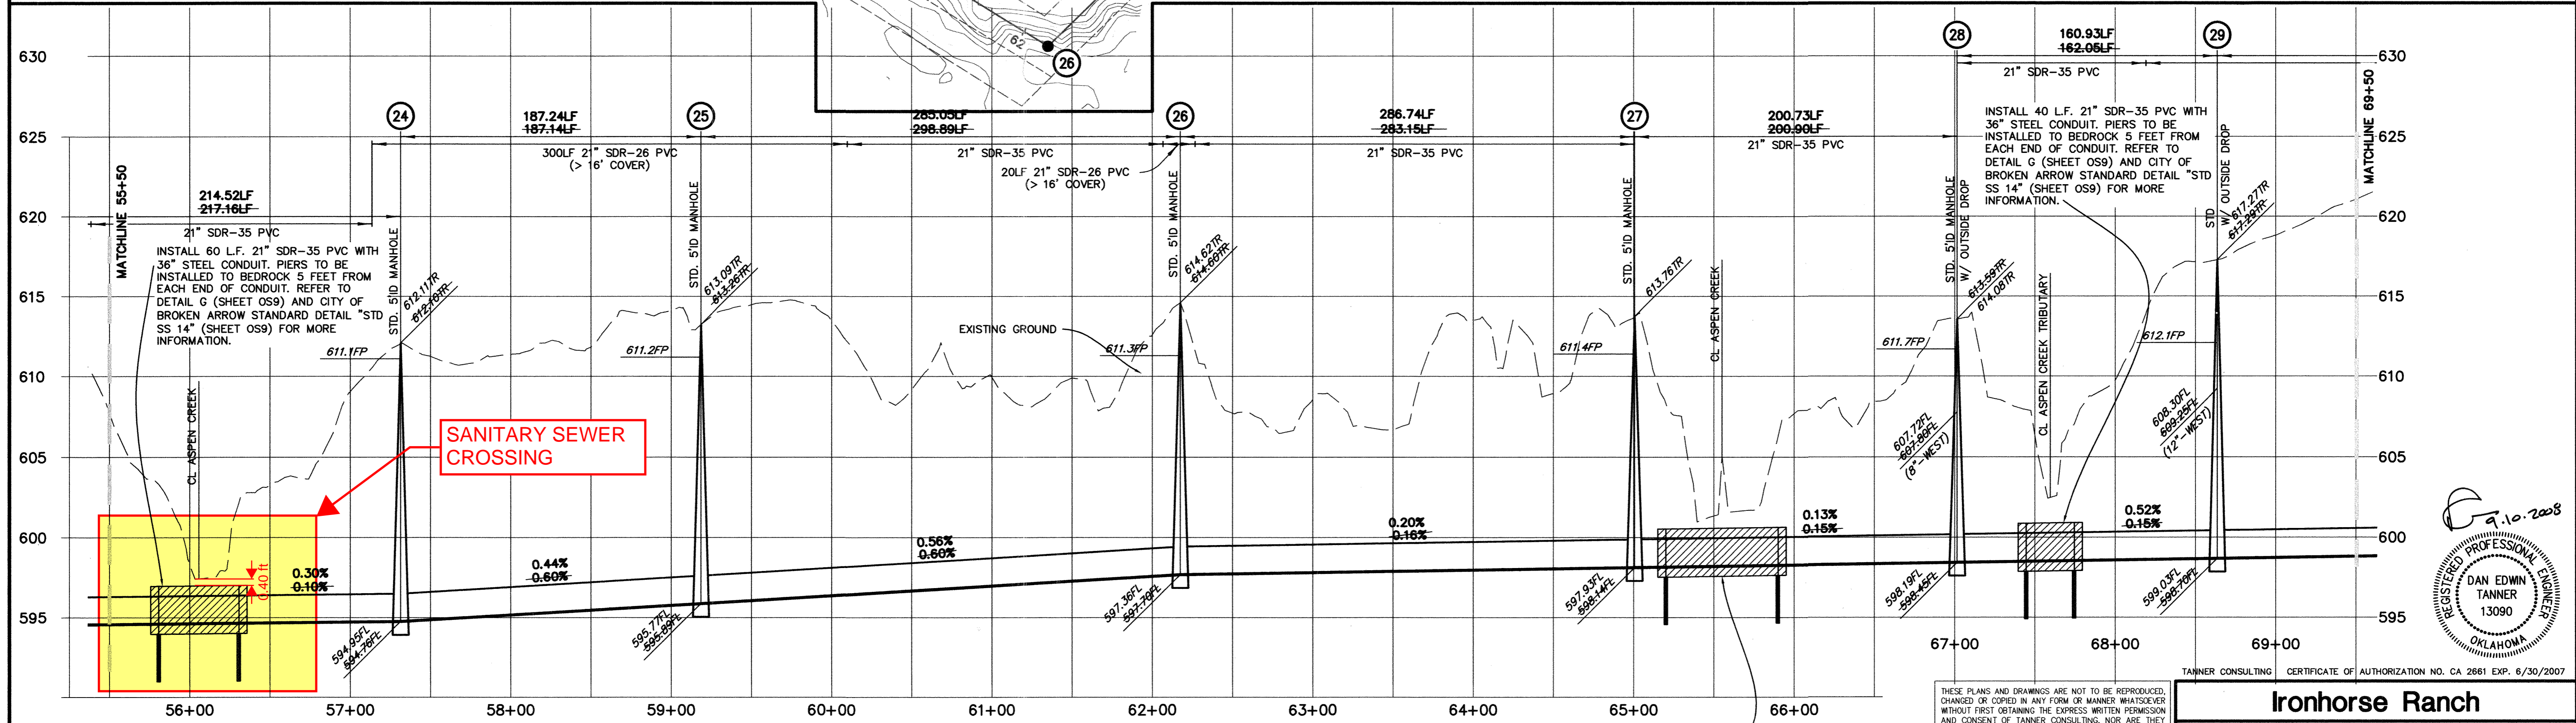
FILE: _____ PROJECT: 25021.03 DATE: _____
 ATLAS PAGE NO: _____ SHEET OS6 OF 10 SHEETS

INSTALL 80 L.F. 21" SDR-35 PVC WITH 36" STEEL CONDUIT. PIERS TO BE INSTALLED TO BEDROCK 5 FEET FROM EACH END OF CONDUIT. REFER TO DETAIL G (SHEET OS9) AND CITY OF BROKEN ARROW STANDARD DETAIL "STD SS 14" (SHEET OS9) FOR MORE INFORMATION.

This section of the creek has multiple large, downed trees impeding flow and putting a downstream Sanitary Sewer crossing at risk. The sanitary sewer is 21 inches in diameter and was designed in 2008. It also was originally 0.4 ft under the stream bed. Over time the stream bed has eroded and exposed the sanitary sewer line. The sewer is protected in a steel conduit.
