City of Broken Arrow

Drainage Advisory Committee

PROJECT REPORT

DATE:	03/13/2026
NAME	Jeannine Coker
ADDRESS / LOCATION	717 West Washington Street
WATERSHED	Haikey Creek
ESTIMATE	\$12,000.00
CASE NO.	26-011

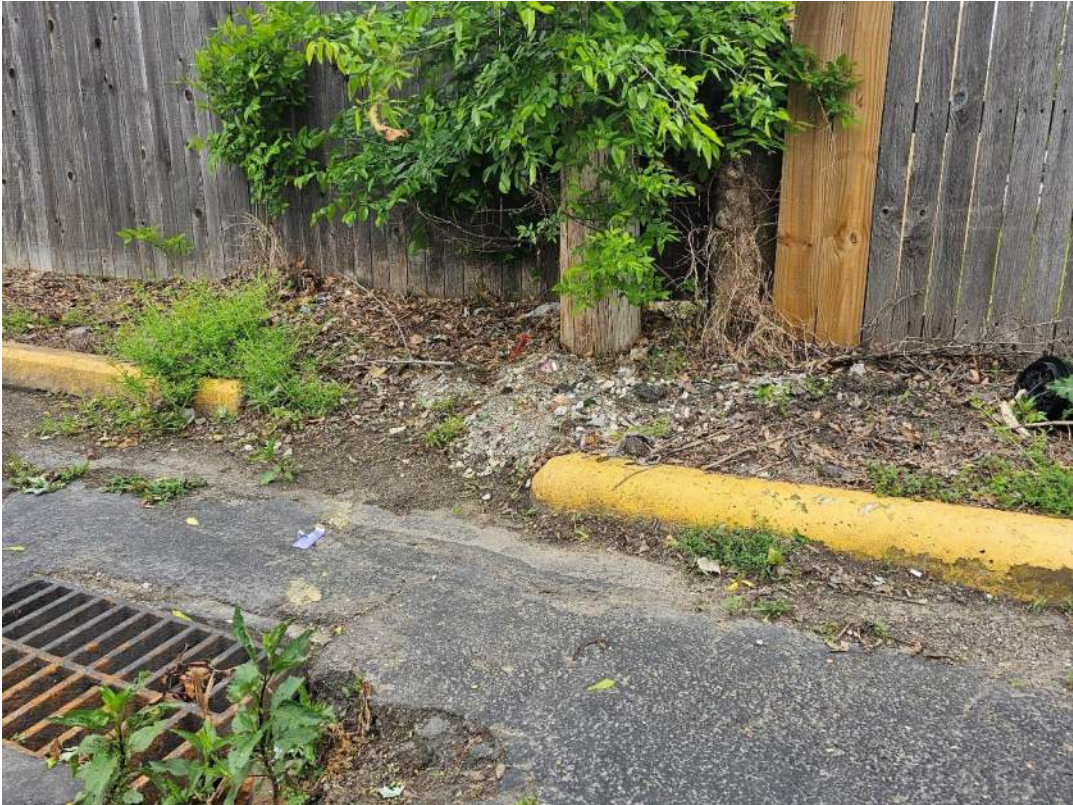
Existing Inlet

A citizen contacted the City requesting assistance with drainage that has been impacting their property from a neighboring commercial development. The commercial development is in an un-platted lot constructed around 1980. The subdivision and commercial development are close to the intersection of Washington and Elm. There are no curbs along the west side of the commercial parking lot. The parking lot drainage area is about 2 Acres. There is a small inlet to collect stormwater runoff on the west side. This conveys and outlets along Washington St. The flow overwhelms the existing inlet and overtops into the neighboring yards.

Possible concept considered is to add a curb to the West side of the commercial parking lot to keep the flows on the commercial site while upsizing the existing inlet to allow it to better handle the flows. Then once captured, the flows will be conveyed to the existing ditch along Washington. This design could be performed in-house with the only expenditures being for survey of the area, and eventually materials for the City's Streets and Stormwater department to later install.

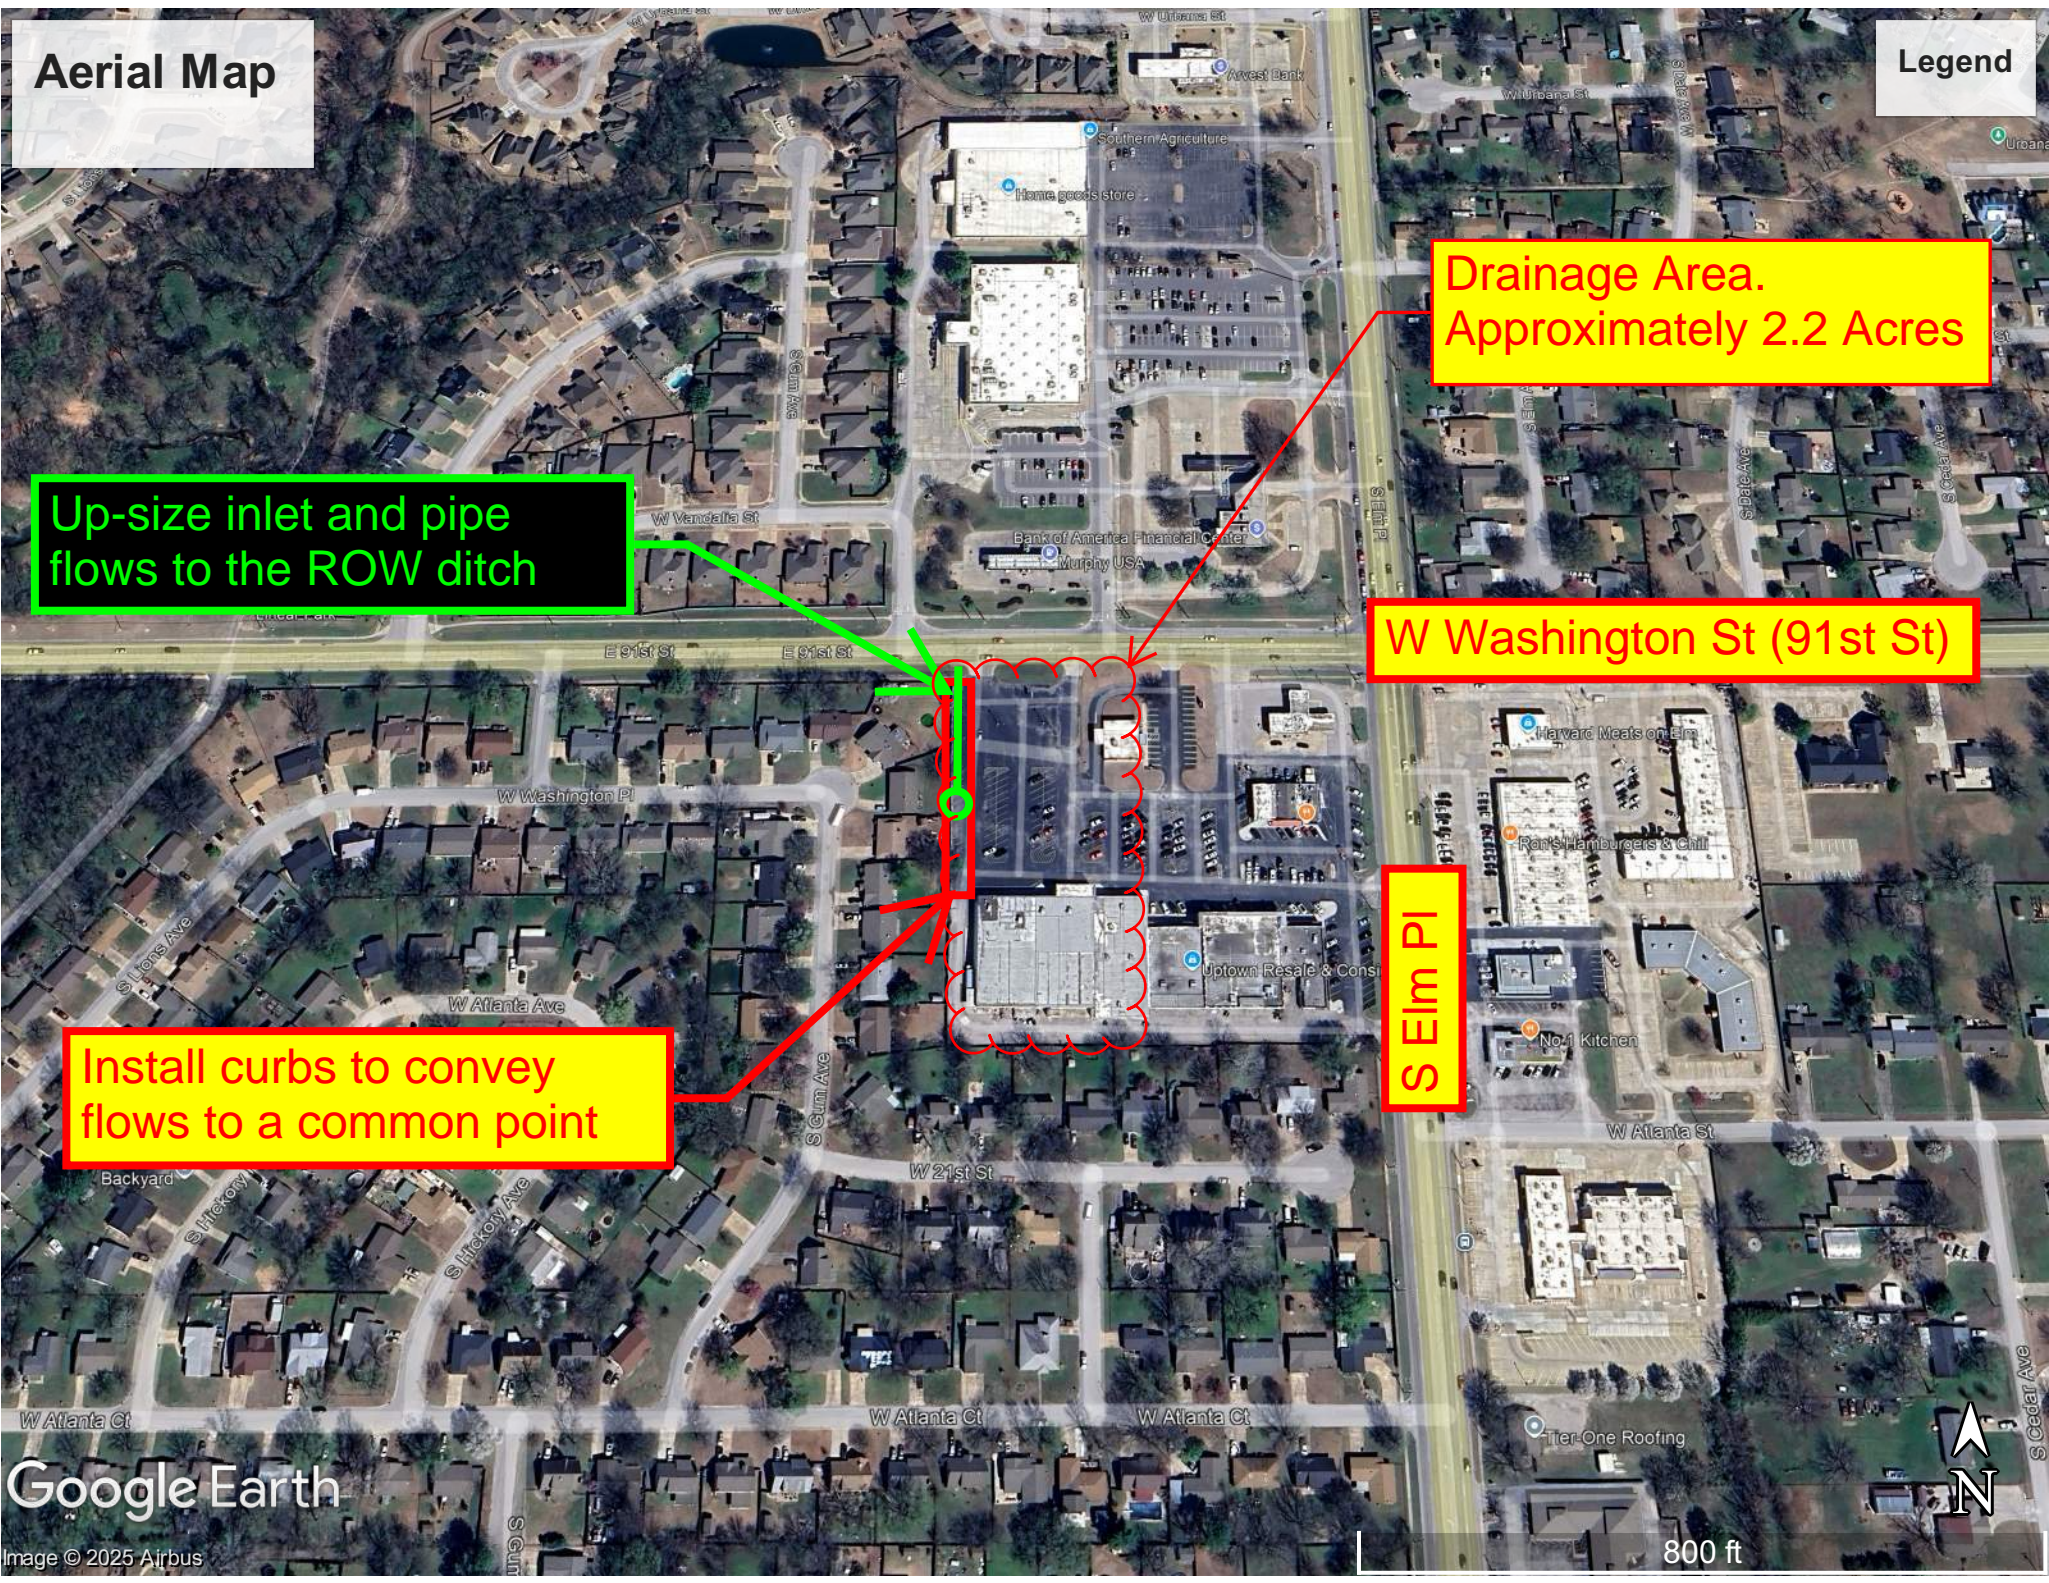
Aerial Map

Drainage Area. Approximately 2.2 Acres

Up-size inlet and pipe flows to the ROW ditch

Install curbs to convey flows to a common point
