LAY-DOWN YARD PUD

D & B

Case number: PUD-002550-2025 and
BAZ-002374-2025

**Laydown Yard
4600 E Gary St
Broken Arrow, OK 74014
Wagoner County**

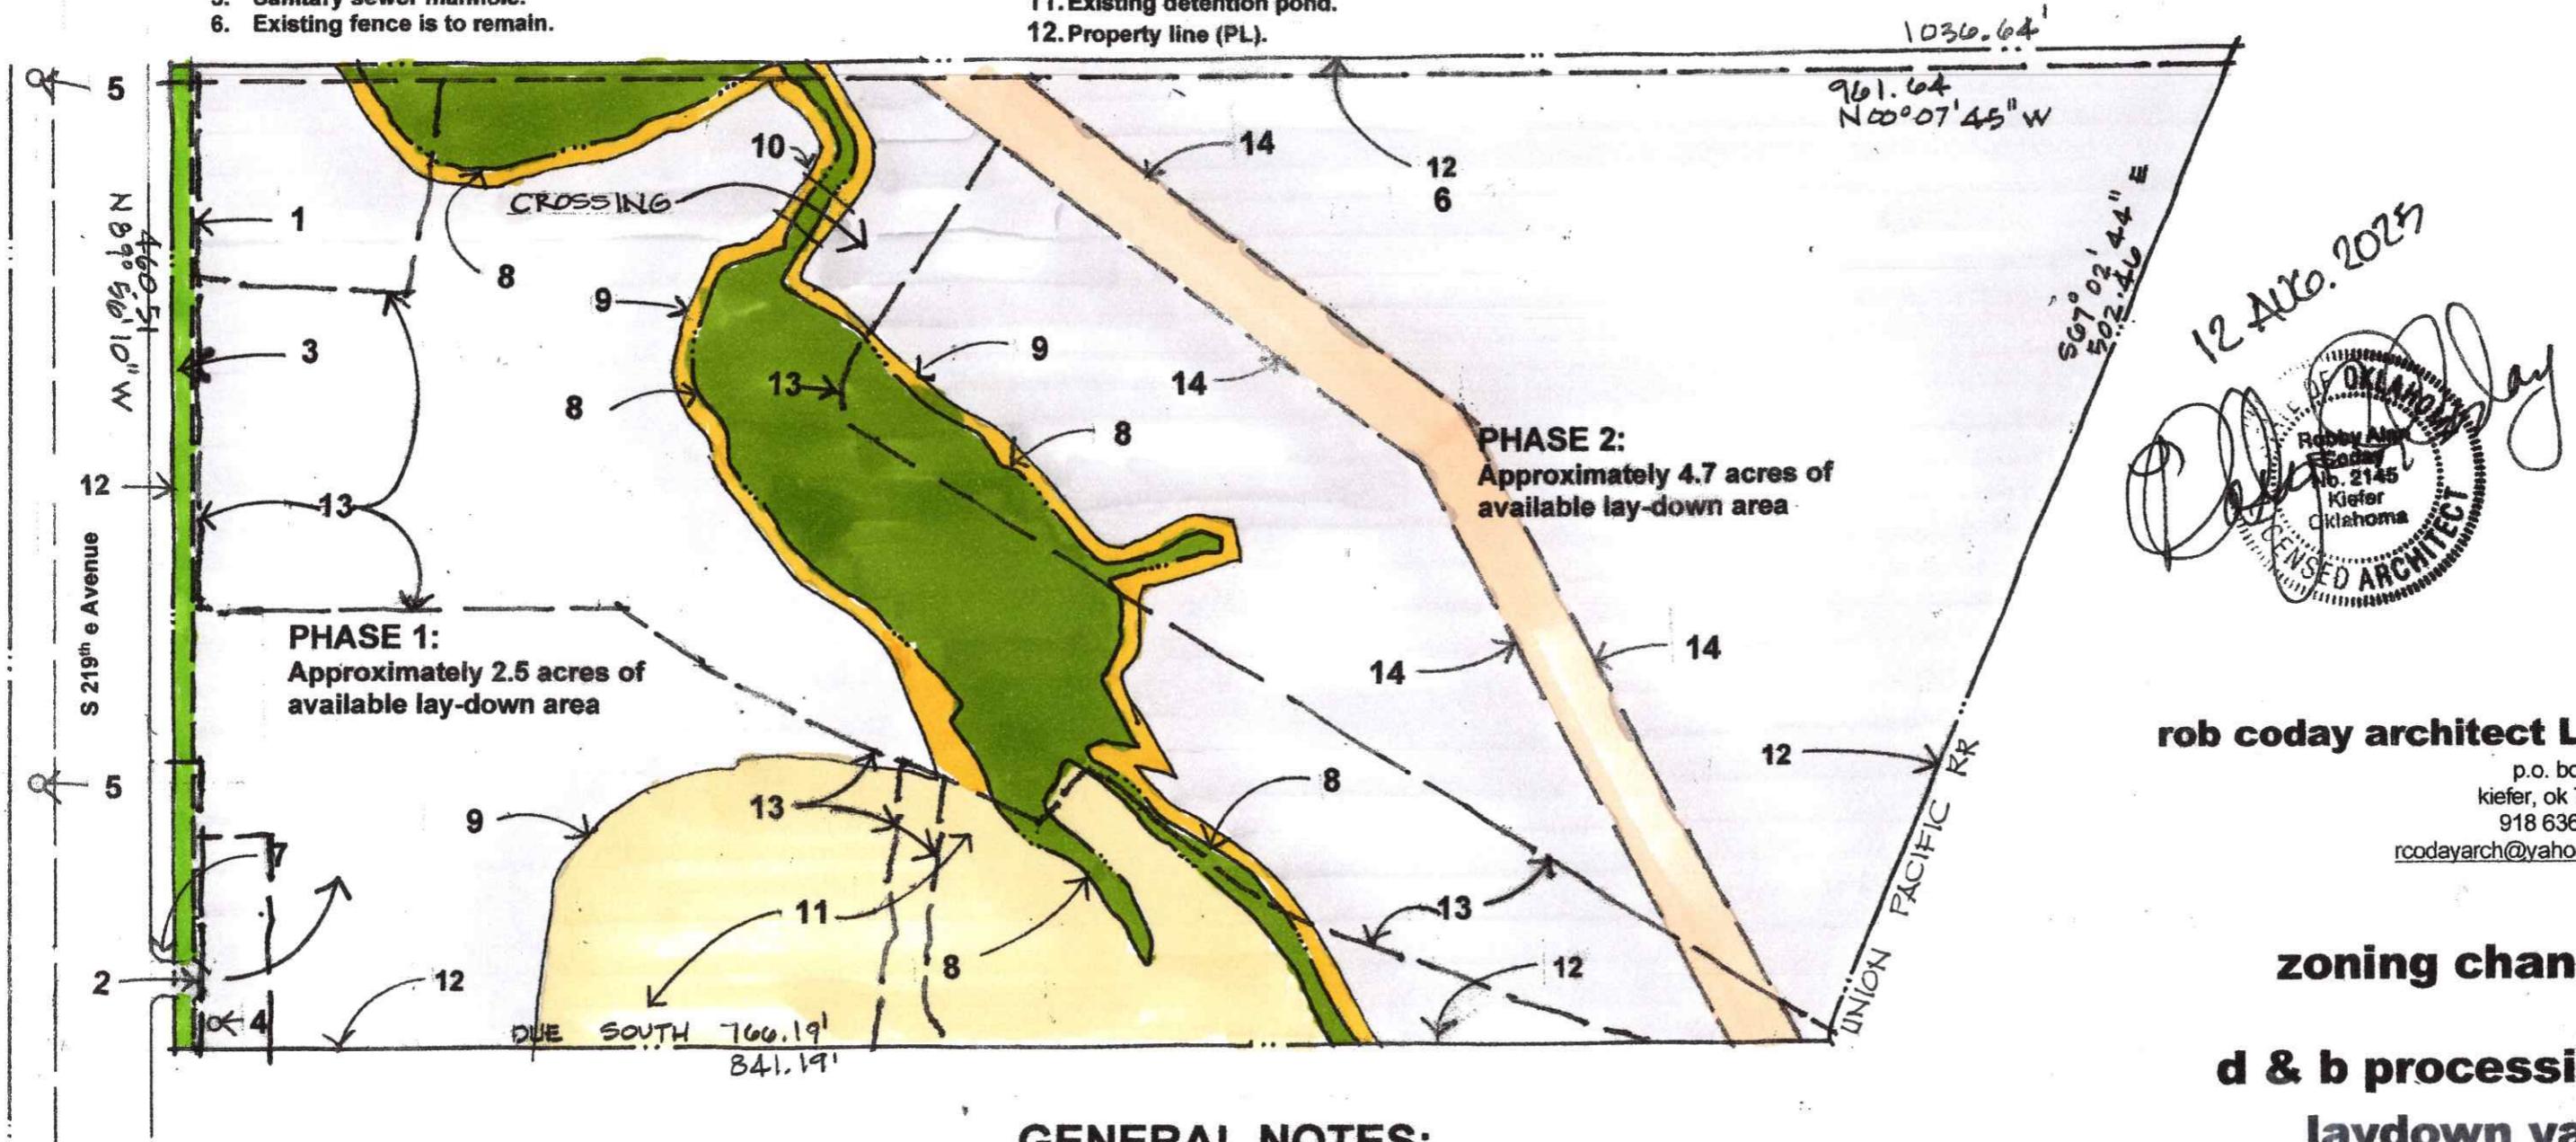
SITE PLAN

1. 6-foot-high metal screening fence.
2. Metal access gate w/ Knox box.
3. 10-foot-wide landscaping strip complete with sprinkler system.
4. Water service with meter. Water service to supply sprinkler system with backflow prevention.
5. Sanitary sewer manhole.
6. Existing fence is to remain.
7. Existing 16" diameter plastic pipe culvert.
8. Boundary of regulated wetland.
9. 8 foot wide "buffer" between regulated wetland and new gravel for laydown yard.
10. Wetland crossing structure.
11. Existing detention pond.
12. Property line (PL).
13. Existing Drainage easement which directs offsite stormwater. Possible to be amended (per Civil Engineer's design) with final stormwater design. Line: _____
14. Sanitary Sewer Easement. Line: _____

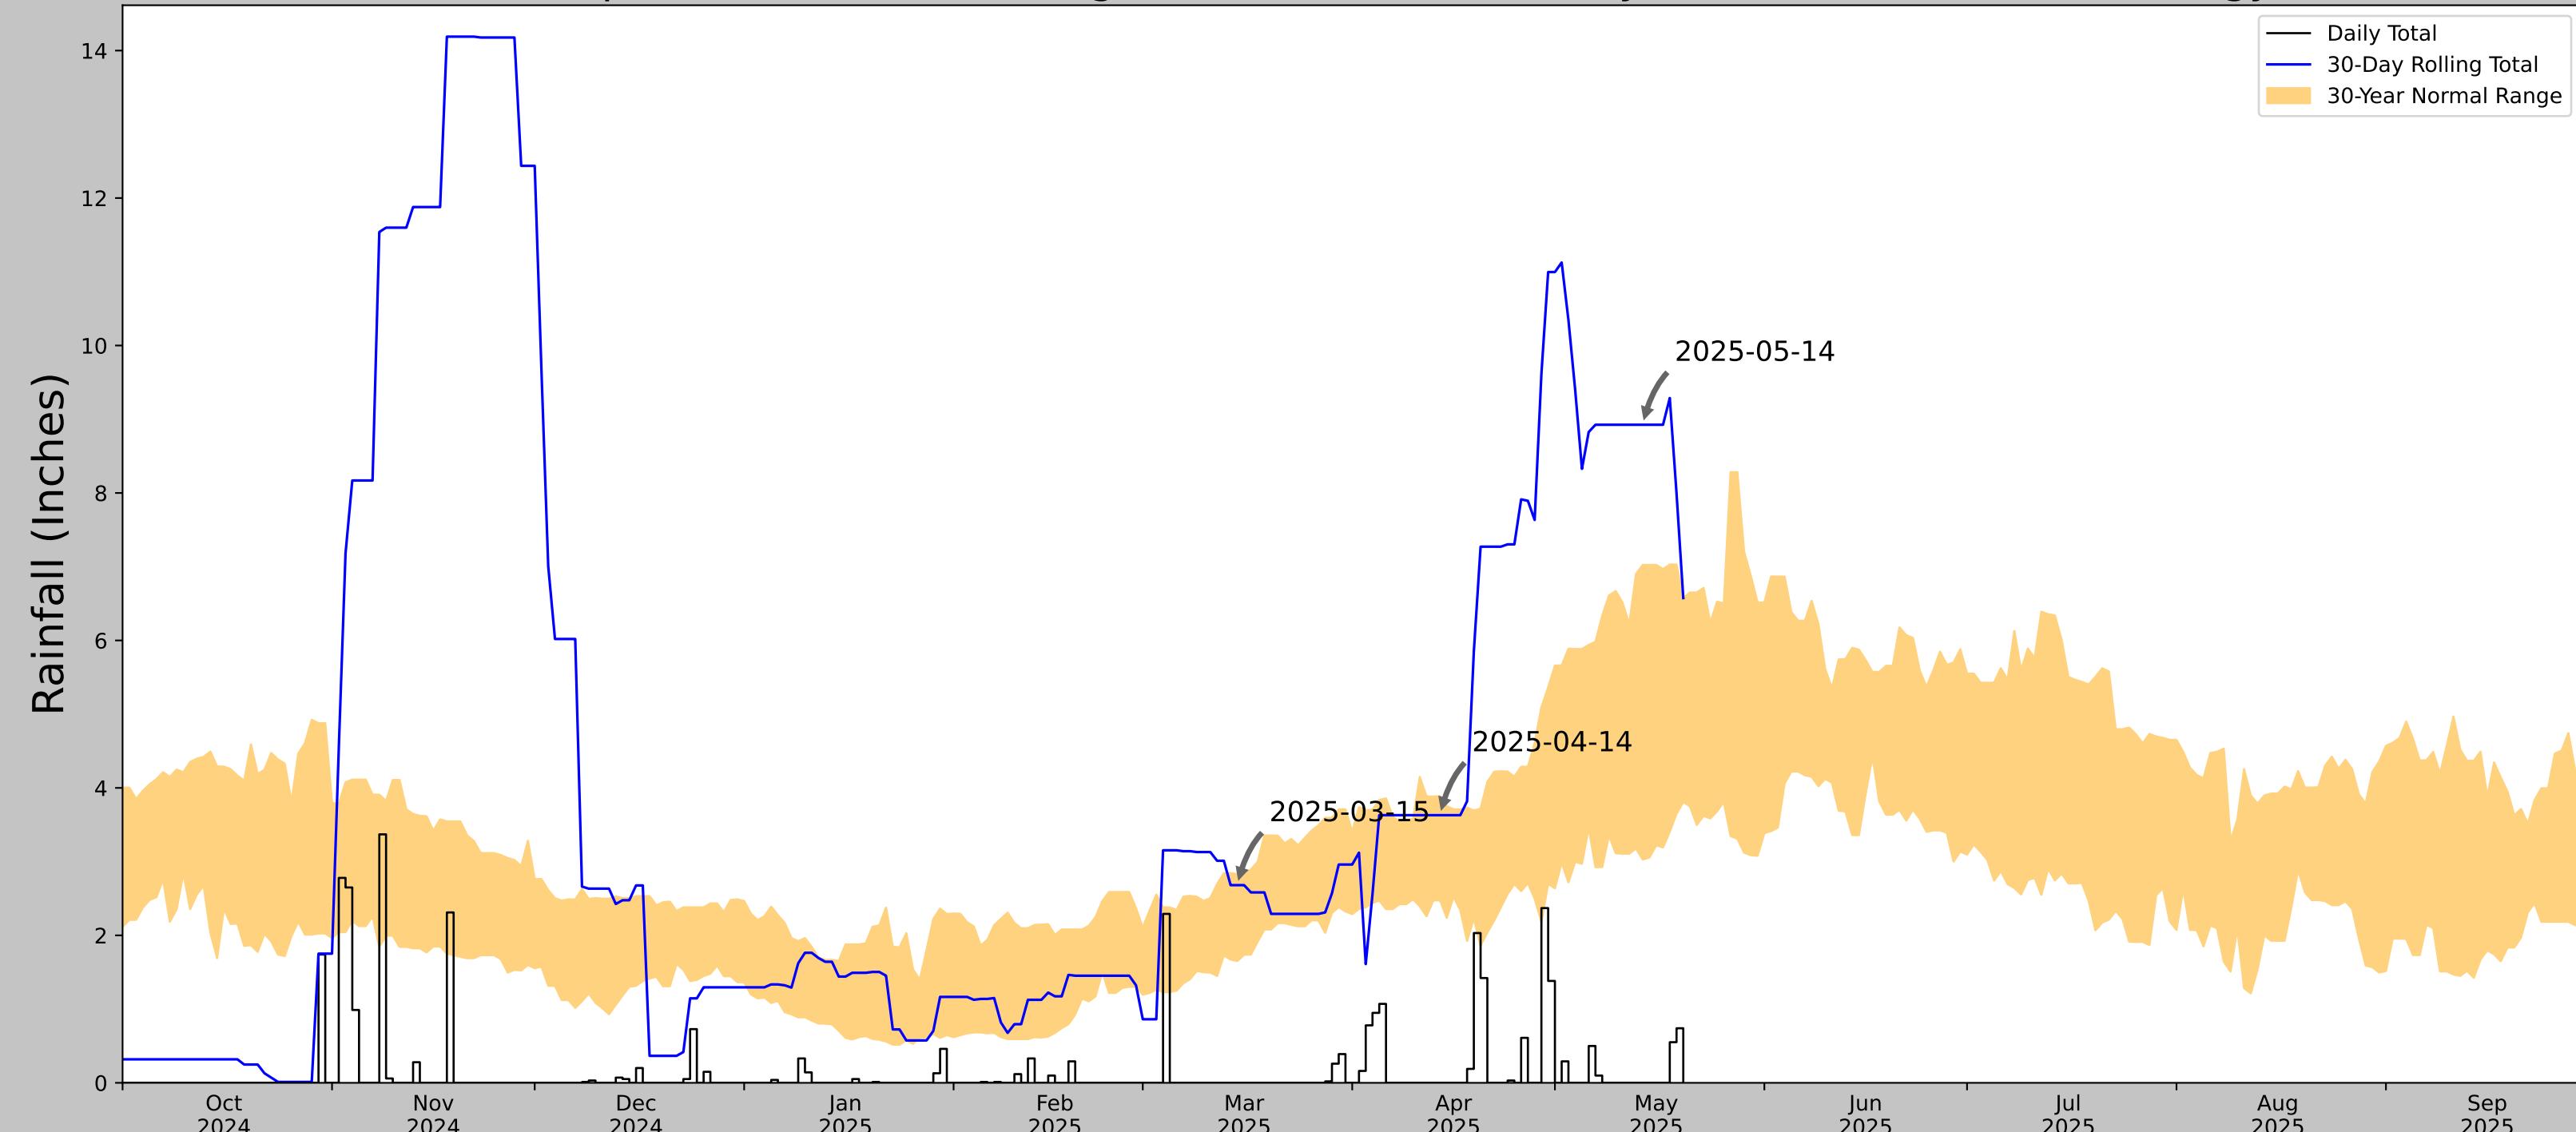
Antecedent Precipitation vs Normal Range based on NOAA's Daily Global Historical Climatology Network

Coordinates	36.025779, -95.734195
Observation Date	2025-05-14
Elevation (ft)	691.554
Drought Index (PDSI)	Mild wetness (2025-04)
WebWIMP H ₂ O Balance	Wet Season

30 Days Ending	30 th %ile (in)	70 th %ile (in)	Observed (in)	Wetness Condition	Condition Value	Month Weight	Product
2025-05-14	3.029134	7.023622	8.925197	Wet	3	3	9
2025-04-14	2.475197	3.886614	3.629921	Normal	2	2	4
2025-03-15	1.651969	2.830709	2.681102	Normal	2	1	2
Result							Wetter than Normal - 15

The antecedent precipitation conditions at the Project were evaluated prior to conducting the fieldwork on May 14 and 16, 2025, using the USACE Antecedent Precipitation Tool (APT) version v.2.0.0. The generated result of APT evaluation is included in **Appendix B**. Based on this evaluation; the survey occurred during the wet season and the antecedent precipitation was wetter than normal during fieldwork in May 2025.

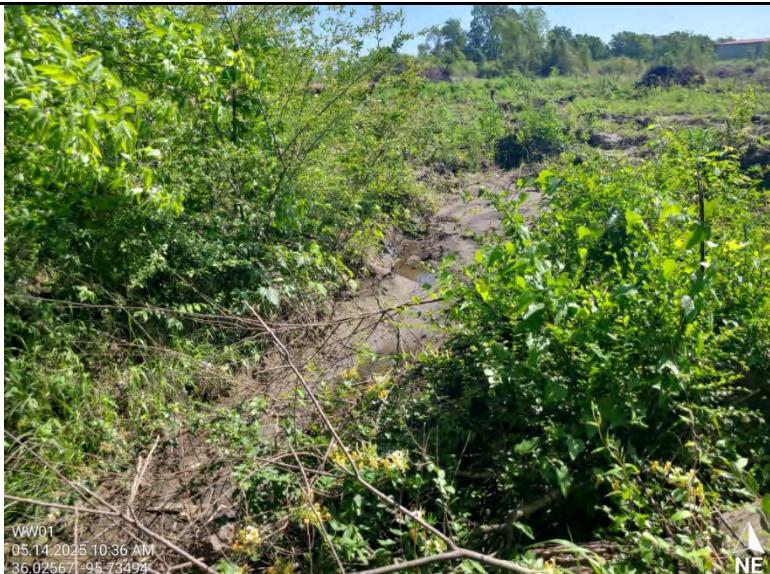
Photograph 3

LOCATION: WW01 (Waterway 01)

Notes: Intermittent stream with sediment bed. Facing upstream.

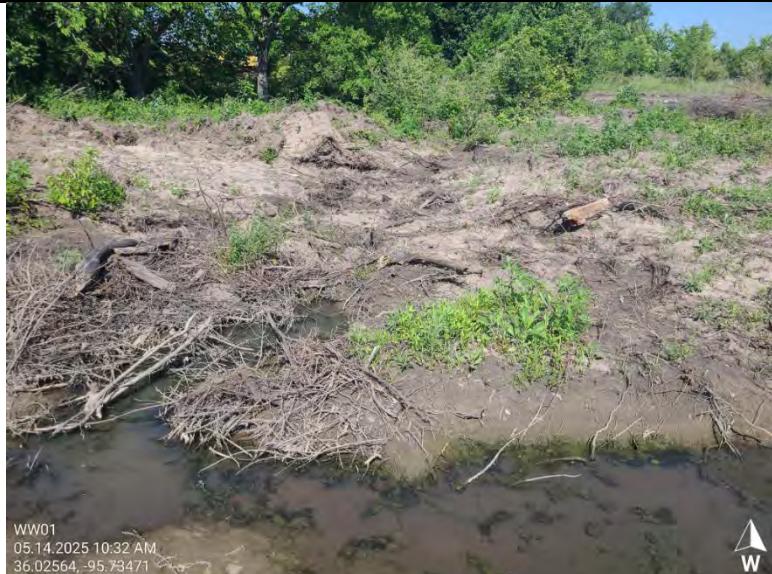
Photograph 4

LOCATION: WW01

Notes: Example of earthwork activities potentially altering turbidity, flow rate, and flow path by sediment deposition.

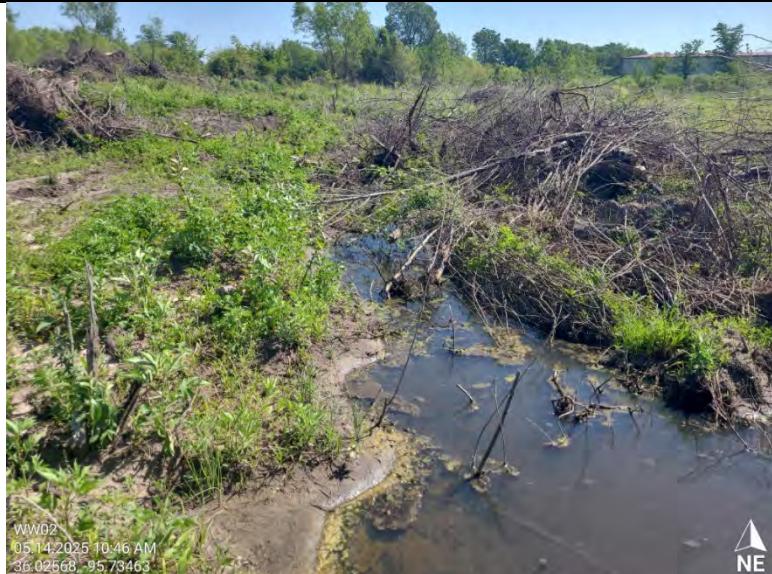
**Photograph 5**

LOCATION: WW02

Notes: Intermittent stream with sediment bed. Facing upstream.

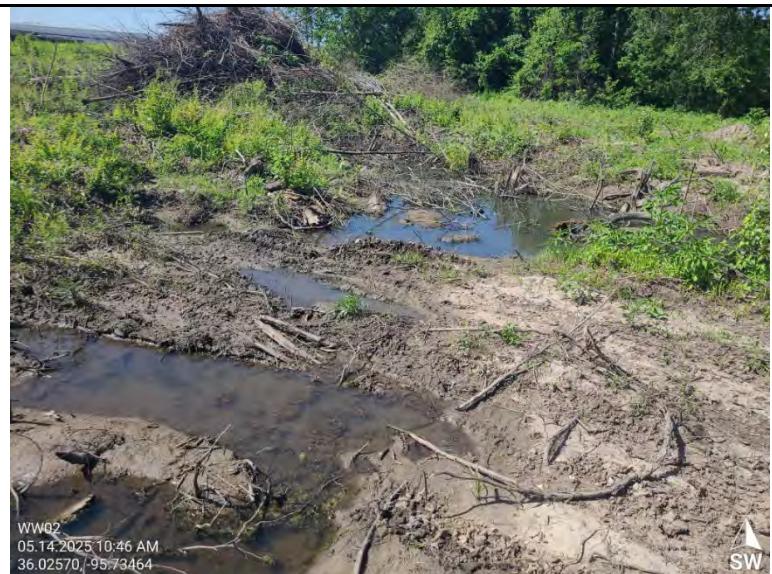
**Photograph 6**

LOCATION: WW02

Notes: Example of vehicle traffic impact potentially altering turbidity, flow rate, and flow path. Facing downstream.

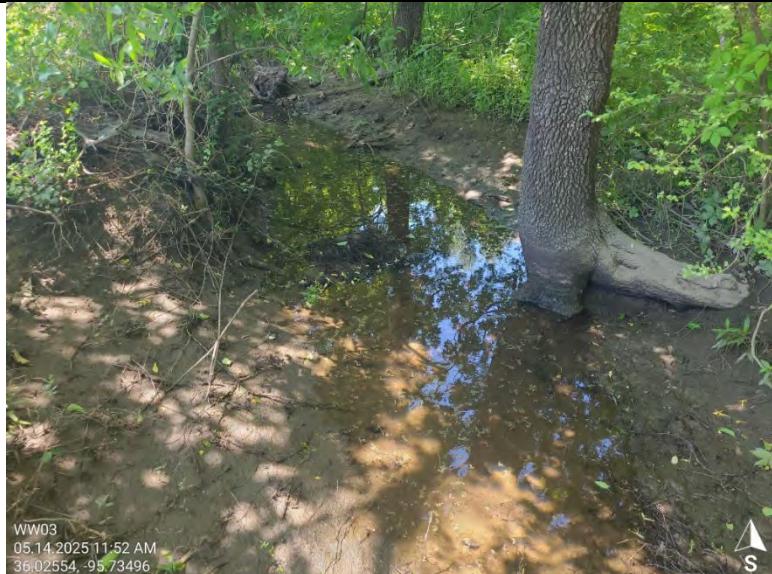
Photograph 7

LOCATION: WW03

Notes: Intermittent stream with sediment bed. Facing downstream.

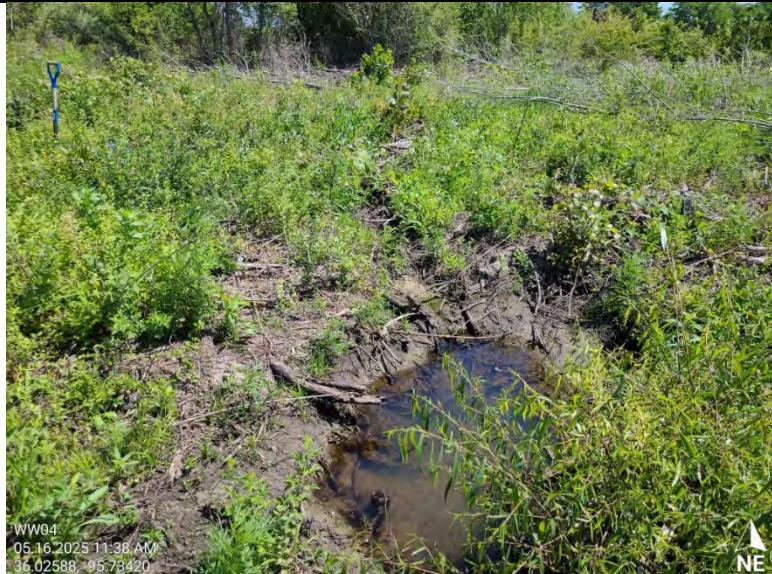
**Photograph 8**

LOCATION: WW04

Notes: Ephemeral stream with intermittent OHWM. Facing upstream.

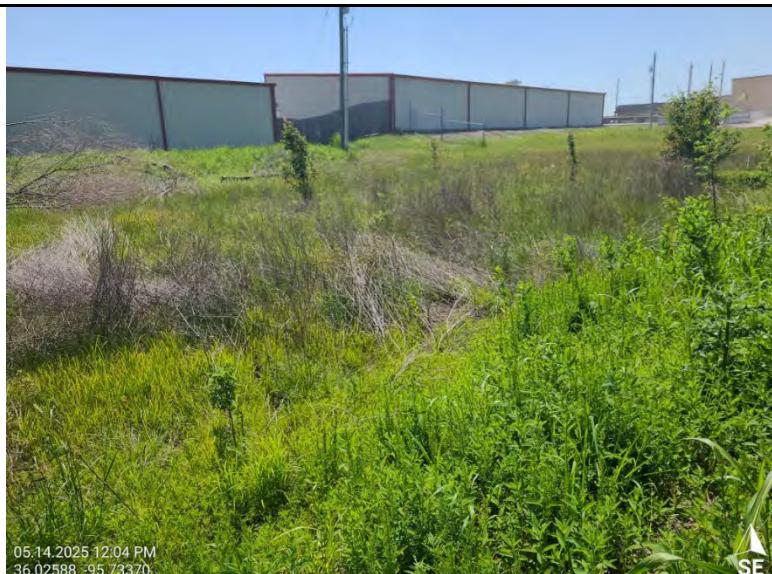
**Photograph 9**

LOCATION: WET01-PEM (Palustrine Emergent Wetland 01) and DP01

Notes: DP01 (Data Point 01) met all three wetland criteria. WET01-PEM is within retention pond.

WET01-PEM is a palustrine emergent wetland that is present within a historical retention pond. The dominant vegetation observed within the retention pond is the Rufous bulrush (*Scirpus pendulus*). Additional species are broomsedge bluestem (*Andropogon virginicus*) and common spike-rush (*Eleocharis palustris*). The retention pond receives upland flow from the east adjacent property and drains through a concrete outlet as sheet flow into WET02-PEM.

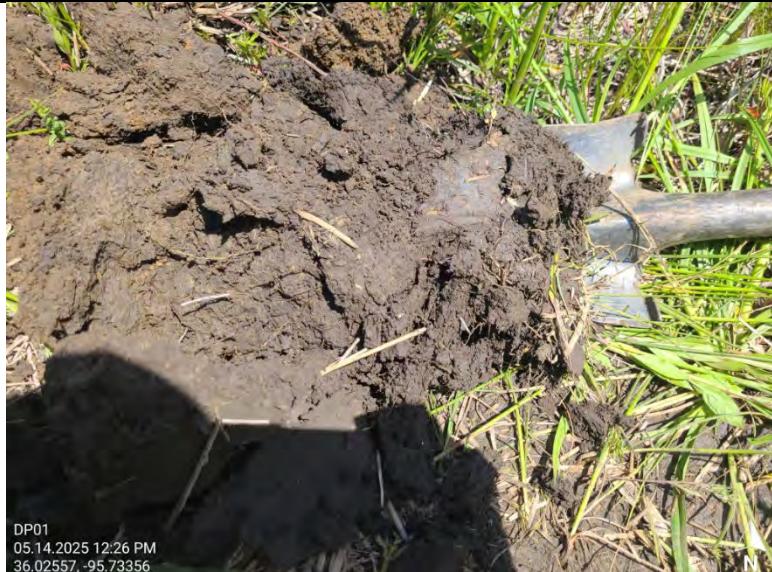
Photograph 10

LOCATION: DP01

Notes: Soil sample. Evidence of hydric soil observed.

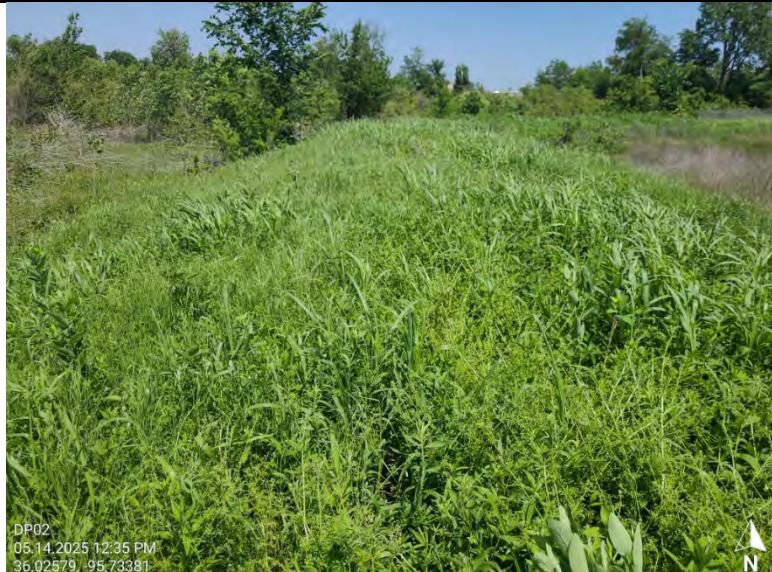
**Photograph 11**

LOCATION: DP02

Notes: DP02 is upland reference data point for WET01-PEM, located on retention pond berm.

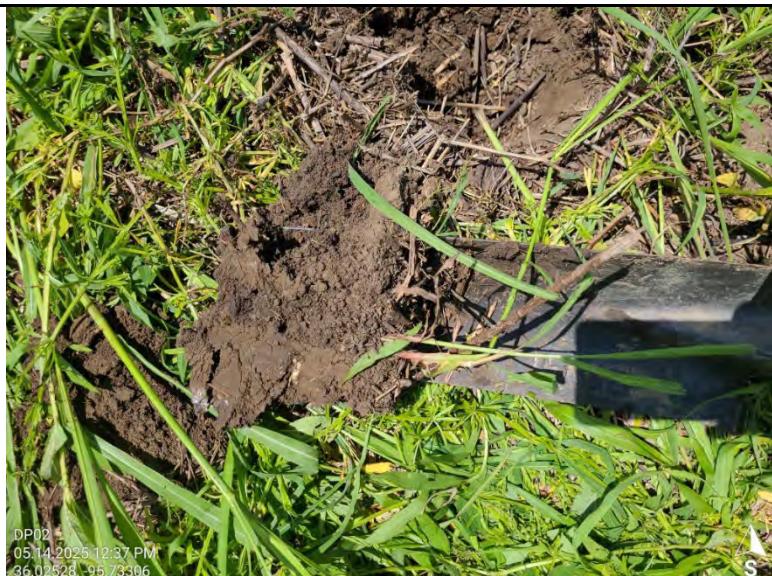
**Photograph 12**

LOCATION: DP02

Notes: Soil sample. No evidence of hydric soil observed.

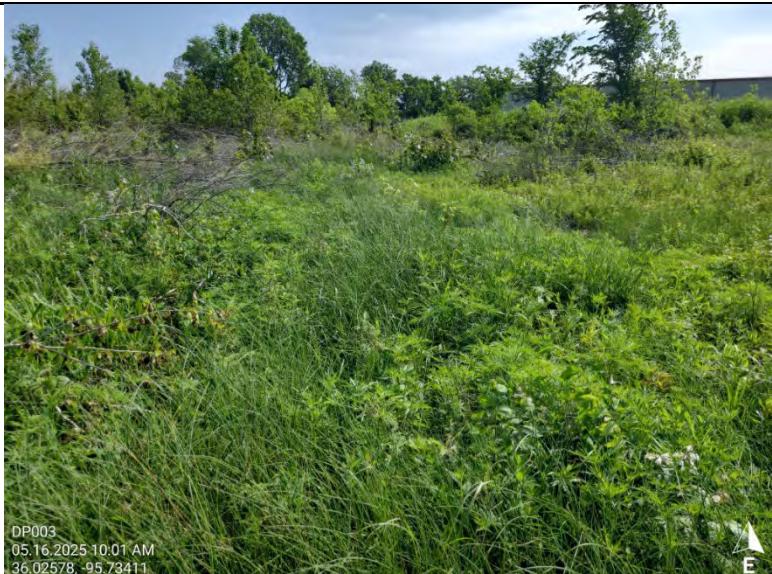
Photograph 13

LOCATION: DP03

Notes: DP03 is upland reference data point for WET02-PEM.

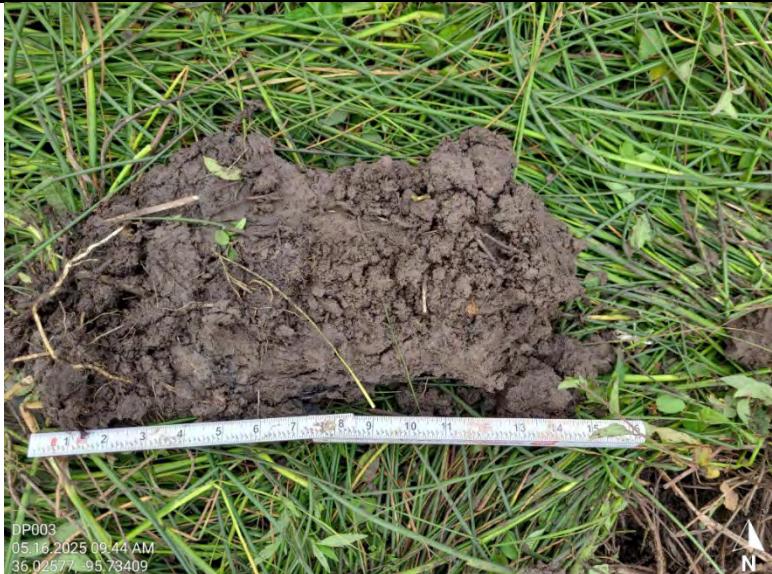
**Photograph 14**

LOCATION: DP03

Notes: Soil sample. No evidence of hydric soil observed.

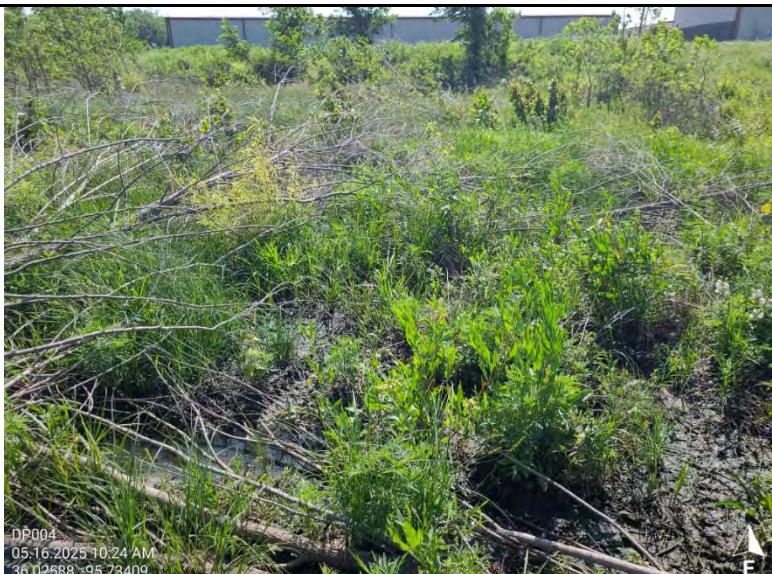
**Photograph 15**

LOCATION: WET02-PEM and DP04

Notes: DP04 met all three wetland criteria. WET02-PEM directly abuts WW01.

WET02-PEM is a palustrine emergent wetland adjacent to WW01 with which it exhibits a continuous surface connection. Dominant vegetation consists of swamp dock (*Rumex verticillatus*), bearded beggarticks (*Bidens aristosa*), summer grape (*Vitis aestivalis*), tall goldenrod (*Solidago altissima*), poison ivy, black willow, climbing rose (*Rosa setigera*), foxtail sedge (*Carex vulpinoidea*), and fleabane (*Erigeron annuus*). Intermittent standing water and drainage patterns were observed. Debris from tree removal is present within the wetland. The eastern portion of WET02-PEM likely receives subsurface flow from the retention pond.

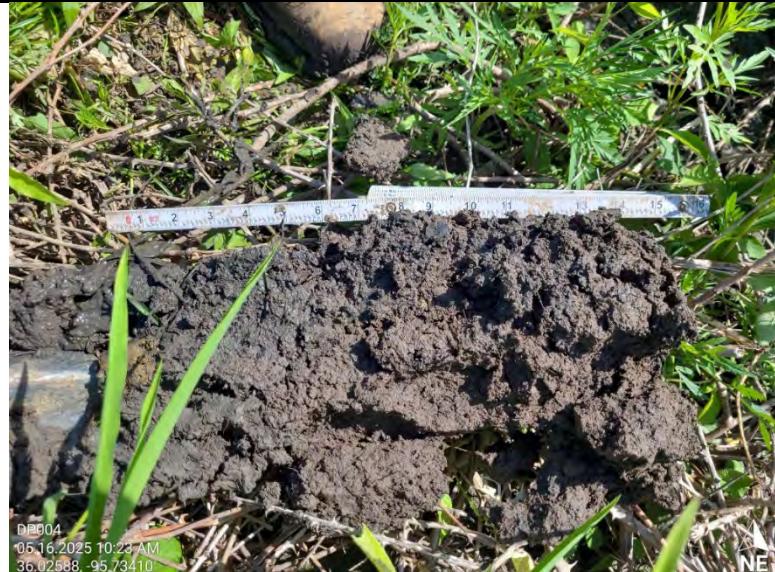
Photograph 16

LOCATION: DP04

Notes: Soil sample. Evidence of hydric soil observed.

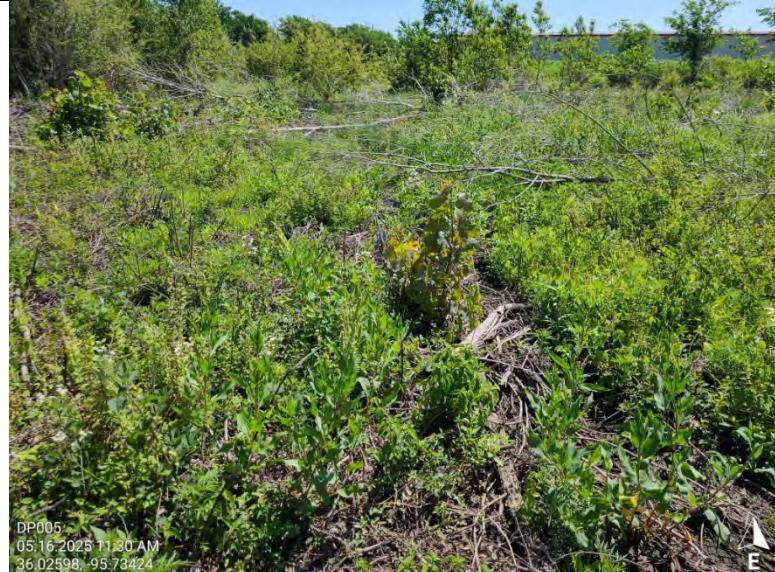
**Photograph 17**

LOCATION: DP05

Notes: DP05 is upland data point to confirm extent of WET02-PEM.

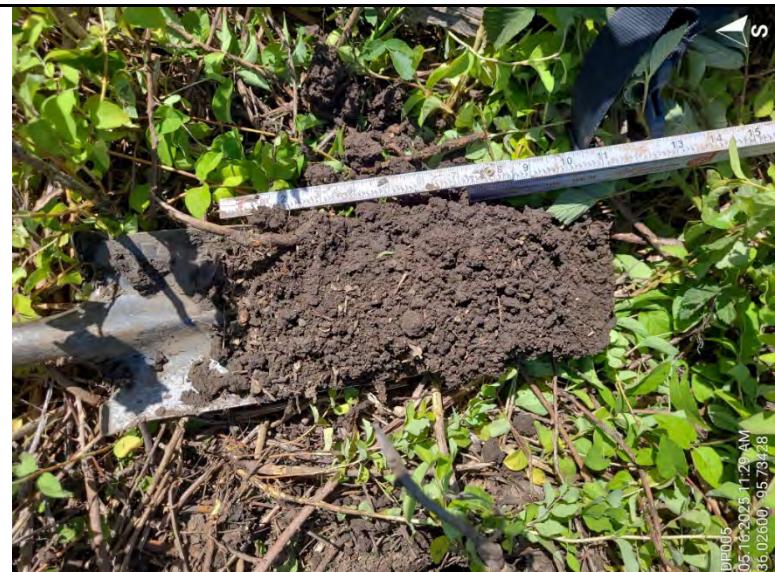
**Photograph 18**

LOCATION: DP05

Notes: Soil sample. No evidence of hydric soil observed.

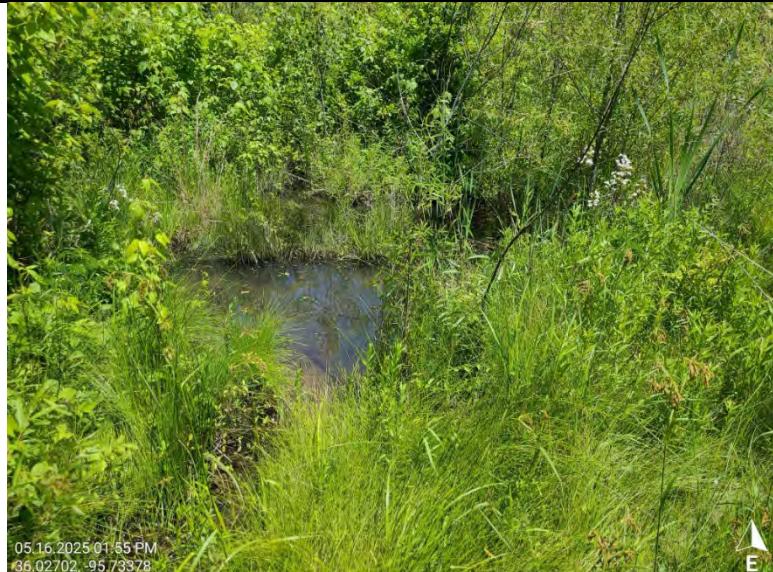
Photograph 19

LOCATION: WET03-PFO and DP06

Notes: DP06 met all three wetland criteria. WET03-PFO is adjacent to active construction and impacted sewage release on its southeastern extent. Photo taken from northern extent.

WET03-PFO is a forested wetland within the northern portion of the Project. Dominant vegetation consists of black willow, common spike-rush, and poison ivy. Other vegetation consists of American elm, American sycamore (*Platanus occidentalis*), late boneset (*Eupatorium serotinum*), and Japanese honeysuckle. Standing water and saturation were observed and confirmed from aerial imagery were observed. The southwestern portion of WET03-PFO has been impacted by the ongoing wastewater utility construction and sewage spill. During the May 2025 survey, the ROW between WET03-PFO and WB01 was graded, potentially filled, and installed with construction matting. These observations

At the time of the May 2025 survey, there was construction on the municipal wastewater utility right of way that transects the Project. The right of way was graded, cleared of all vegetation, and construction matting was placed over areas between WET03-PFO and WB01. Earthwork activities were evident in areas adjacent to the right of way, altering the soils, vegetation community, and hydrology. Pooling was observed in areas and is shown in the photolog (**Appendix D**) and in **Figure 5**. The construction foreman indicated that the wastewater pipeline failed, resulting in a sewage release to the immediate area. The amount and extent of sewage release had not been determined at the time of the May 2025 survey. The approximate extent of sewage release footprint shown on **Figure 5** was determined by odor and presence of algae in areas of pooling, but the footprint has not been confirmed. Given accessibility was restricted due to avoid untreated sewage and active construction, the extent of WET03-PFO within the potential sewage release footprint was visually estimated from a safe distance and further refined with aerial imagery. These conditions classify WET03-PFO as an Atypical Situation. The presence of wetland hydrology and hydrophytic vegetation were confirmed, but soil samples were not feasible to define the entire extent of WET03-PFO.

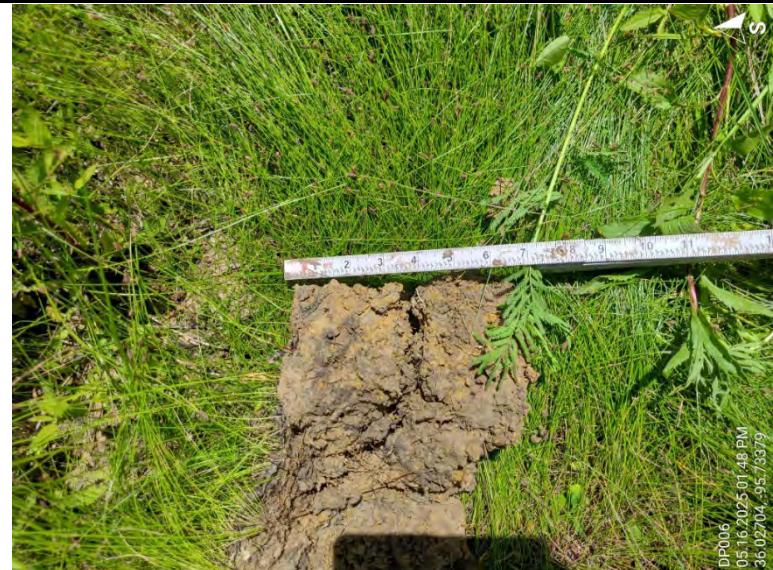
**Photograph 20**

LOCATION: DP06

Notes: Soil sample. Evidence of hydric soil observed.

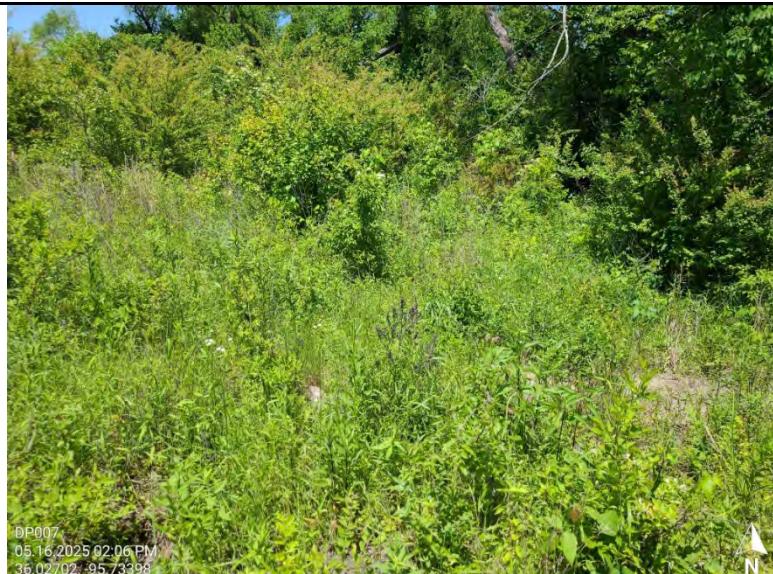
**Photograph 21**

LOCATION: DP07

Notes: DP07 is upland reference data point for WET03-PFO.

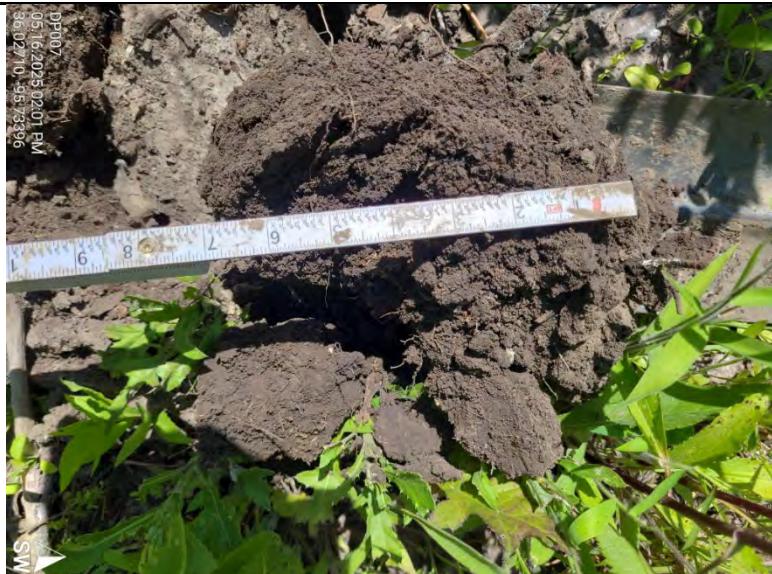
Photograph 22

LOCATION: DP07

Notes: Soil sample. No evidence of hydric soil observed.

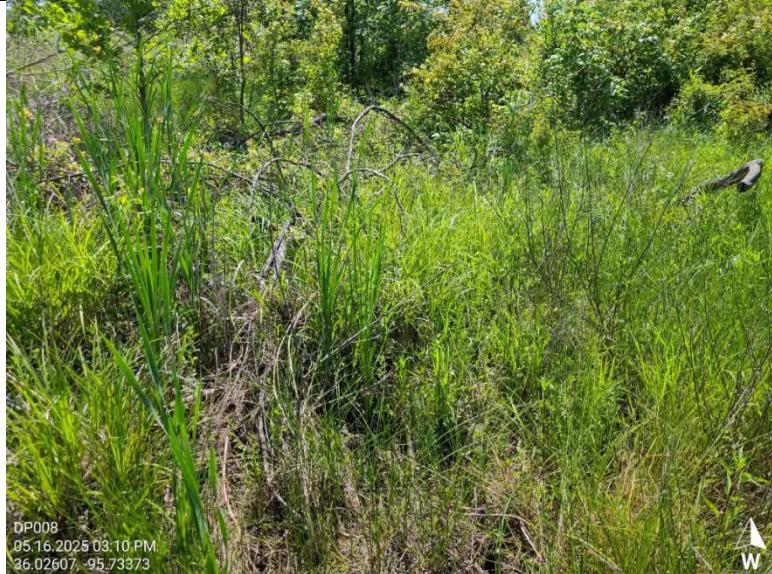
**Photograph 23**

LOCATION: WET02-PEM and DP08

Notes: DP08 is wetland reference data point to confirm extent of WET02-PEM.

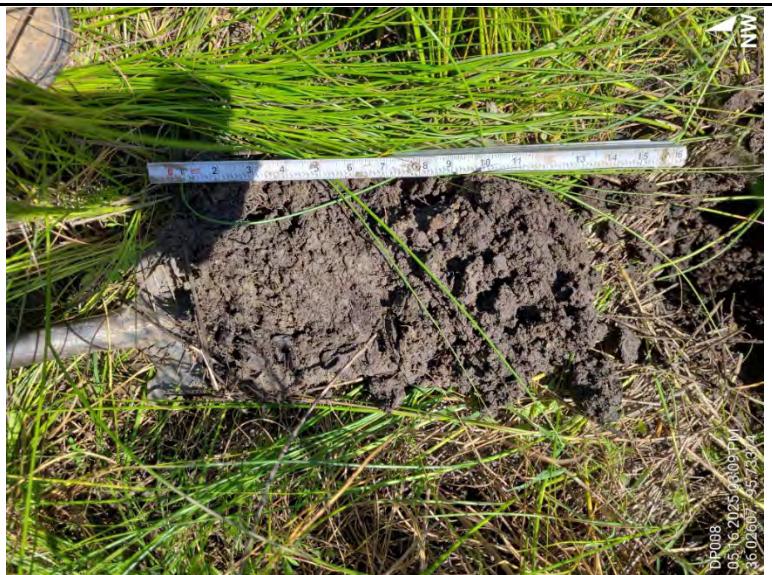
**Photograph 24**

LOCATION: DP08

Notes: Soil sample. Evidence of hydric soil observed.

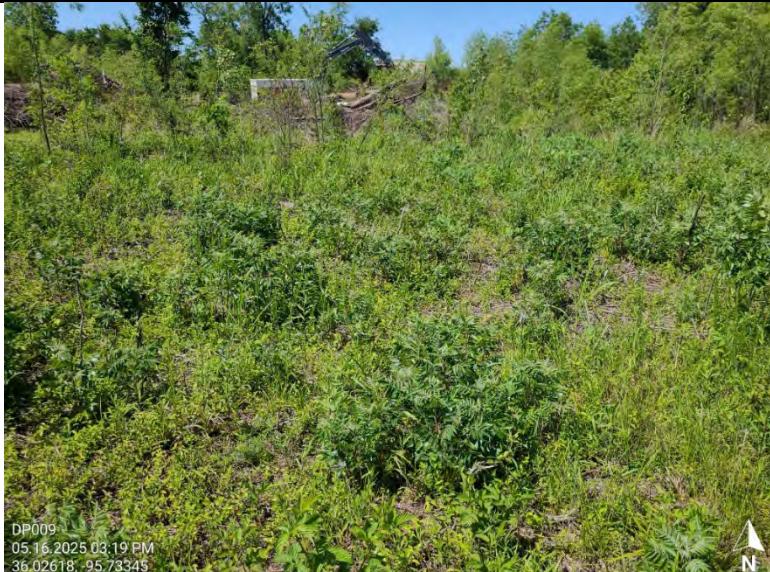
Photograph 25

LOCATION: DP09

Notes: DP09 is upland reference data point for WET02-PEM.

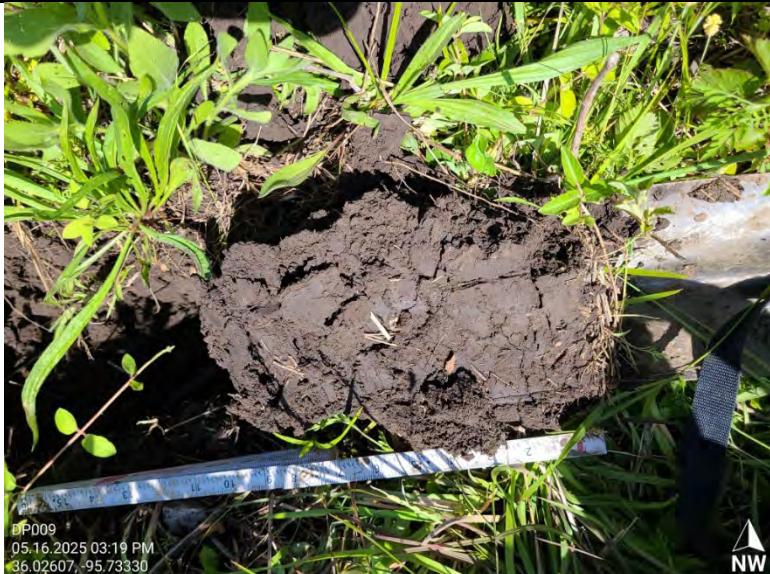
**Photograph 26**

LOCATION: DP09

Notes: Soil sample. No evidence of hydric soil observed.

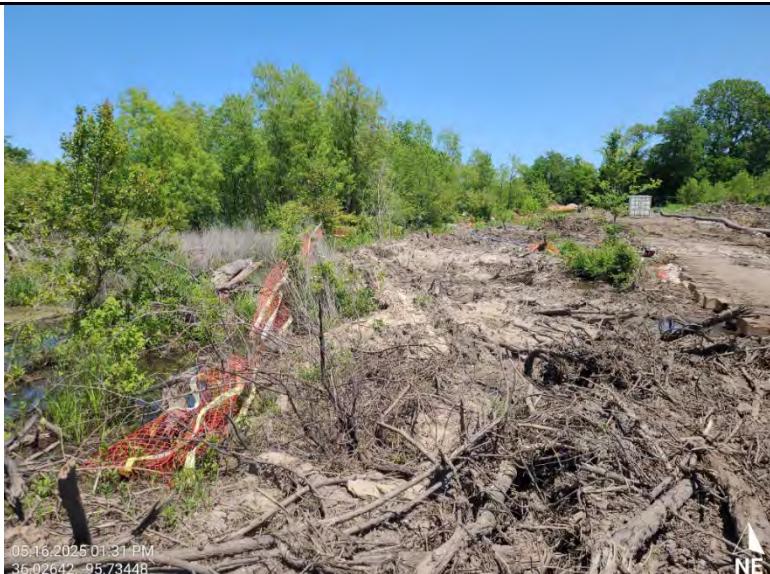
**Photograph 27**

LOCATION: Central portion of Project and WET03-PFO

Notes: Sewer line right-of-way (ROW) active construction and portion of WET03-PFO.

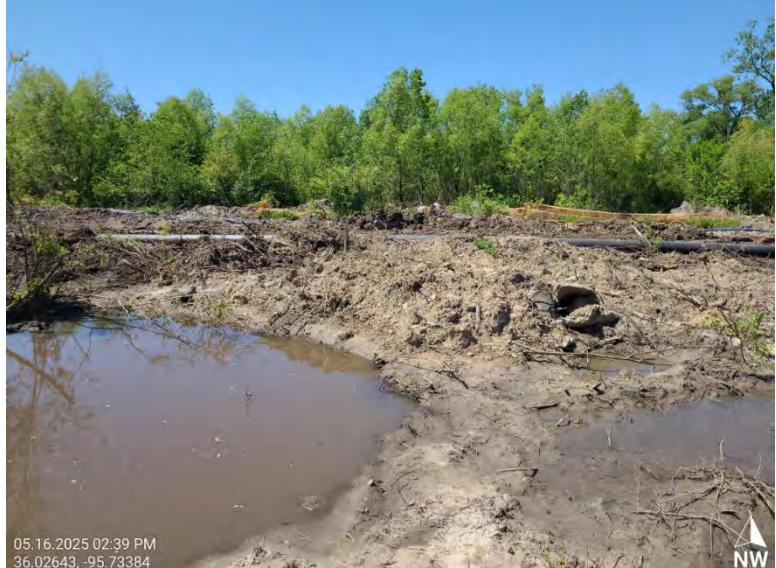
Photograph 28

LOCATION: Adjacent to sewer line ROW

Notes: Evidence of earthwork activities and pooling.

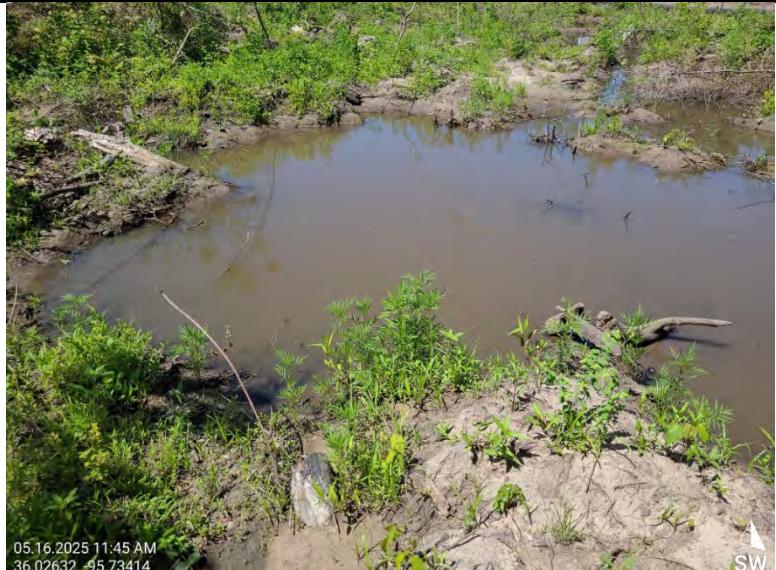
**Photograph 29**

LOCATION: WB01 (Waterbody 01)

Notes: Pond located near earthwork activities.

WB01 is an isolated impoundment northeast of WW02 and adjacent to the municipal wastewater utility pipeline right of way. Evidence of earthwork activities and additional pooling were observed within the immediate proximity of WB01. WB01 did not have a continuous surface connection with WET03-PFO or WW02 at the time of the May 2025 survey, however there likely was a historical continuous surface connection based on aerial imagery and local topography.
