City of Broken Arrow

Drainage Advisory Committee

PROJECT REPORT

DATE:	June 24, 2025
NAME	Tyler Yoak
ADDRESS / LOCATION	Indian Springs County Club
WATERSHED	Arkansas River (Elm Creek)
ESTIMATE	\$125,000
CASE NO.	25-015

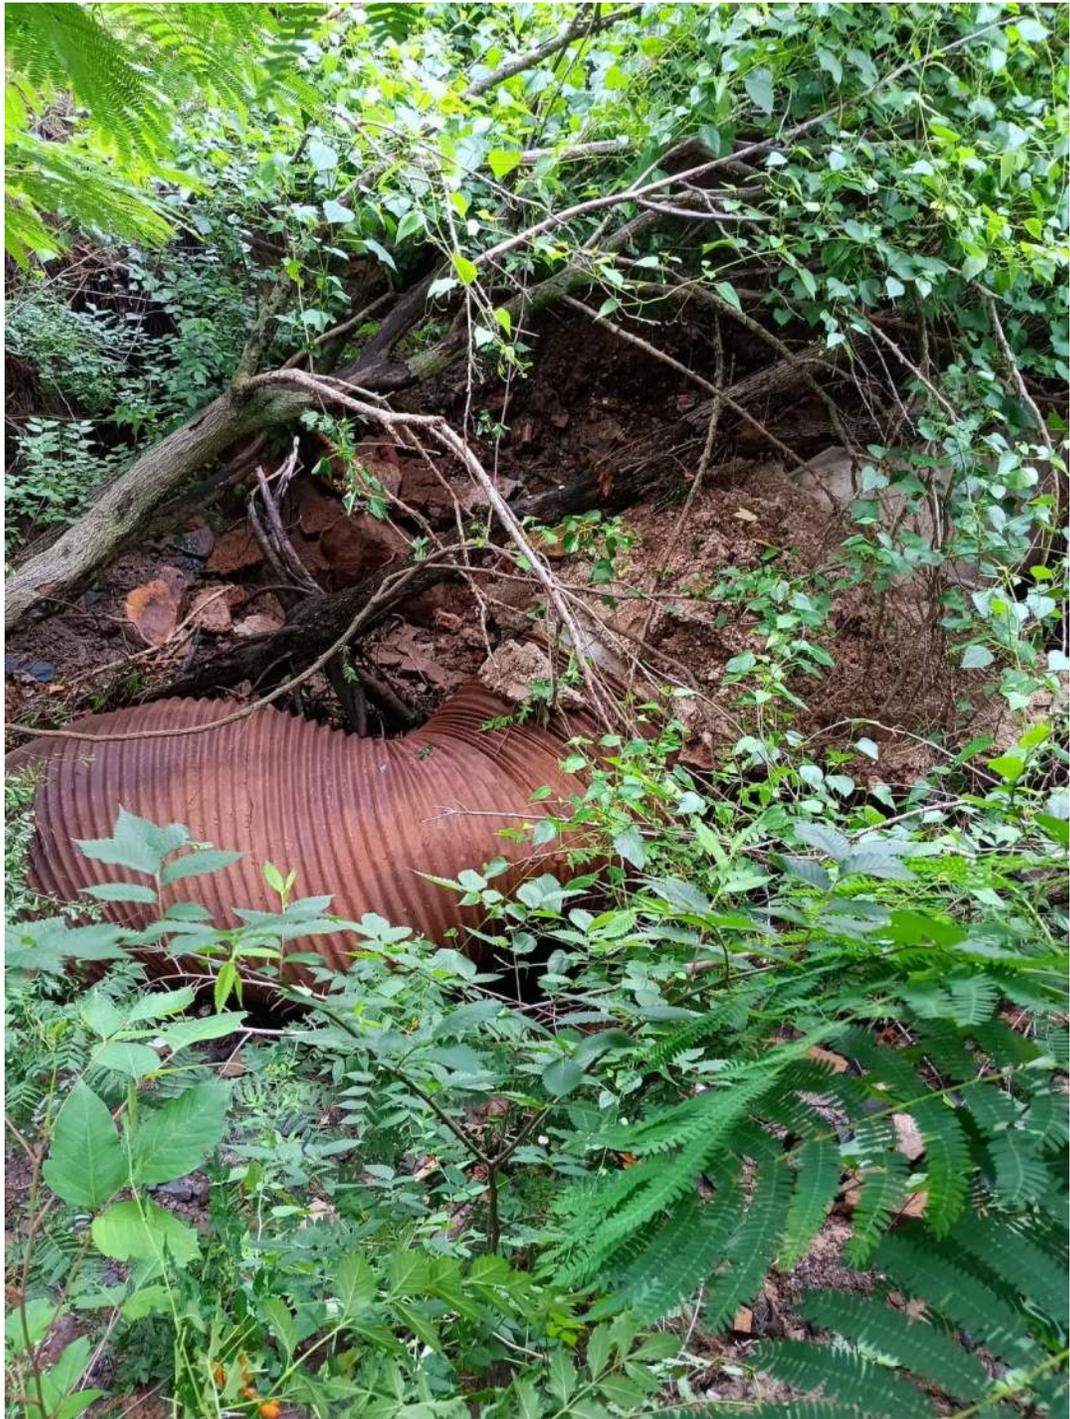
**Additional erosion caused to valley
hillside to the northeast of the pipe.
Water was never intended to get to
this point in the valley, but because
if its backing up, it floods the
valley during torrential rains.**
