City of Broken Arrow

Drainage Advisory Committee

PROJECT REPORT

DATE:	January 23, 2024
NAME	Patrick Wilson, City of Broken Arrow
ADDRESS / LOCATION	
WATERSHED	Adams Creek
ESTIMATE	\$50,000.00
CASE NO.	24-002

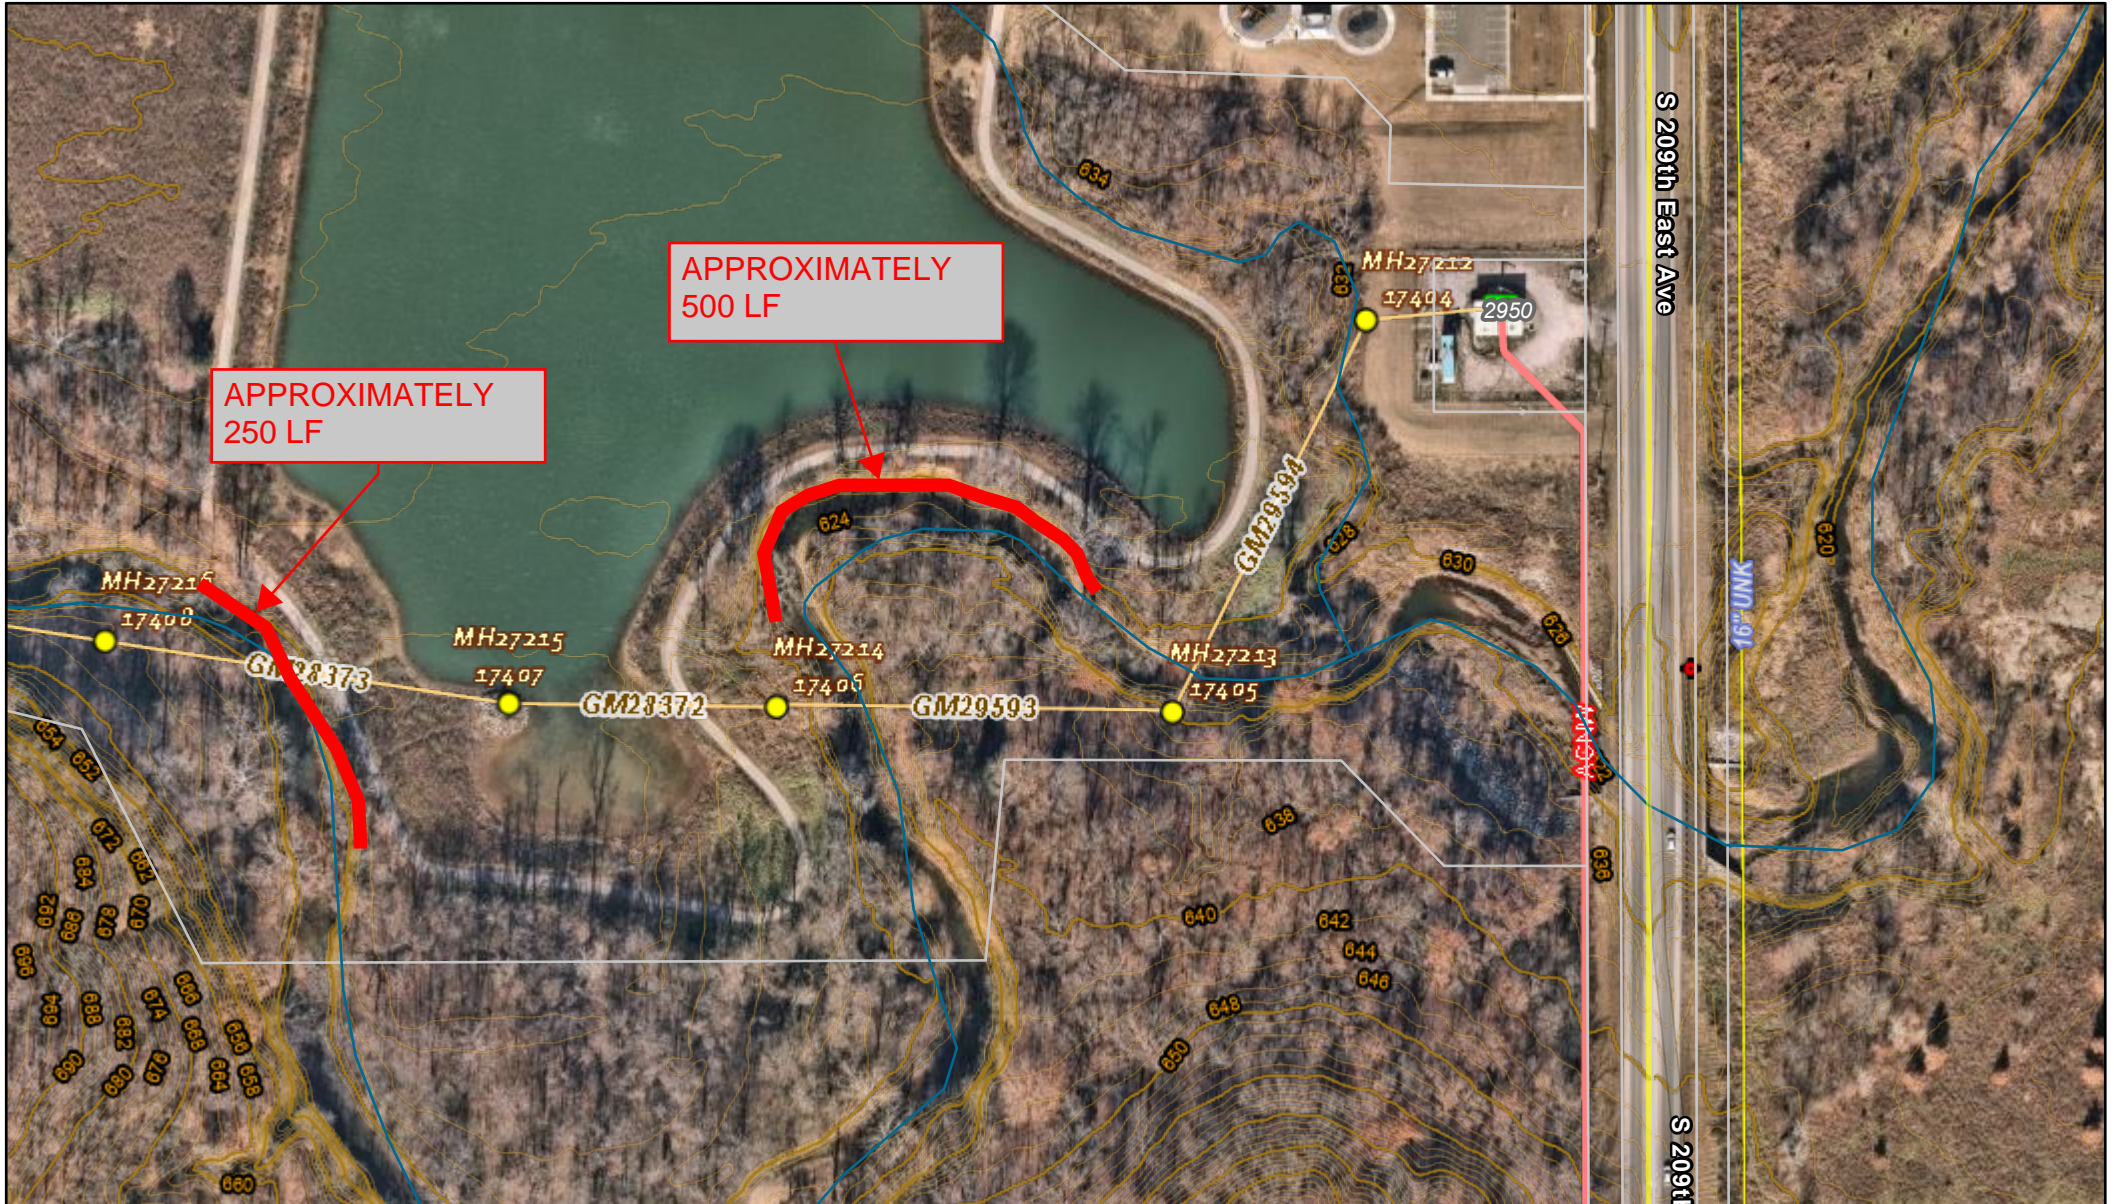
POTENTIAL MITIGATION LOCATIONS

Erosion is occurring along the north bank of Adams Creek adjacent to Preserve Park Regional Detention Pond.

The stream bank is eroding adjacent to the detention pond embankment.

A 30-inch sanitary sewer runs parallel to the detention pond and along/through Adams Creek to the Adams Creek Northwest lift station. A portion of the steel casing over the line is exposed on the creek.

Mitigate the erosion to protect the regional detention pond, sanitary sewer, and 37th St culverts.
