# City of Broken Arrow

## PROJECT REPORT

| ADDRESS / LOCATION | Liberty Trail along Creek Turnpike, west of S. Elm St. |

**Subject: Liberty Trail retaining wall evaluation – Broken Arrow, OK**

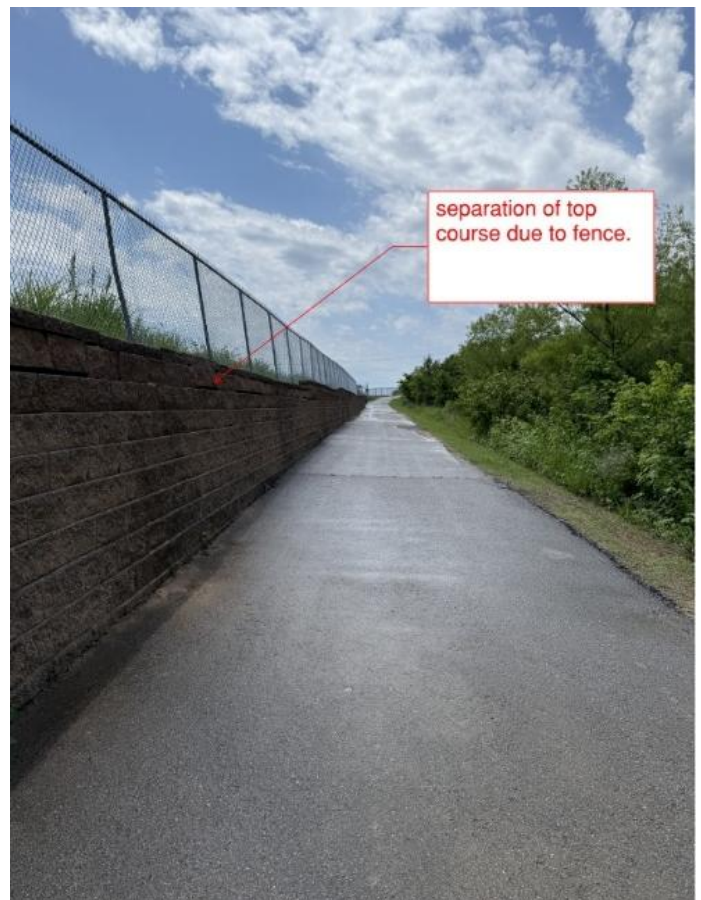
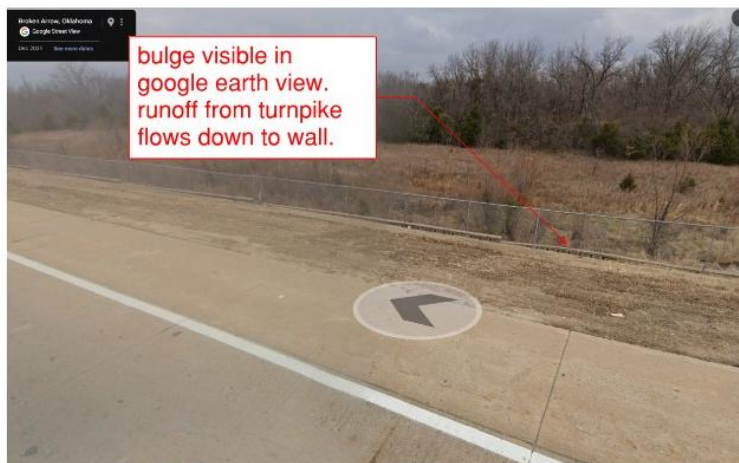
The retaining wall is constructed of standard 8-inch sand-colored segmental concrete block units, forming a mechanically stabilized earth (MSE) system. Field observations revealed the following notable conditions:

The observed deformations and structural distress are most likely the result of water infiltration and inadequate construction practices. Key findings include:

- The wall lacks essential drainage provisions such as weep holes and a 12-inch clean gravel backfill zone, both of which are standard design requirements.
- No geogrid reinforcement was observed. This is a critical omission, particularly for retaining walls exceeding 4 feet in height, as it compromises lateral earth support (see Figure 2 for a standard geogrid-reinforced wall cross-section).

- **Demolish and reconstruct** the existing wall using a segmental block retaining wall system that complies with current industry standards and best practices.
- **Reuse existing block units** that remain in good structural condition to reduce material costs.
- **Install a surface drainage swale** along the top of the wall to intercept and redirect stormwater runoff from the turnpike, thereby minimizing water accumulation behind the wall.
