PROJECT REPORT

DATE:	04/18/24
NAME	Brian Able
ADDRESS / LOCATION	519 S Redwood Ave
WATERSHED	Haikey Creek
ESTIMATE	\$0
CASE NO.	24-009

519 S Redwood Ave is in the Union Station South subdivision, platted in 1992. The initial contact with the City of Broken Arrow stated sink holes were forming in the back yard around the sanitary sewer. The City performed an inspection and a CCTV inspection of the sewer line did not find any breaks or soil in the main. There was noted burrowing animals in the back yard.

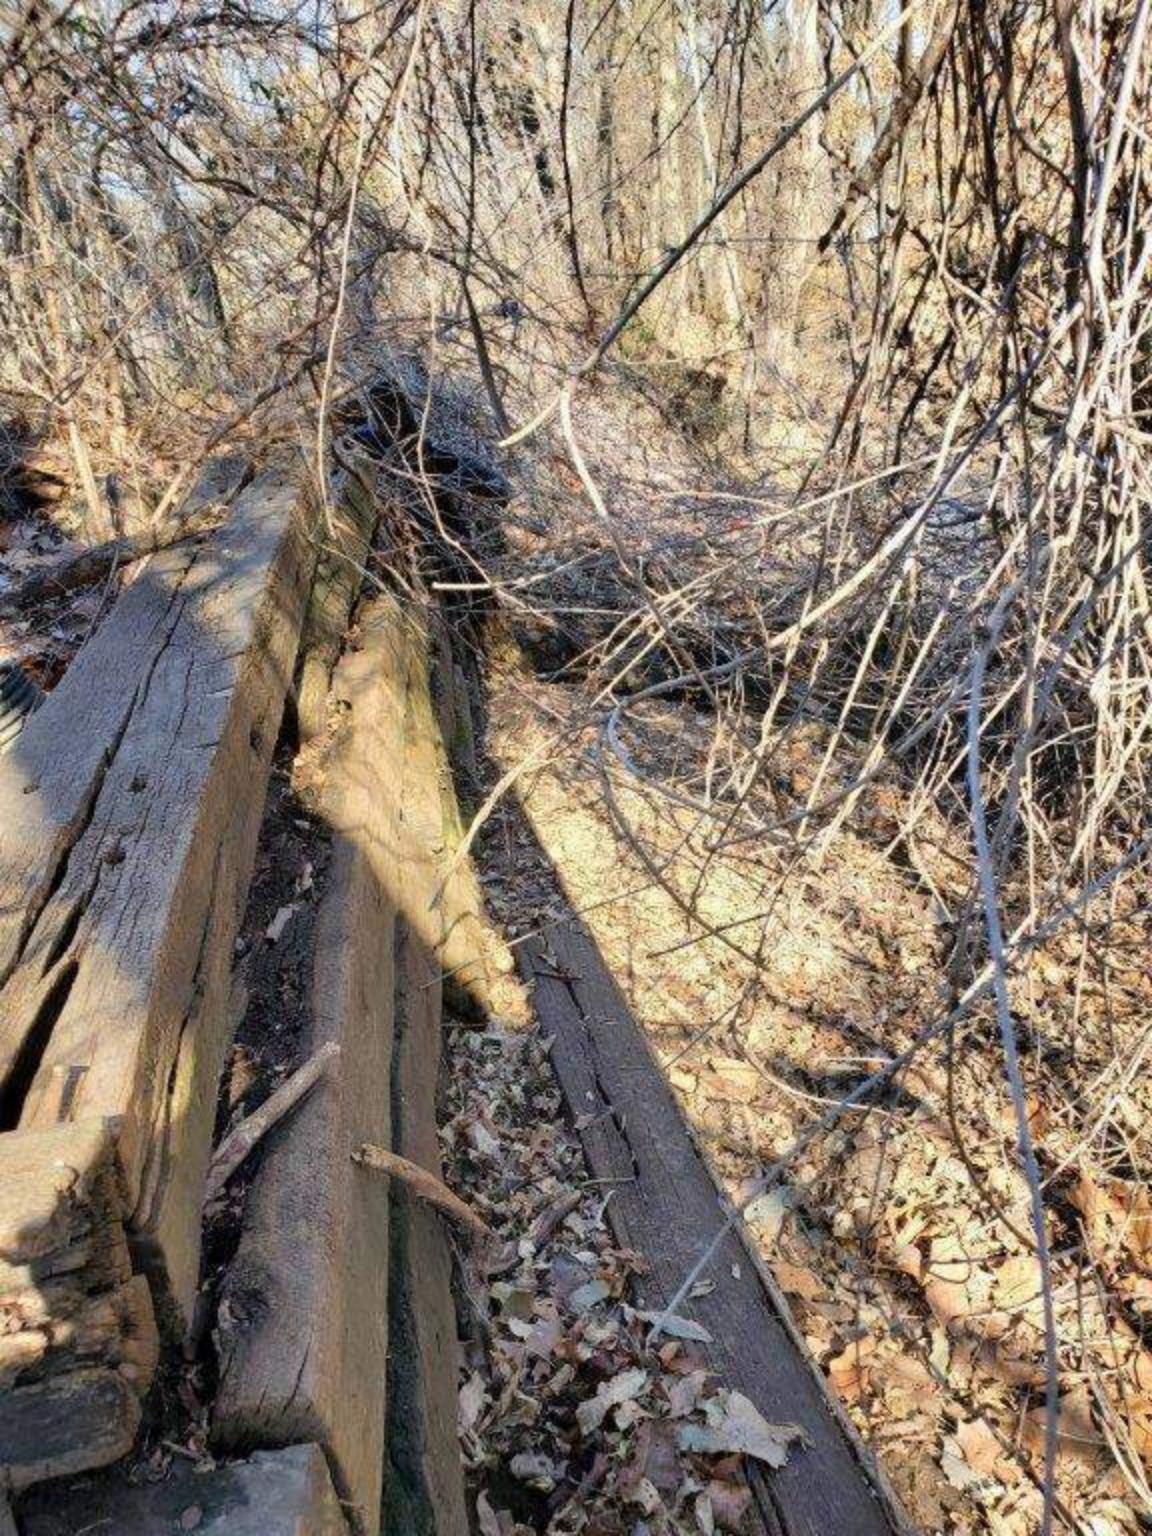
Pipes

The City came out to view the concerns again in November 2023. At that time, it was stated the creek behind the house could be impacting the timber retaining wall causing the soil to wash out and the City would inspect further. The City inspected the timber retaining wall in February 2024. It was noted that there is some erosion along the western bank of Olive Creek, but nothing out of the ordinary for this type of creek. It was also noted that a resident has two black corrugated pipes extending though the timber retaining wall. Below these pipes can be seen an area that has been washed out/eroded by the pipe discharge. This eroded area appears to be undermining the bottom of the retaining wall. The apparent undermining and high creek flows could cause soil to migrate away from the wall and surrounding areas. Also, the tunnels left by burrowing animals could provide a path for the water and potentially increase the amount of soil migration.
