# City of Broken Arrow

## Drainage Advisory Committee

## PROJECT REPORT

DATE:	5/17/22
NAME	Brian Morgan
ADDRESS / LOCATION	315 West Galveston Street
WATERSHED	Haikey Creek
ESTIMATE	\$51,000.00
CASE NO.	22-004

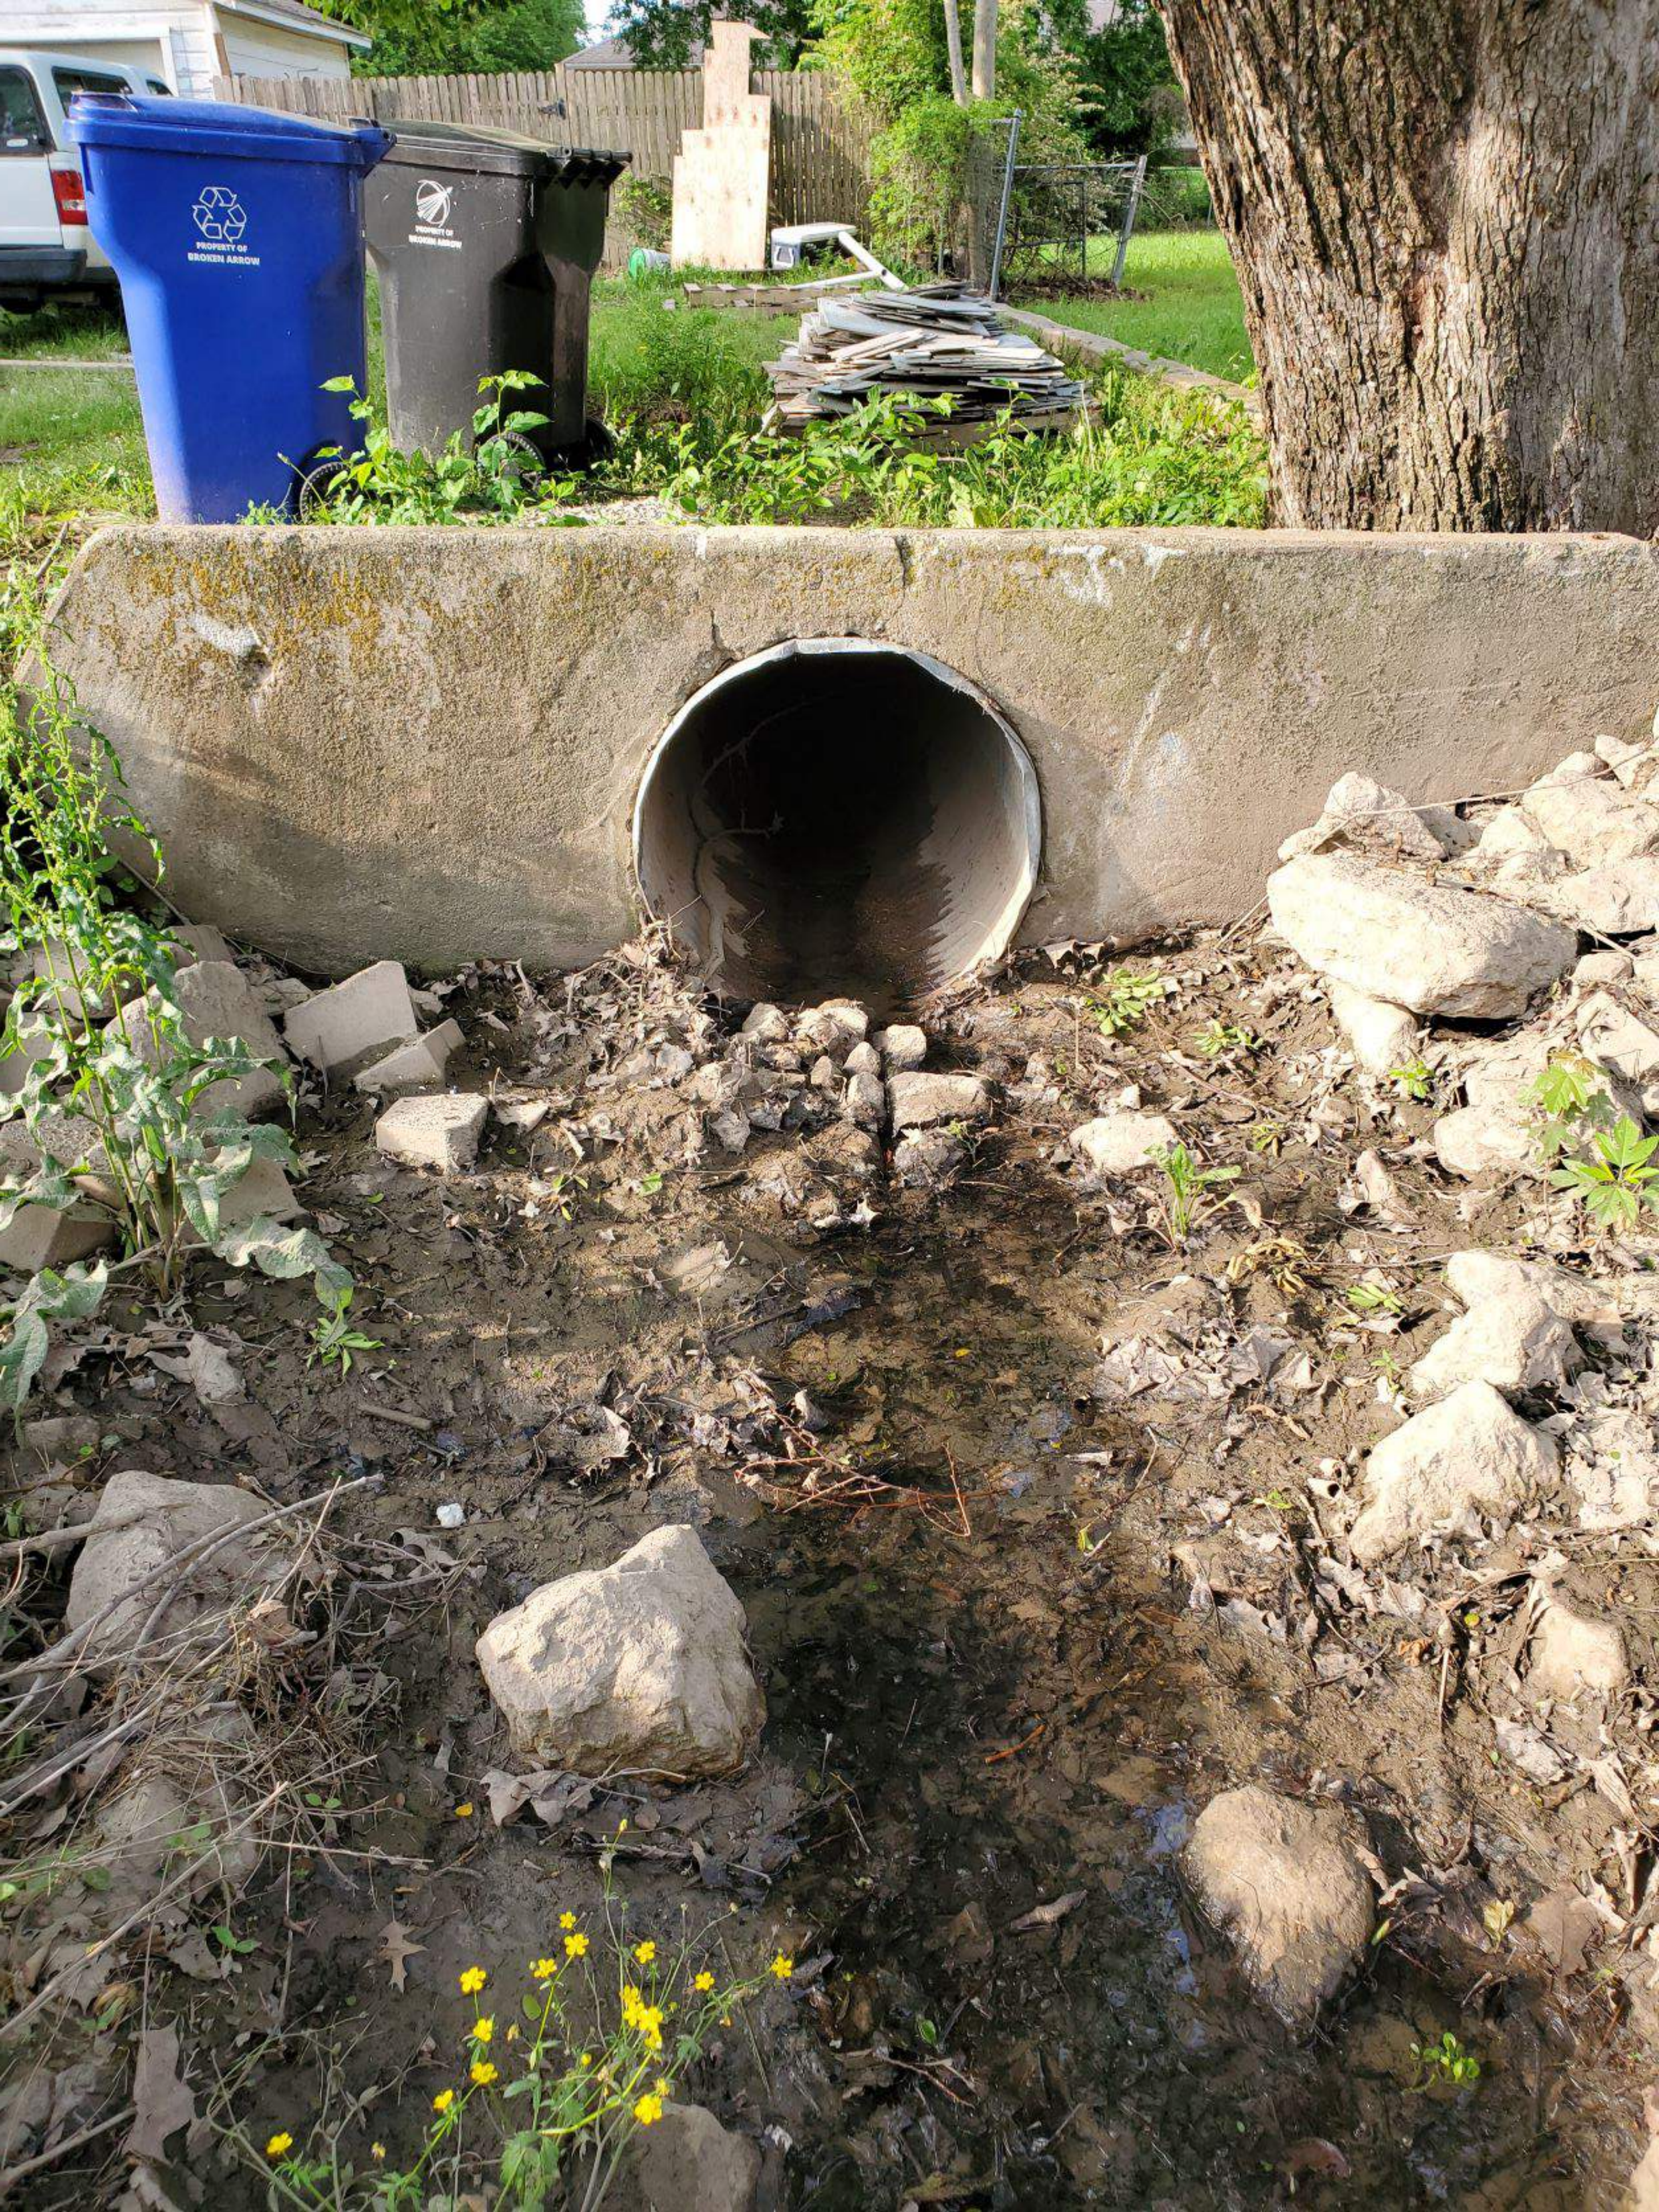
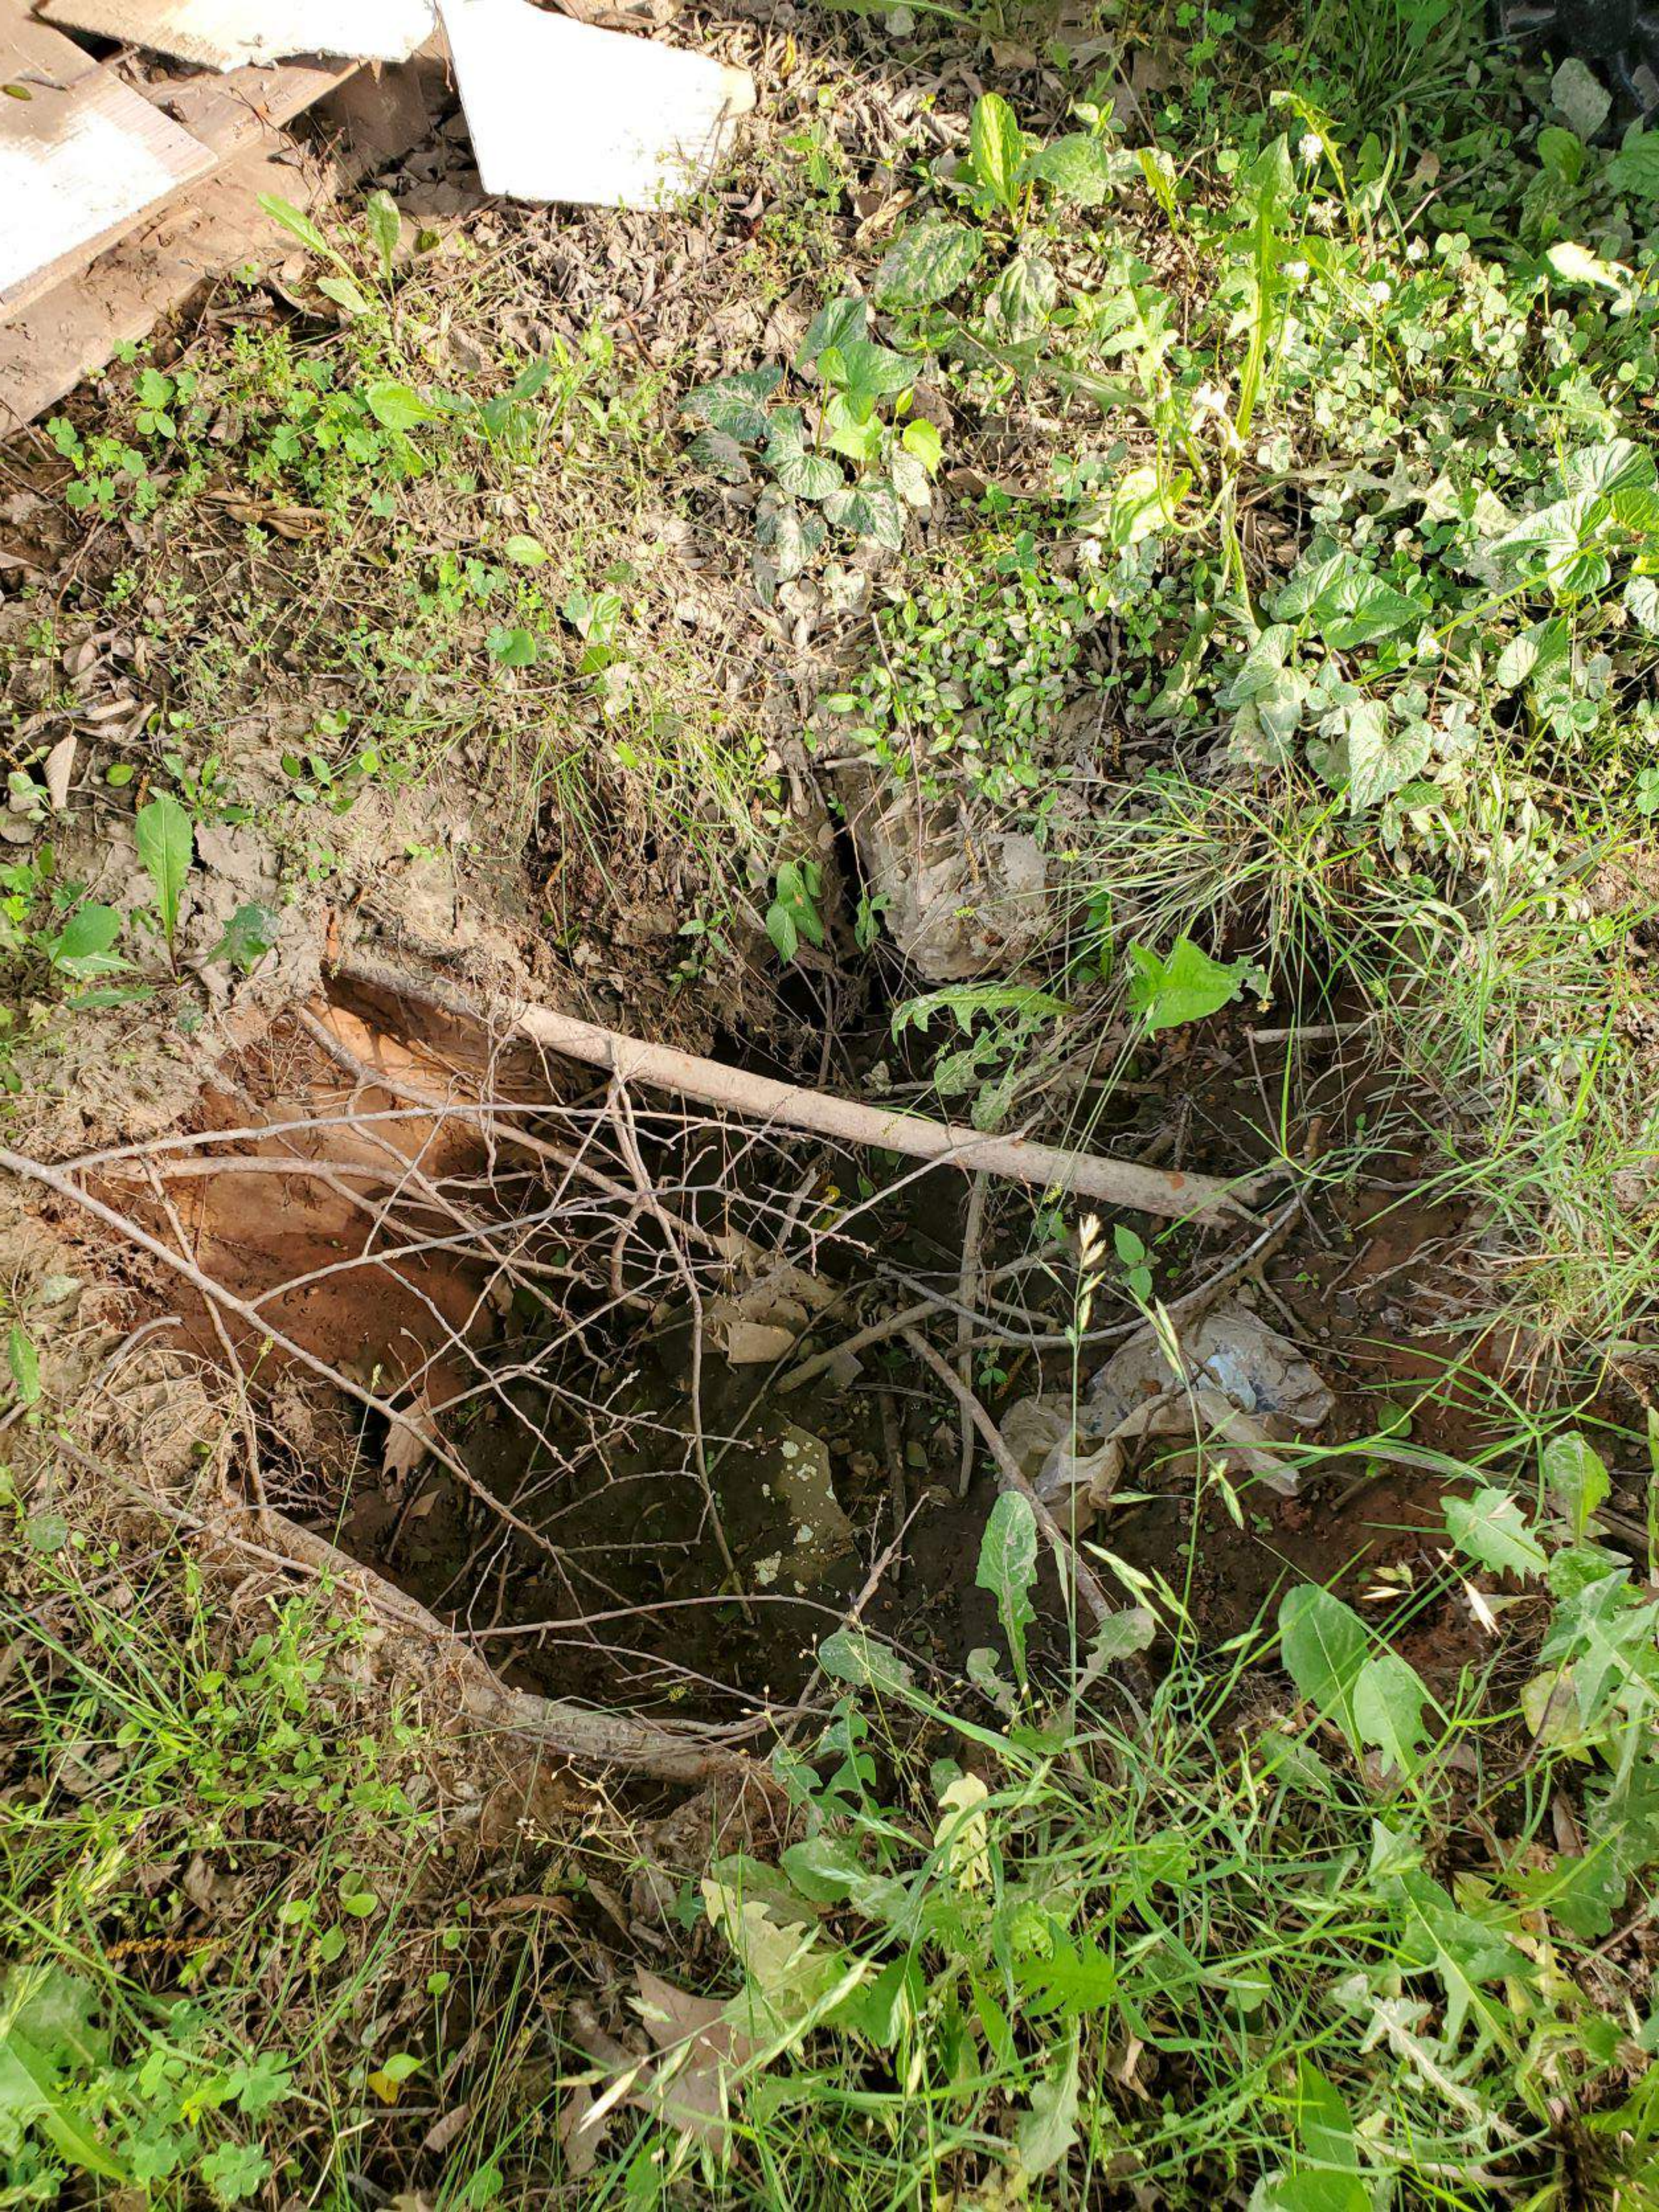
A 36 inch corrugated metal pipe (CMP) was placed in the open ditch in the late 1970's to early 1980's by a previous home owner. Over time the CMP has started to fail and is clogging. The failure is seen through multiple holes forming around the pipe. The clogging of the pipe is restricting the flow and causing localized flooding around the houses upstream of the pipe. The localized flooding is impacting traffic and the roadway has overtopped according to residents.

Corrugated pipe is deteriorating, obstructing flow of drain water. Because of this, the area floods. This includes but is not limited to the yards, driveways, crawl spaces and roads of our street (Galveston) We all love our street and area we live, but the drainage problem is a big problem every time we get a descent rain.

Staff recommend replacing the failing 36 inch CMP with a plastic 36 inch pipe as a maintenance item. This will clear the pipe and allow the water to flow downstream greatly reducing the localized flooding.

Recommend approval of \$51,000.00 for removal and replacement of the existing 36 inch pipe to reduce localized flooding and roadway overtopping.
