# City of Broken Arrow

## PROJECT REPORT

## DALLAS STREET STORM SEWER IMPROVEMENTS

## STORM SEWER PLAN & PROFILE

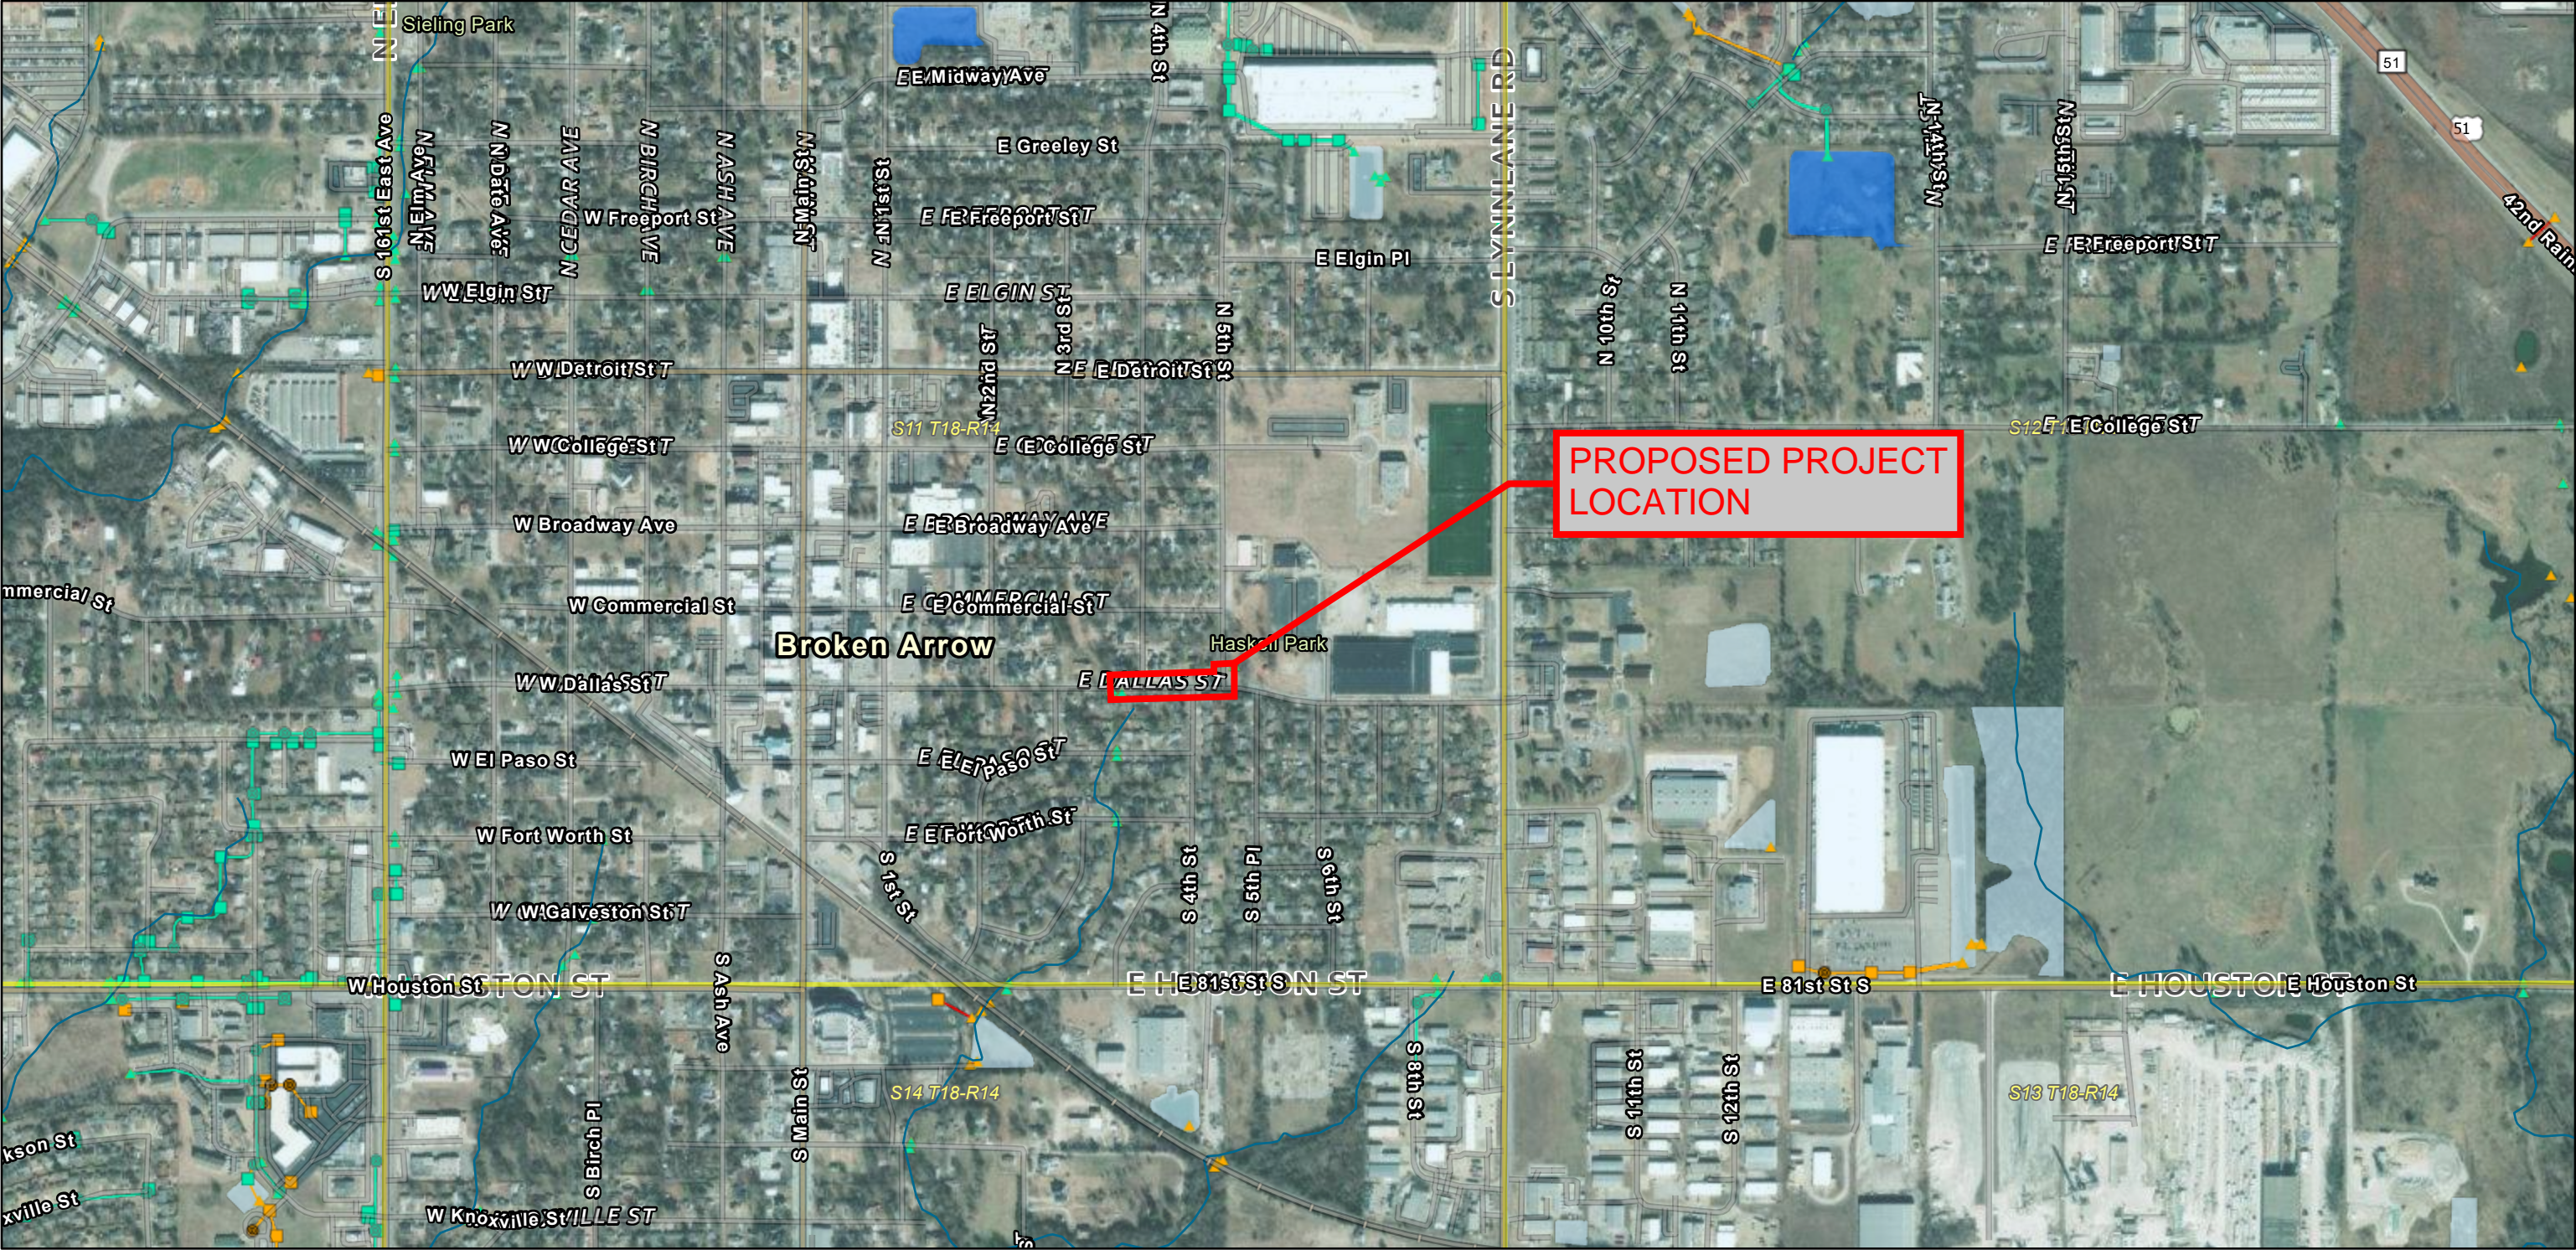
Aerial

E Dallast St
