City of Broken Arrow

Drainage Advisory Committee

PROJECT REPORT

DATE:	04/11/2024
NAME	Nathanael Kohl, PE, CFM, Stormwater Project Engineer
ADDRESS / LOCATION	3321 W Commercial St
WATERSHED	Haikey
ESTIMATE	\$30,000.00
CASE NO.	24-005

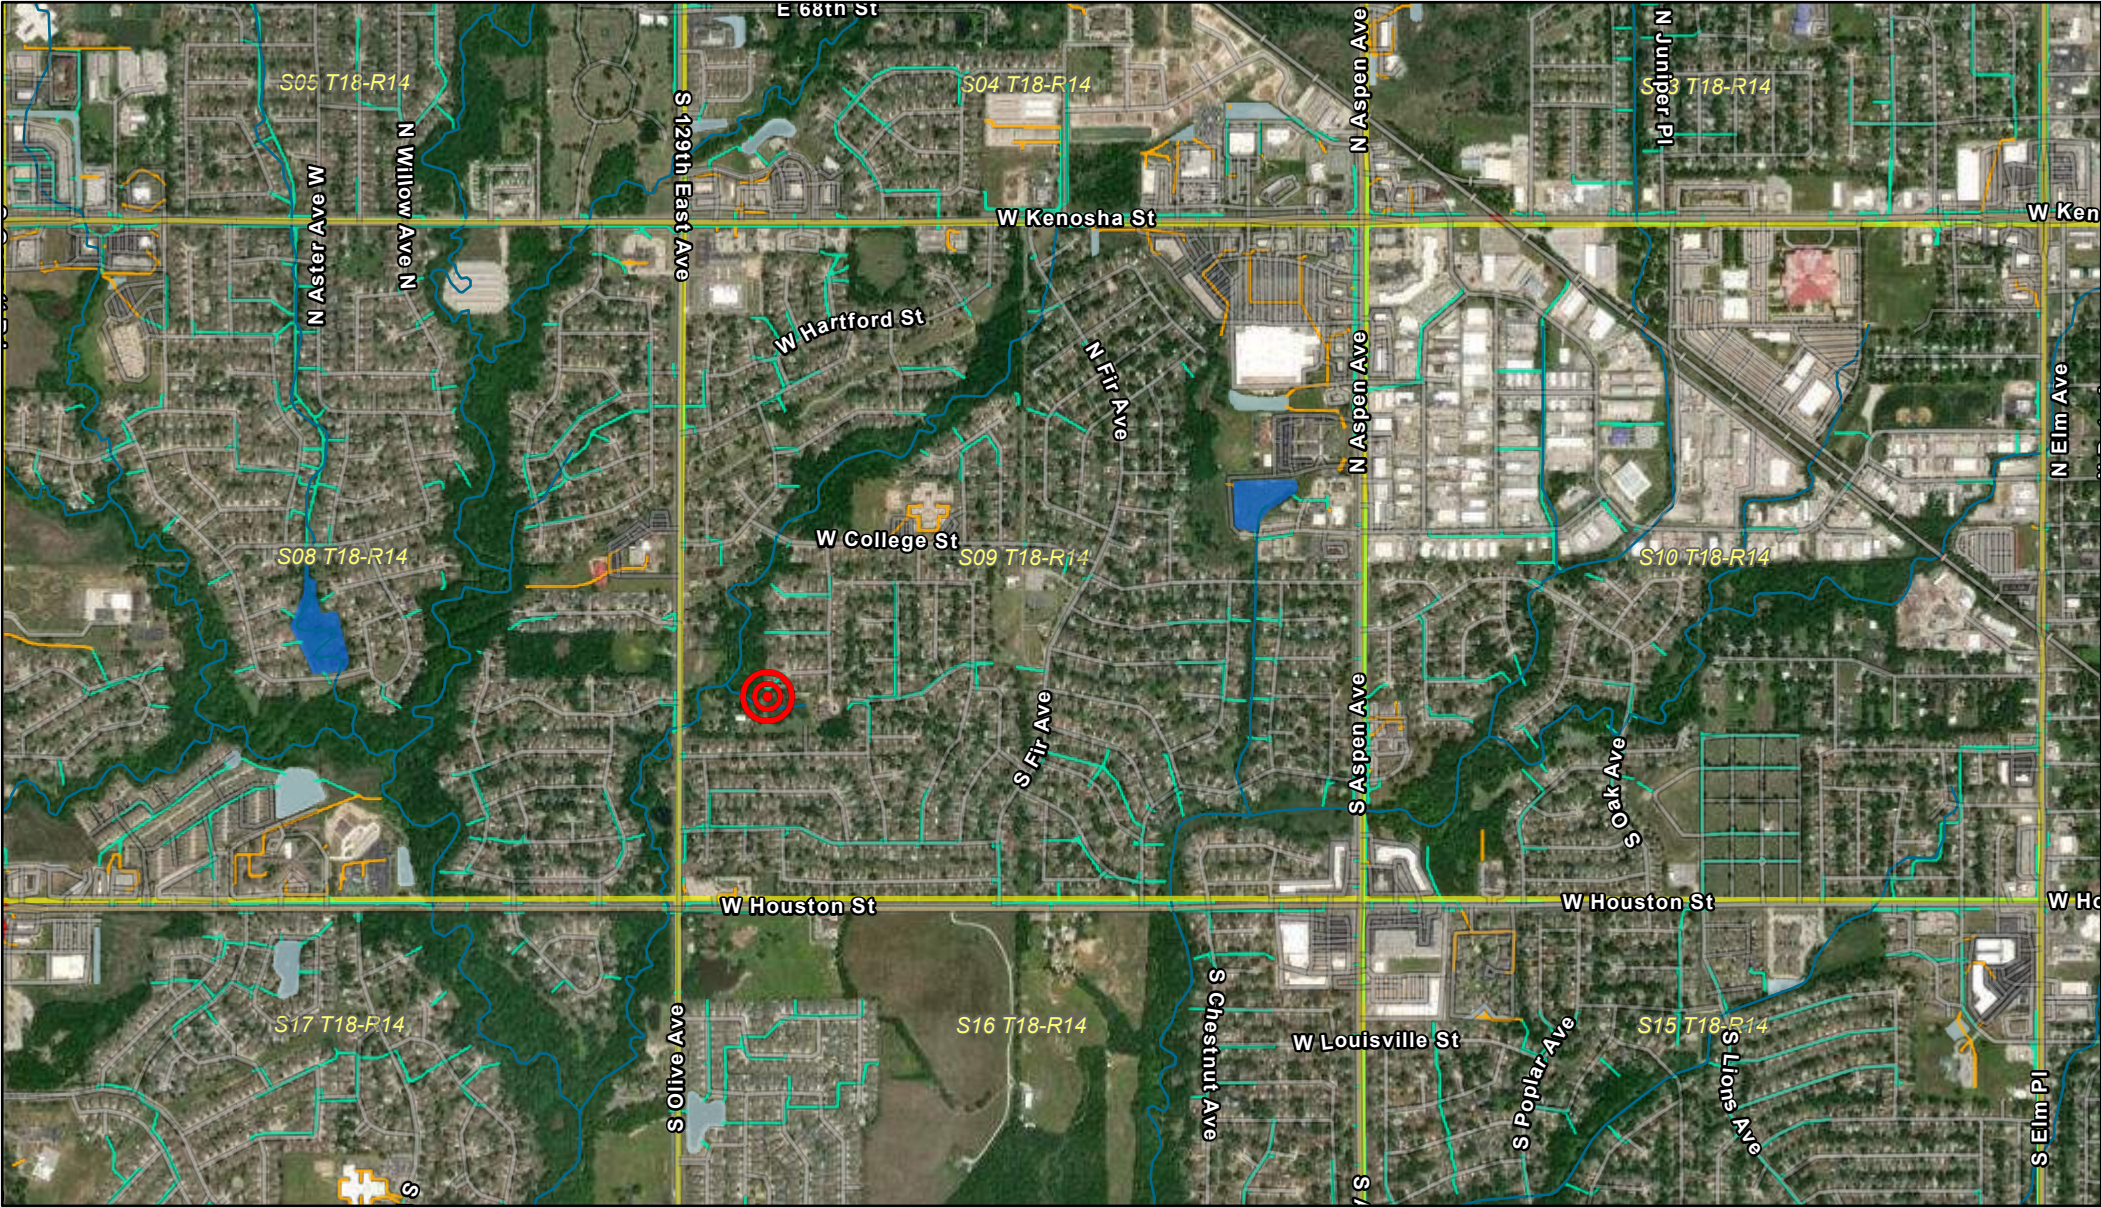
Hyam Pond Outlet Location

In 2012, the City of Broken Arrow designed and constructed a project to extend a storm sewer from S Lewis Ave to the Creek behind 3321 W Commercial St. As a part of this project a new outfall was constructed on the pond to the south. The outfall was designed to release the water from pond at a rate equal to or less than the existing rate. An easement was not able to be acquired from the property owner to the west.

Therefore, the outfall structure was moved 25 ft east and released in the channel behind 3321 W Commercial St.

Recommend approval and expenditure of \$30,000.00 design funds to be used to design a new outlet system for the pond.

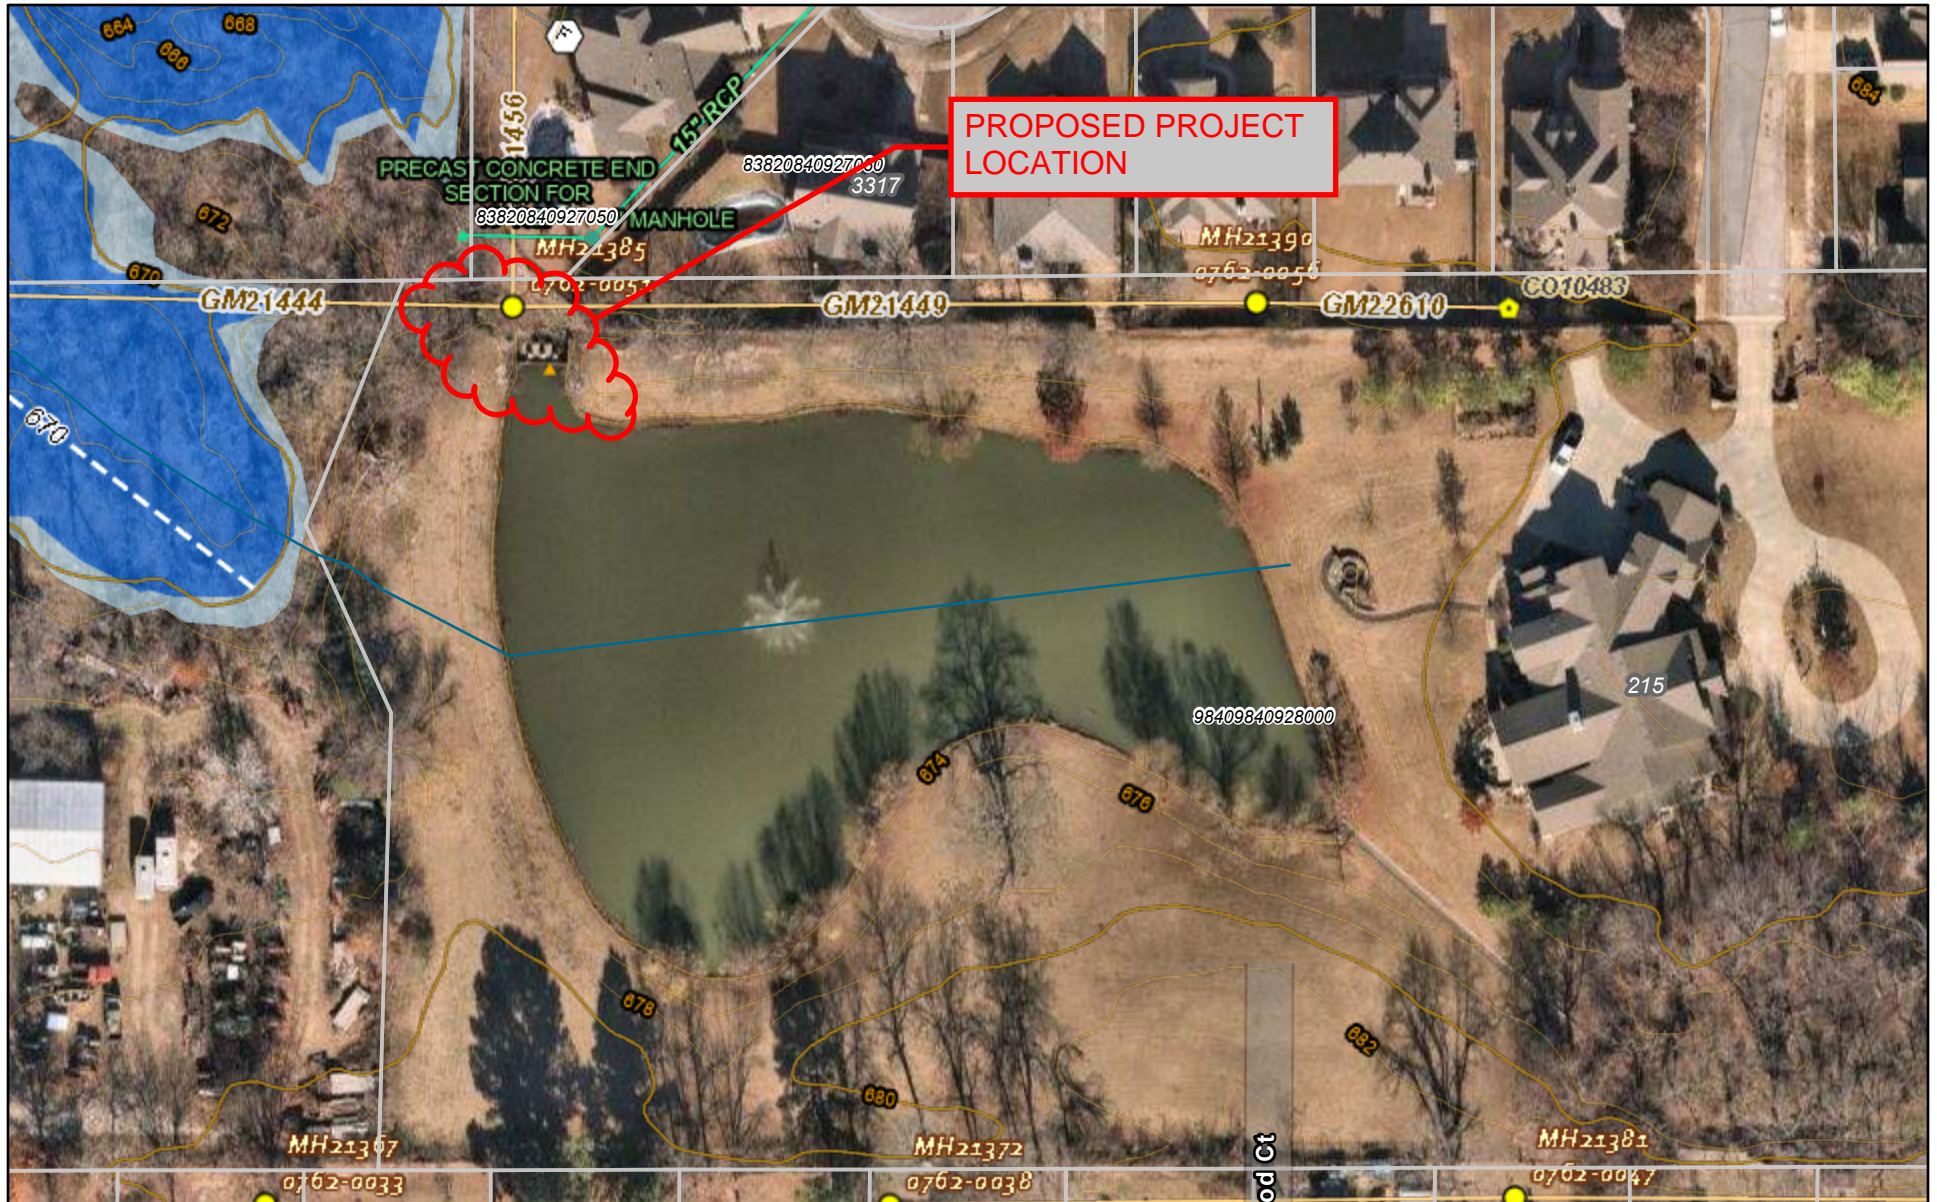
Pond Outlet

A citizen contacted the City asking for help regarding the channel behind his house. The applicant stated that the water from the pipe and outlet flows across the back of his and the neighbors property causing costly erosion along the channel. The channel is eroding along the property line and causing the applicant a sum of money to try to combat.

To redesign the outlet to lessen the erosion and stabilize the bank of the channel to Haikey Creek.

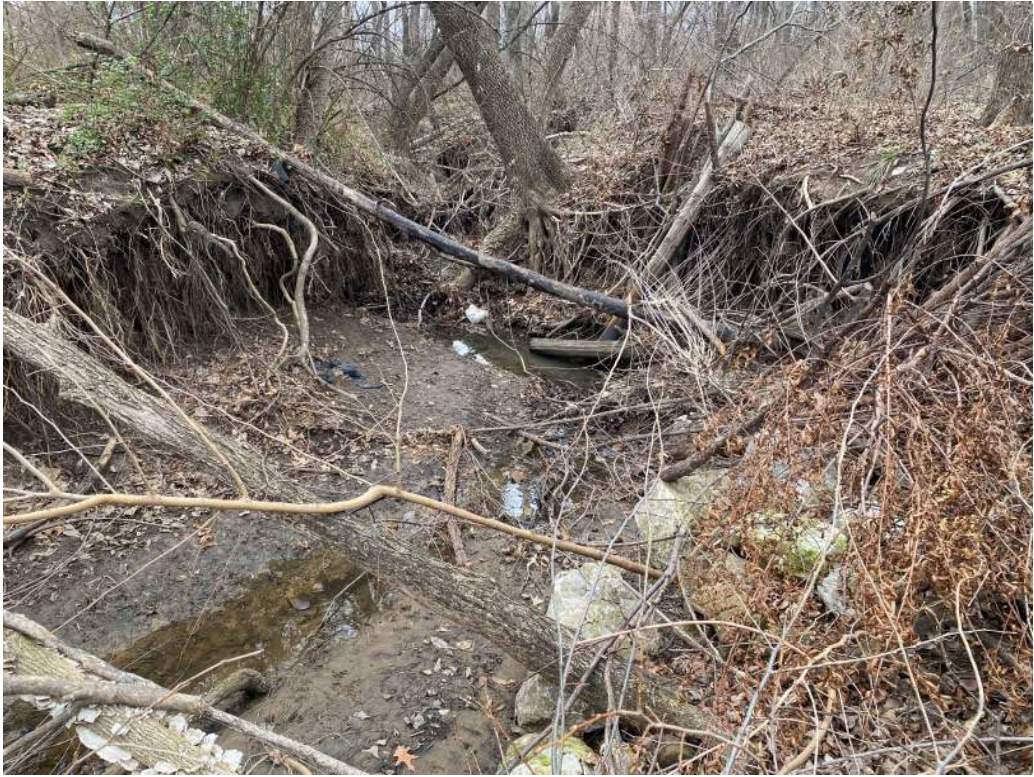
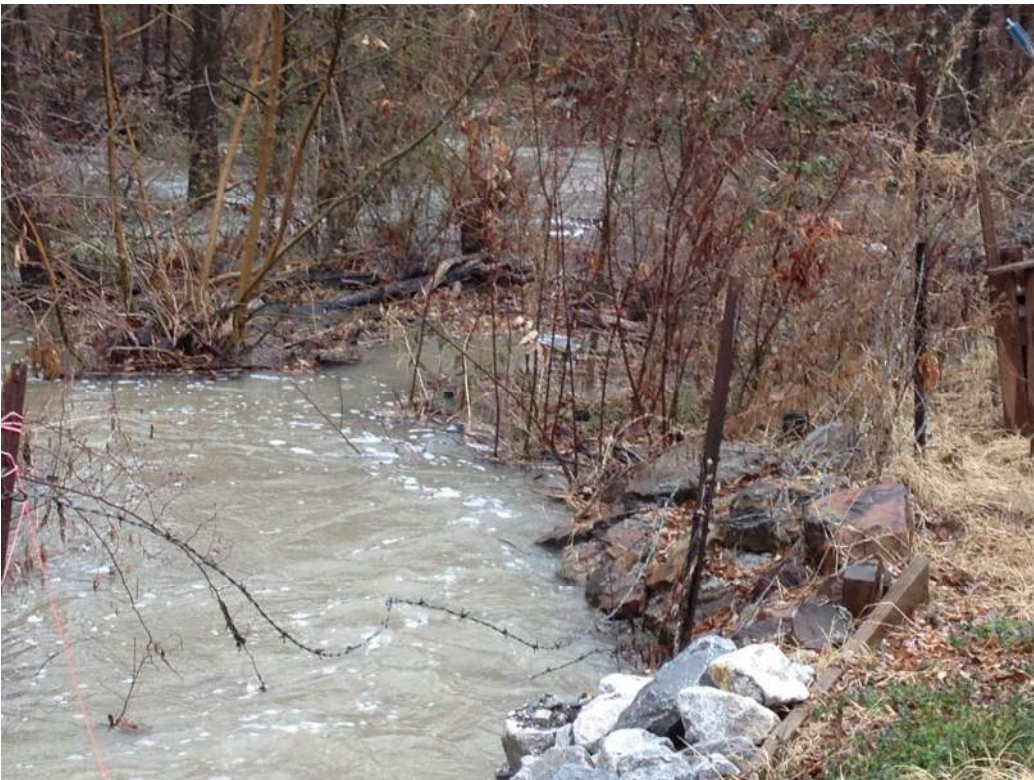
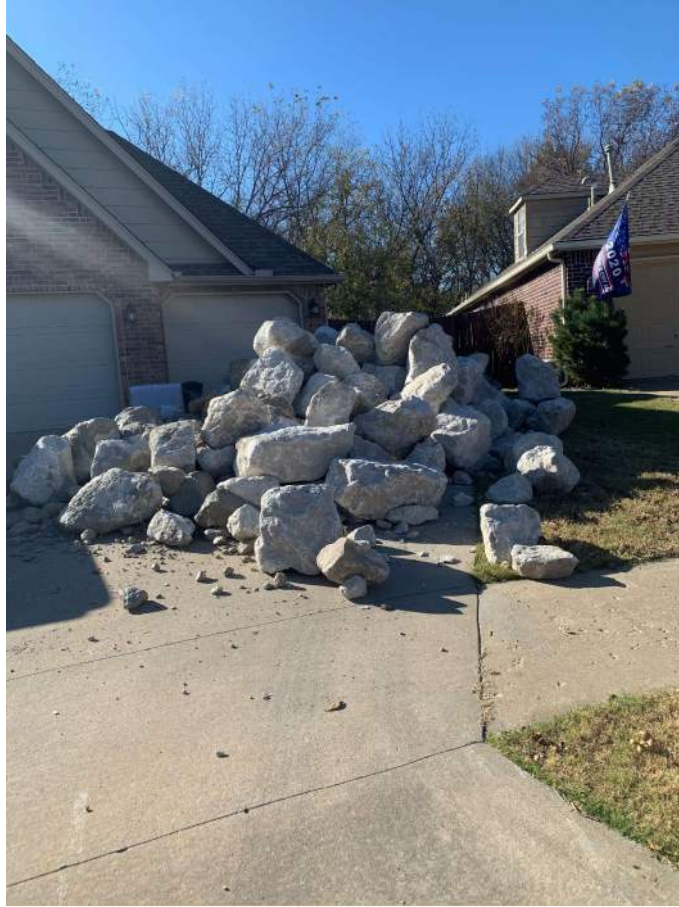
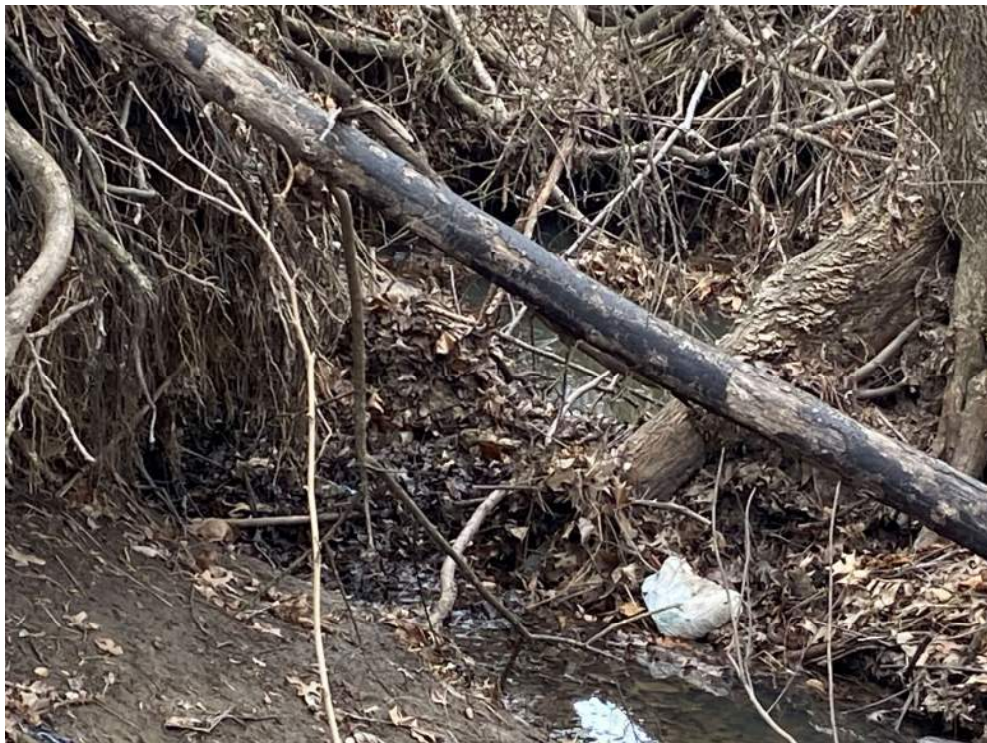
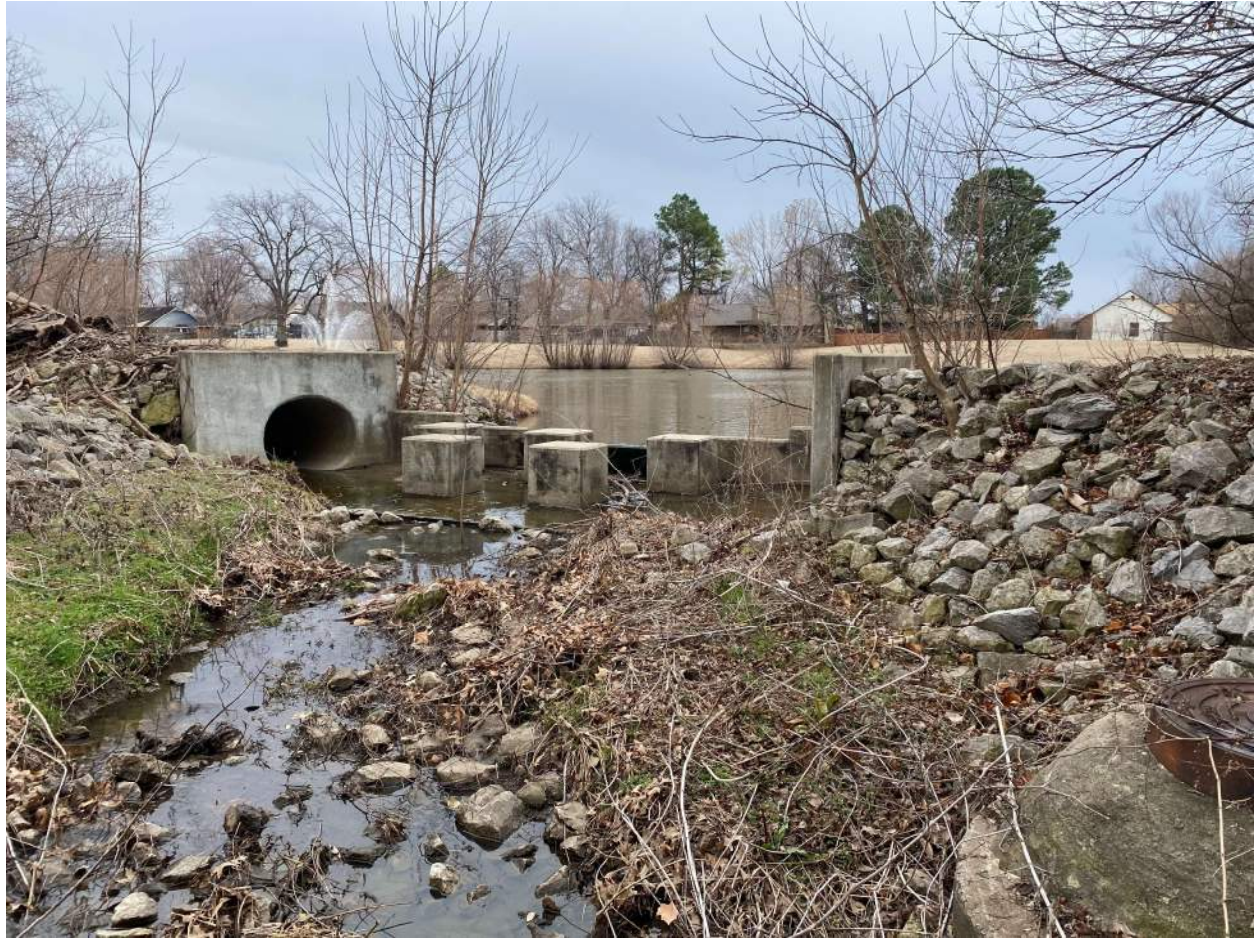
Severe erosion. 50 ft cut out. 15 ft deep / trees down etc, issues for 17 years, We have somehow maintained the creek at great expense (more than \$10000 over last 10, but behind us the erosion gets closer and enlarged made worse some years back when even more water was put through creek -Pond was also enlarged and we were told some 50acres of water would now drain through the creek, we have spent thousands of dollars trying to keep the erosion off our property and have multiple times had to rebuild our property line. The entire creek was dug deeper by BA about 10 years ago, and all the work they did quickly washed away (Rif Raf disappeared quickly, washed away. There is a sewer line that city raised another 12" when you dug out the creek, but all of this... can go underwater. Similar issues too at adjacent street drain with chronic erosion of the silt like soil. Spring rains are somewhat terrifying! Please just go through all the pictures or refer back to the many visits.
