# City of Broken Arrow

## Drainage Advisory Committee

## PROJECT REPORT

| ADDRESS / LOCATION | Preserve Park Detention Pond, Broken Arrow |

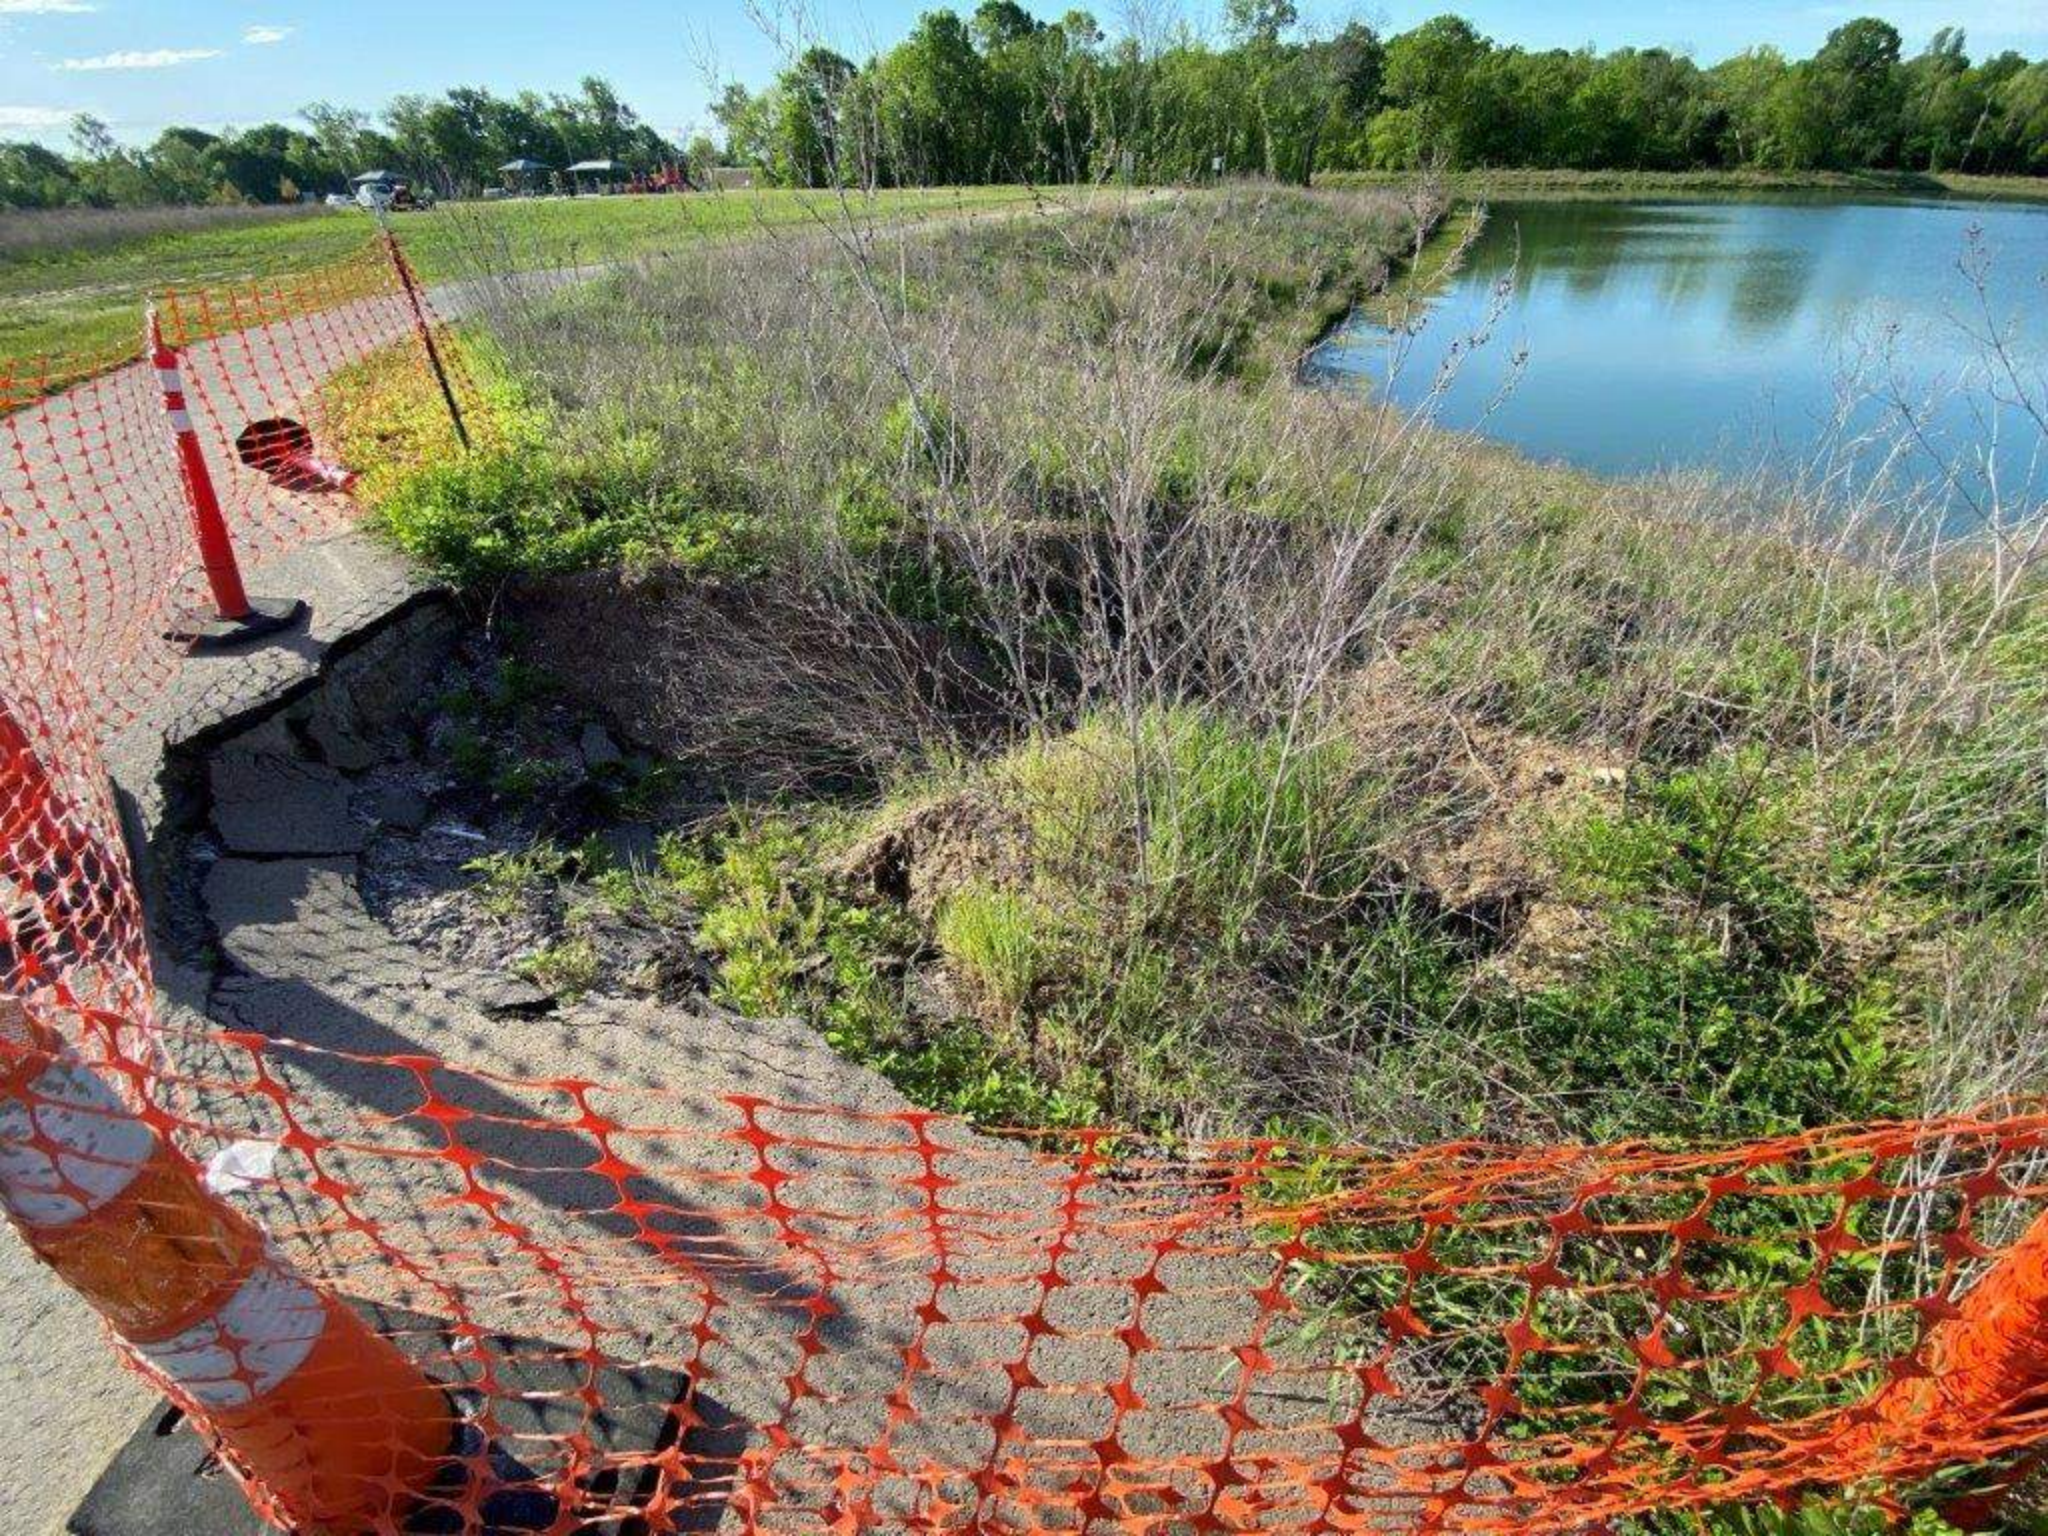
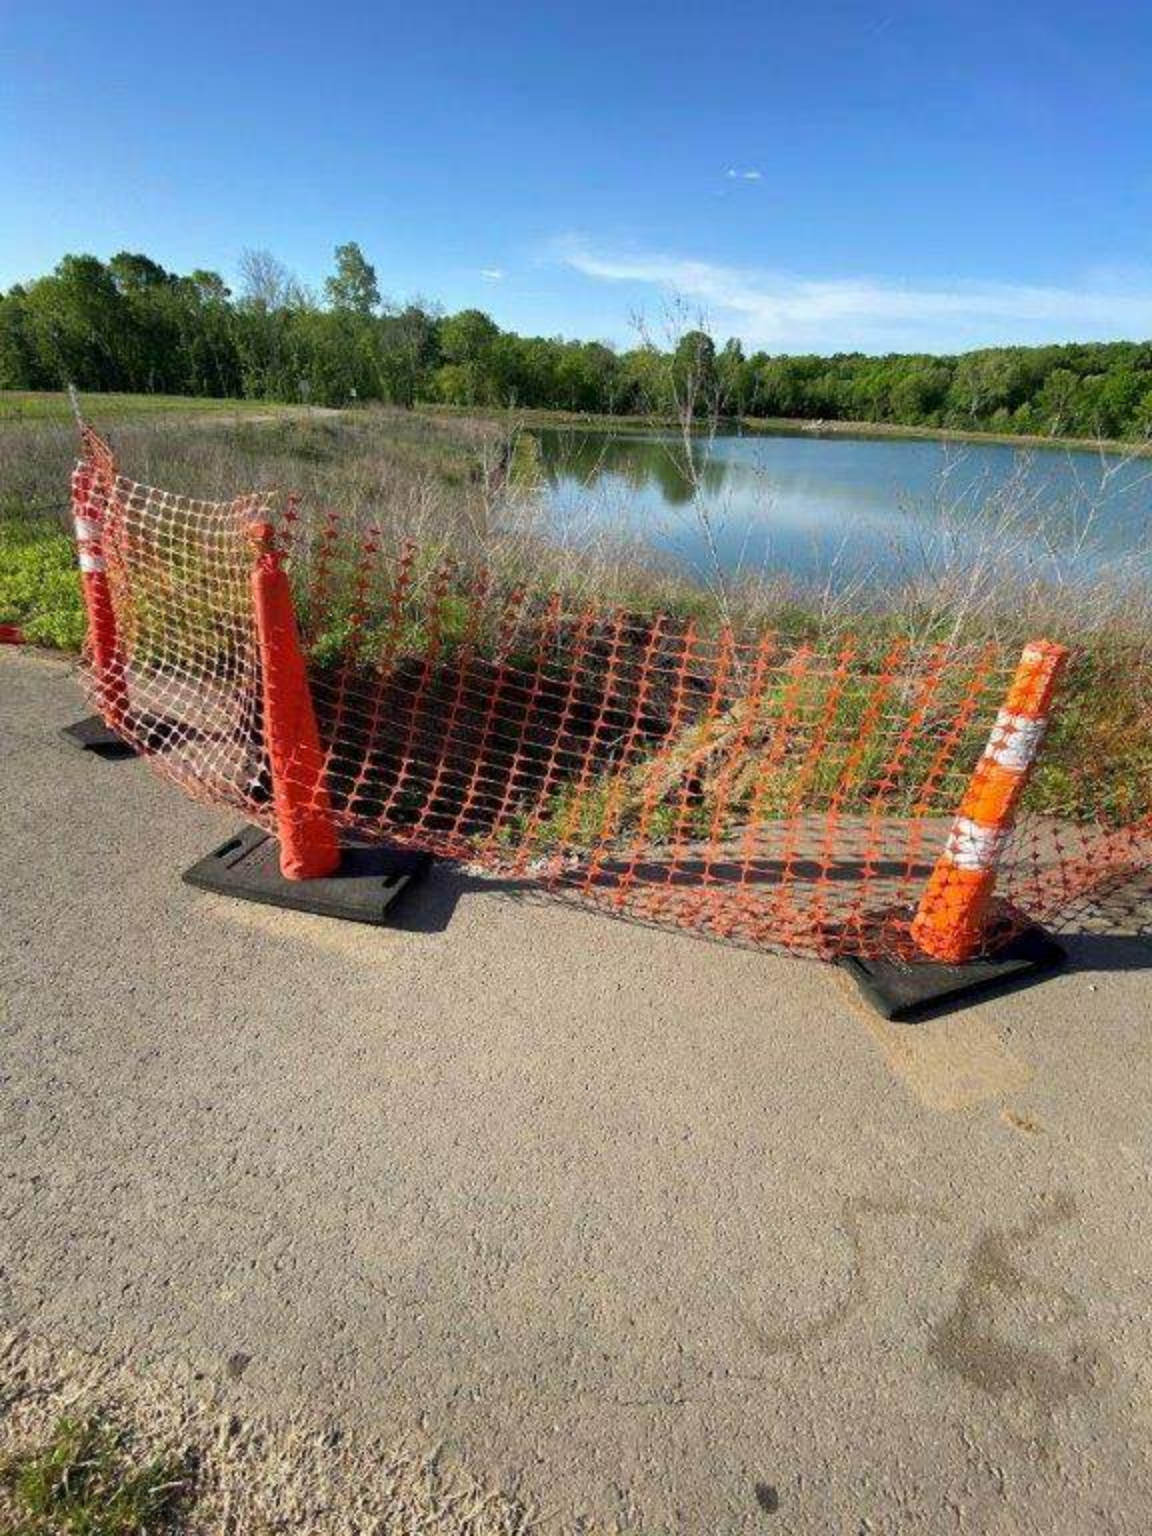
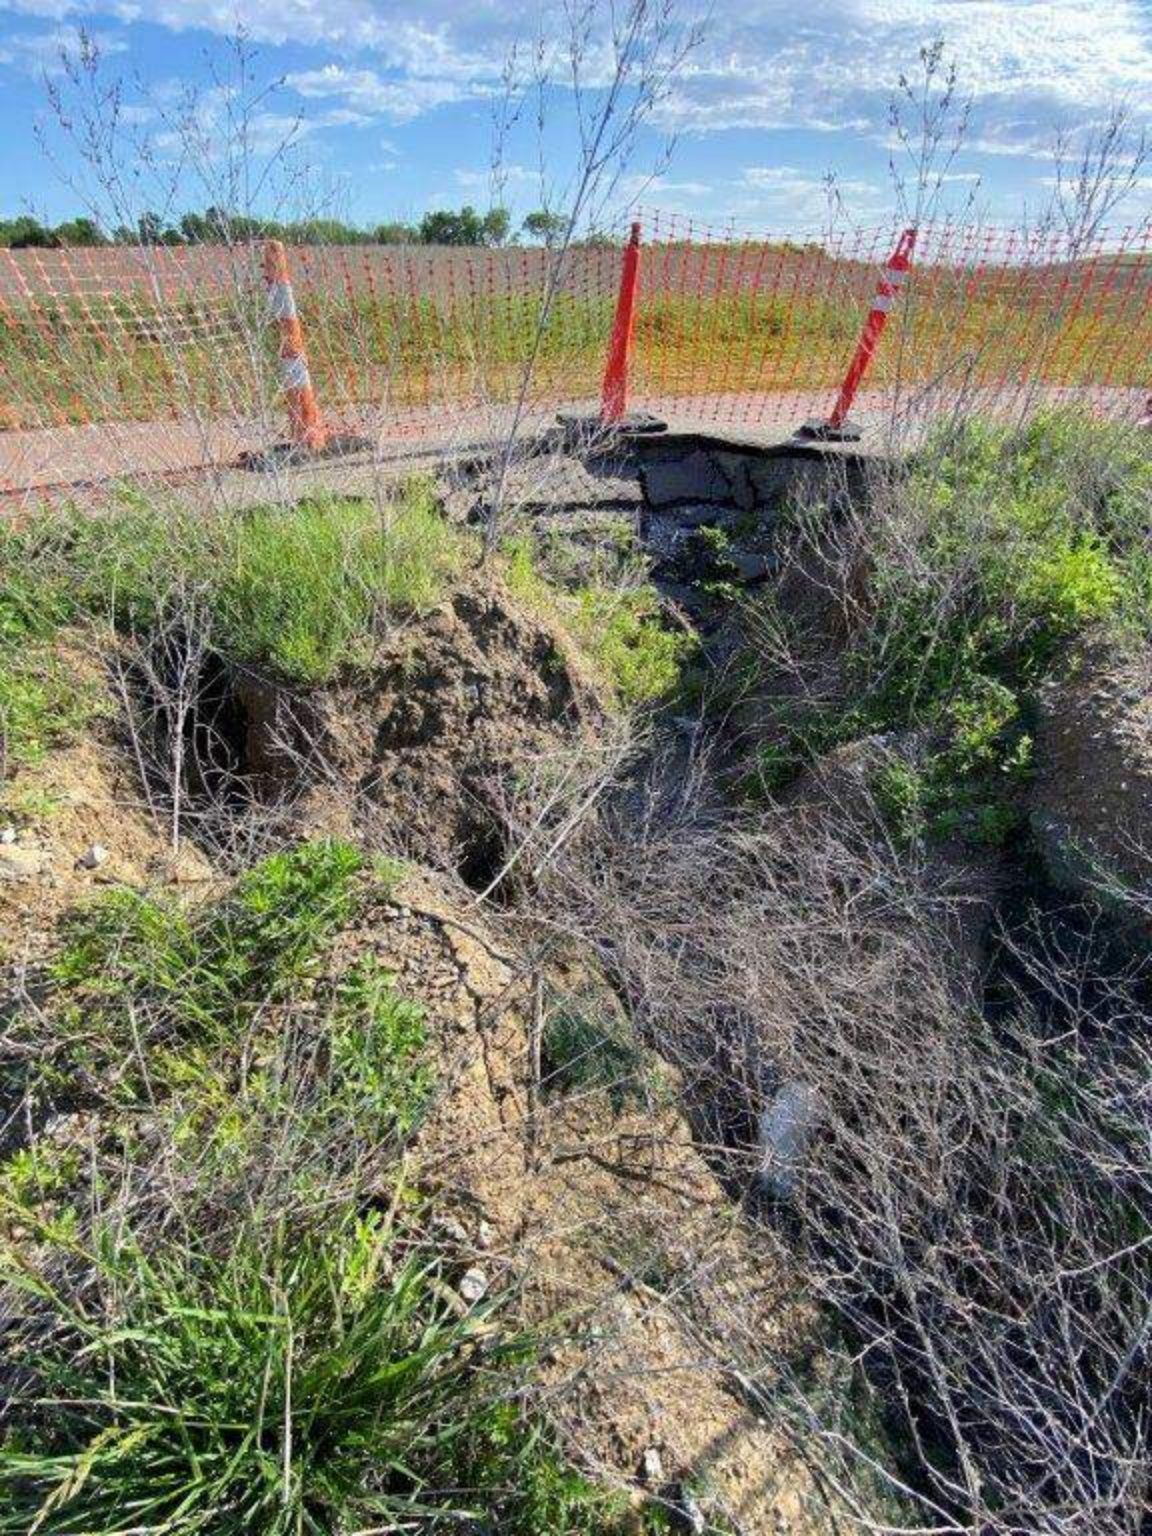
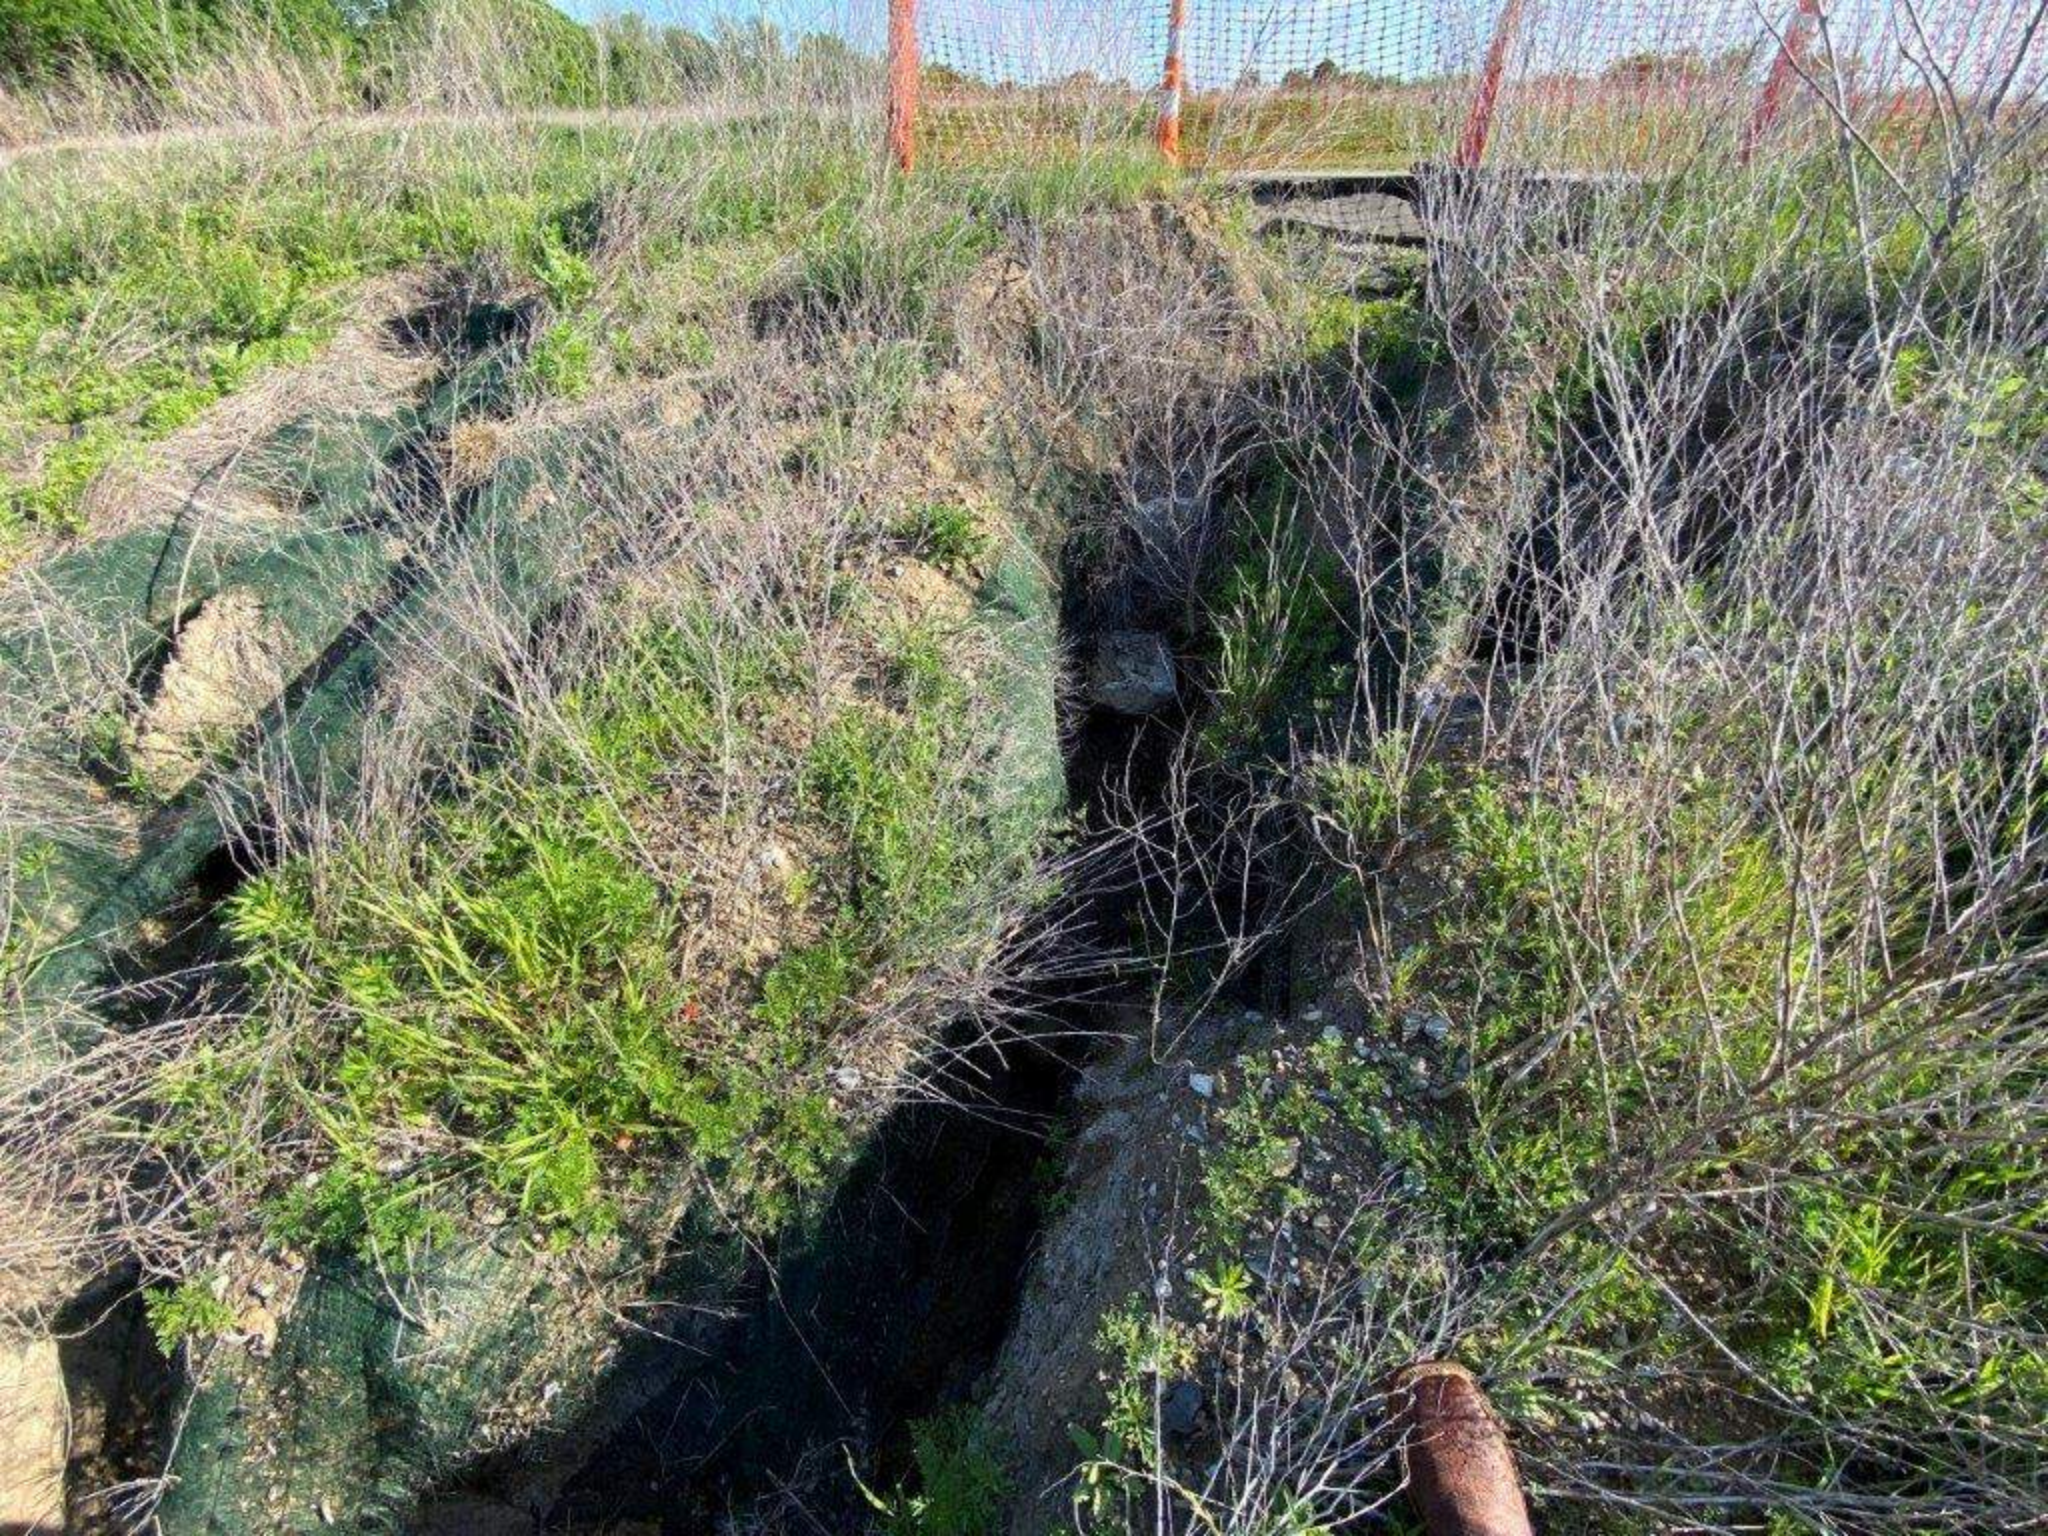
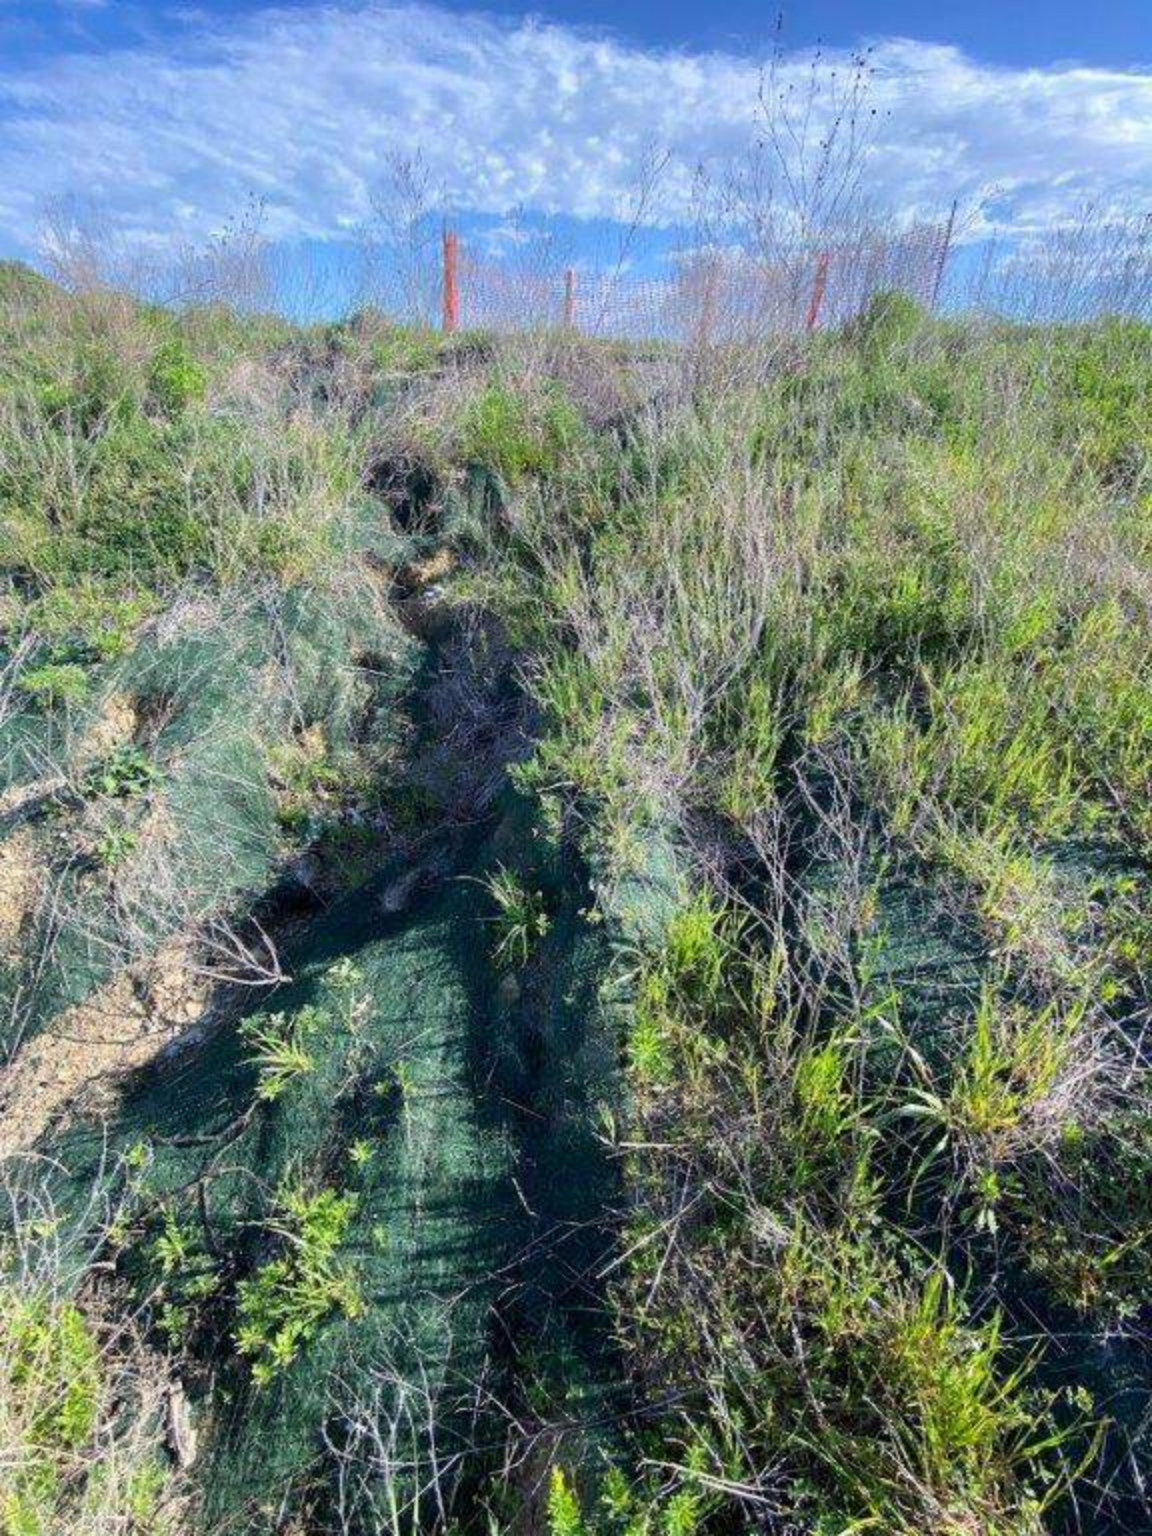
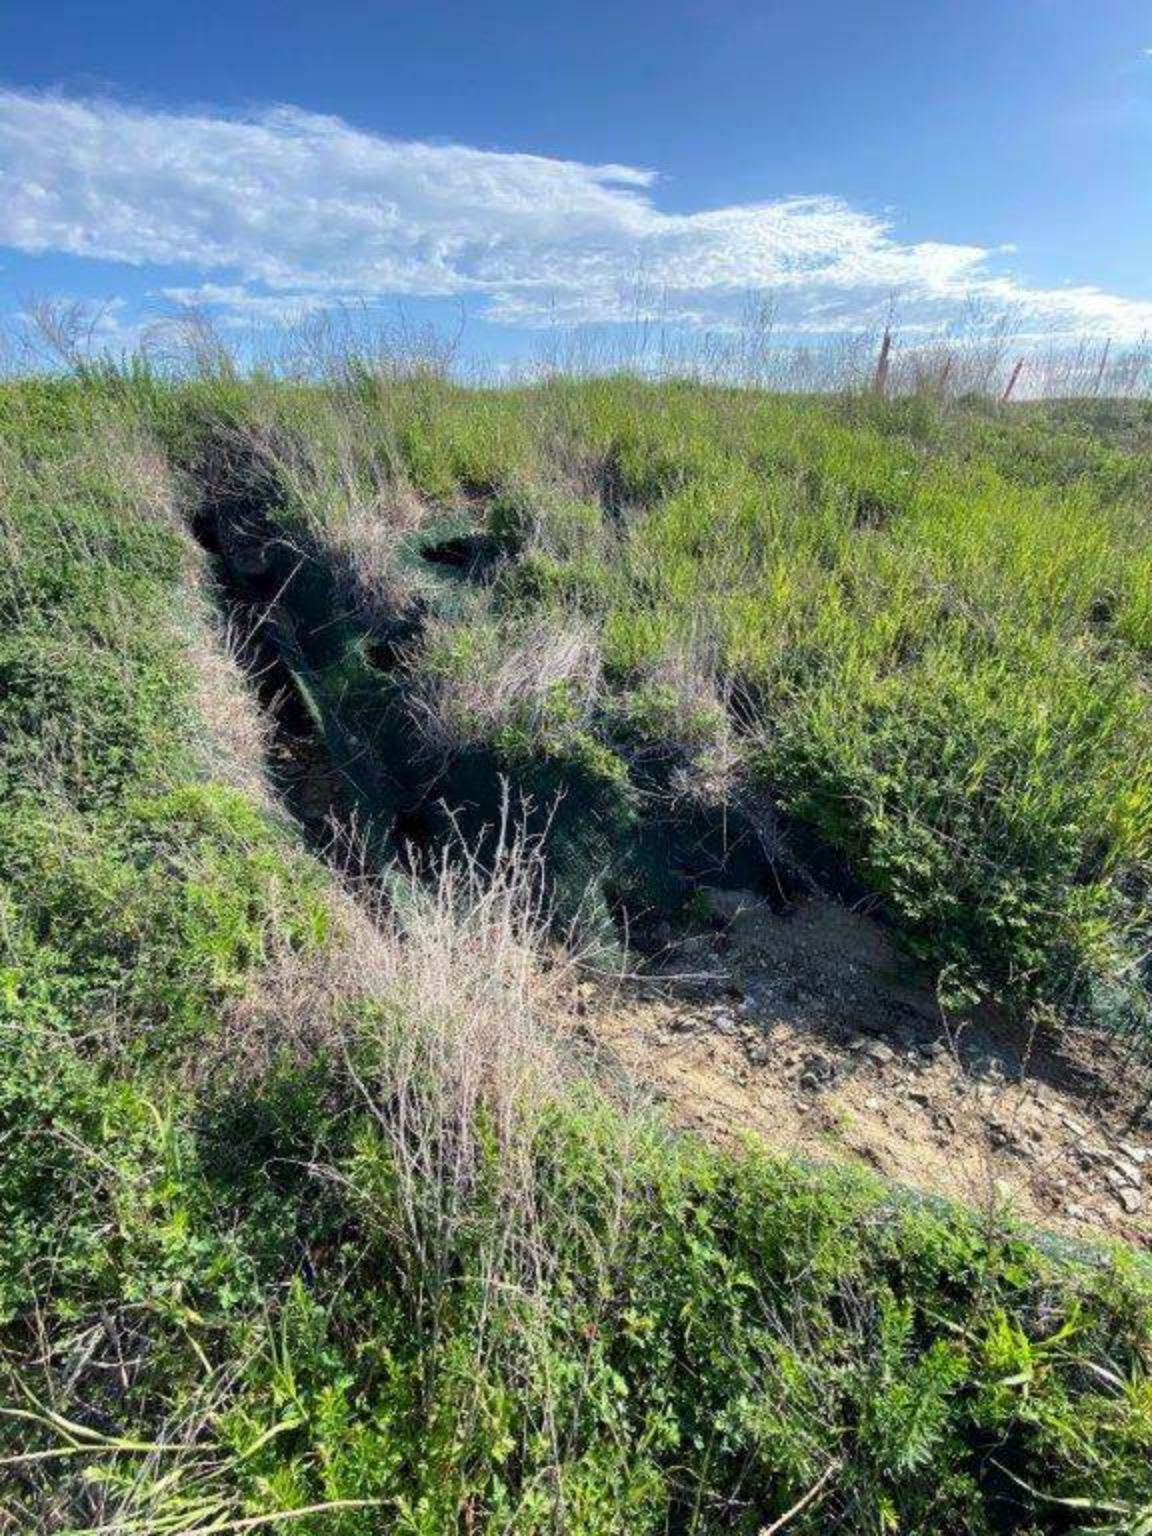
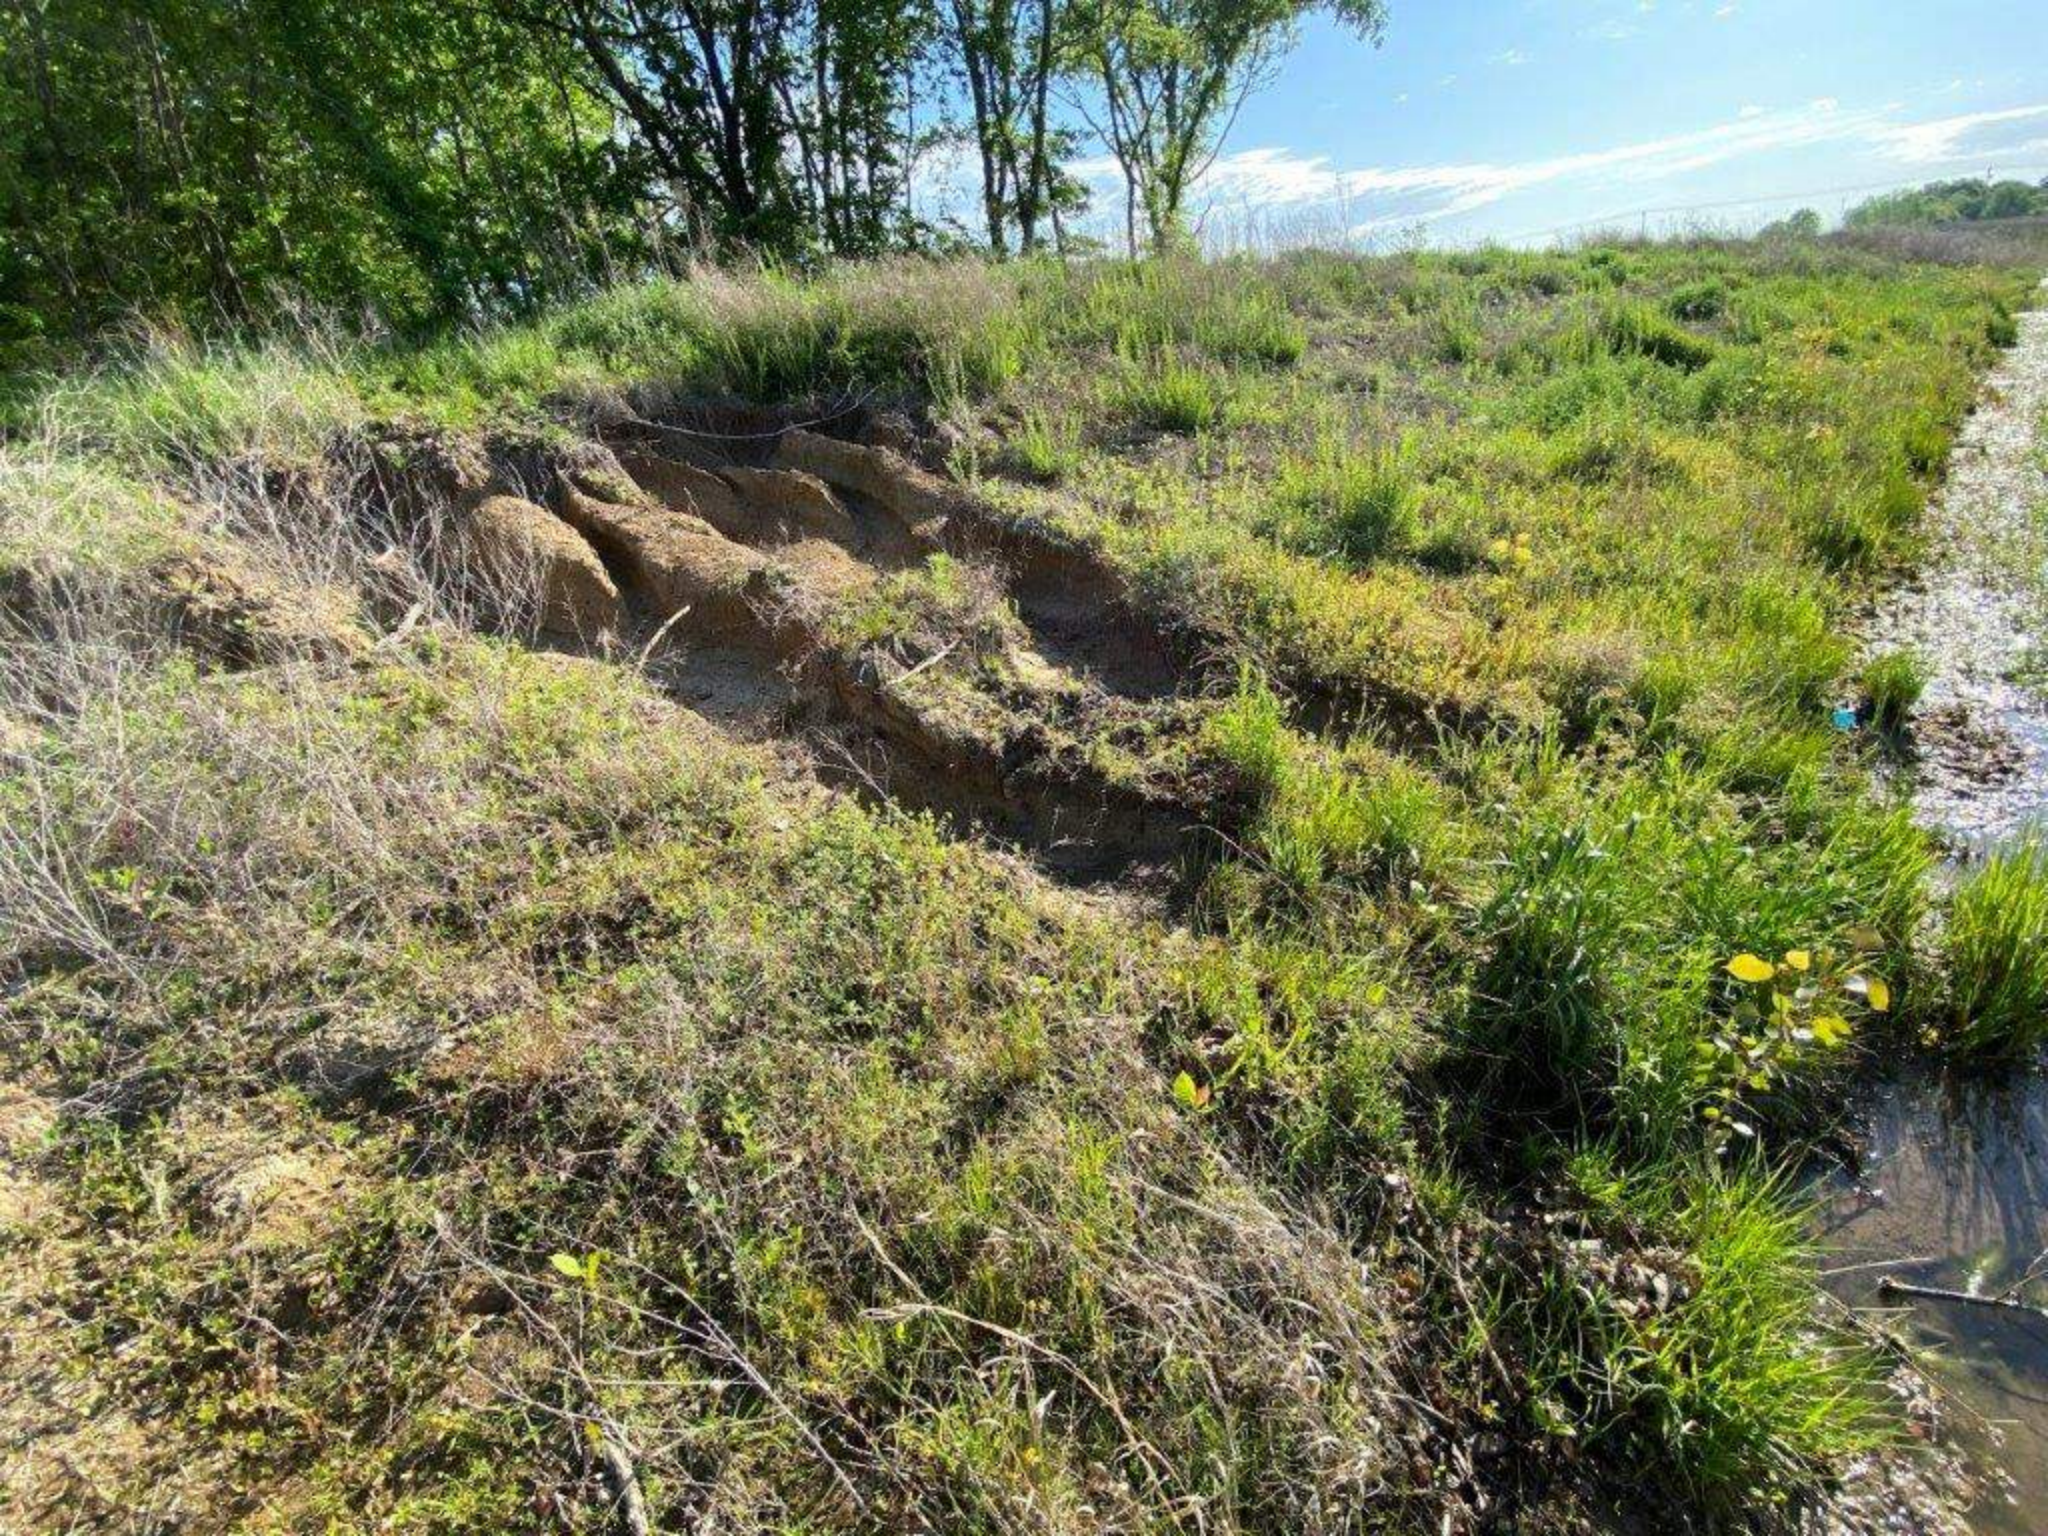
The Preserve Park (37<sup>th</sup> St) Detention Pond is located in Northeast Broken Arrow. The path and the north bank have eroded.

Staff investigated the site and found that the walking path was eroding due to a substantial amount of sheet flow over the path. The flow had also eroded the bank of the pond causing very large gullies to form in the bank. The asphalt path is also eroding and falling into an approximate 3-foot hole. The staff also found that an offsite berm holding water adjacent to the pond has been cut and the flow is eroding the path at that location. On the northwest side of the pond, water builds up and flows over the path and has severely eroded the shore and is starting to erode the asphalt path.

City Staff has designed plans to mitigate and repair these concerns.

The estimated construction cost to install an interceptor ditch, inlets, storm sewer pipes, repair the shore, repair the asphalt path, and other mitigation items is approximately \$325,000.00 in 2024 Dollars.
