City of Broken Arrow

Drainage Advisory Committee

PROJECT REPORT

DATE:	October 16, 2025
NAME	Jerry Wilkins
ADDRESS / LOCATION	8451 S. 9 th Street
WATERSHED	Broken Arrow Creek
ESTIMATE	\$75,000
CASE NO.	25-019

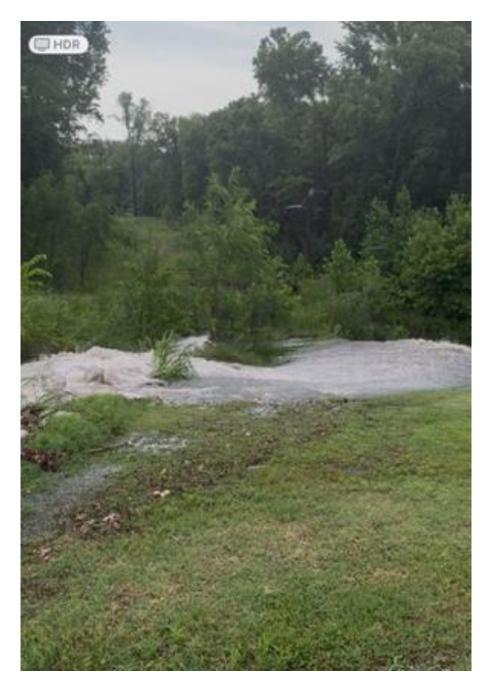
Picture 1: Overflow Weir Channel from Private Pond looking upstream Broken Arrow Creek

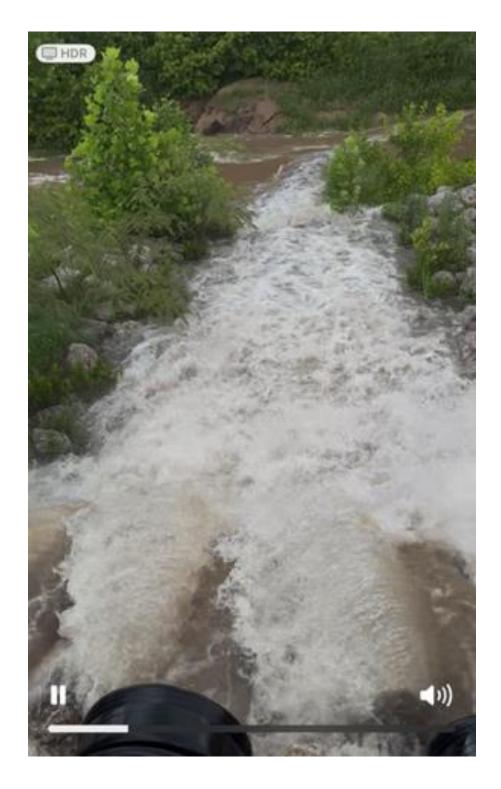
The property was developed in 2021/2022. There are no engineering plans on file for the design of the existing pond to verify it was built to handle the incoming flow. The outflow structure does not appear to be able to handle most storm events efficiently. Also, there is a sanitary sewer manhole in existing outlet structure. The existing sewer in this location is a 60-inch trunk line that is the city's main line to the wastewater treatment plant located just downstream of the applicant's location.

Picture 2: Private Pond outlet looking east towards Broken Arrow Creek

The proposed project will be to design drainage improvements along Natchez to mitigate the overland flow and analyze the pond outlet structure for potential improvements.

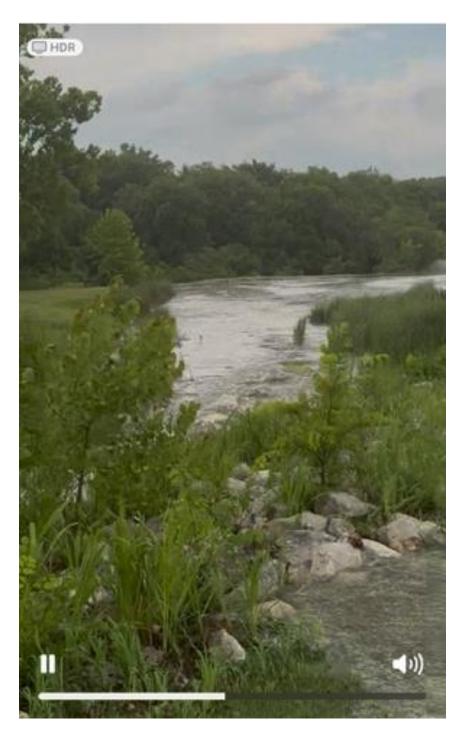
Picture 3: Inflow channel into Private Pond

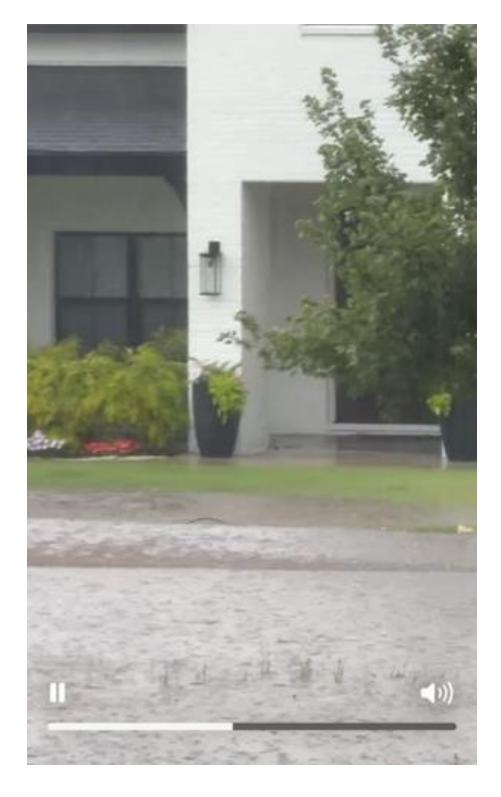
The applicant also has overland flow that comes from S. 9th Street (Lynn Lane) due to lack of drainage ditches or curb and gutter.

Picture 4: Overland sheet flow coming from the west onto Applicant's property

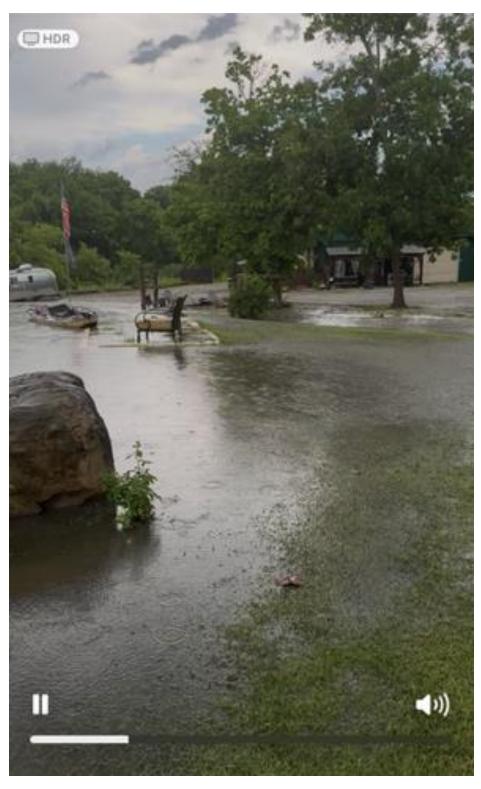
Picture 5: Looking south west of private pond towards Broken Arrow Creek.

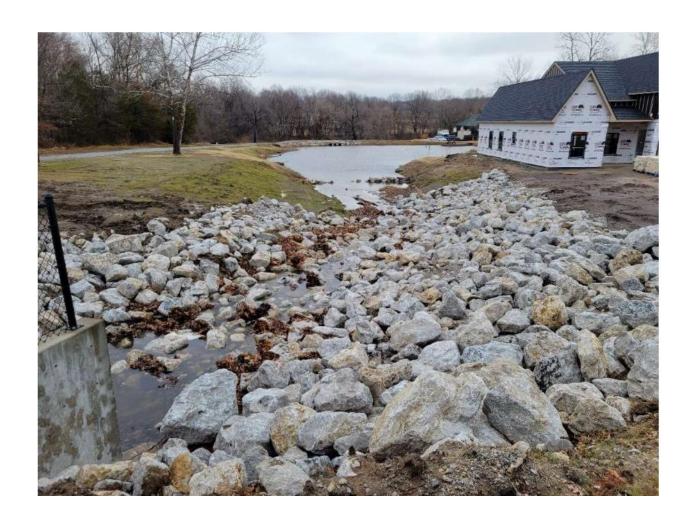
The applicant previously applied to the DAC for erosion concerns at the outlet pipe under Lynn Lane. The original case number was 20-003. Outlet/Channel Improvements were completed in 2021 and \$76,131.66 of proposition 6 funds were expended on this applicant's property.

Picture 6: Standing at Lynn Lane looking east towards Broken Arrow Creek. Previous DAC improvements from Case Number 20-003 Agenda Item 20-1193. Improvements complete in 2021. Total amount spent was \$76,131.66 for upsizing culvert and addressing erosion from culvert.
